ACCIDENT

Aircraft Type and Registration:	Piper PA-34-200T Seneca II, G-CLUE	
No & Type of Engines:	2 Continental Motors Corp TSIO-360-EB piston engines	
Year of Manufacture:	1979 (Serial no: 34-7970502)	
Date & Time (UTC):	28 July 2013 at 1140 hrs	
Location:	Durham Tees Valley Airport	
Type of Flight:	Private	
Persons on Board:	Crew - 2	Passengers - None
Injuries:	Crew - None	Passengers - N/A
Nature of Damage:	Damage to left engine, propeller, main landing gear, flap and aileron	
Commander's Licence:	Private Pilot's Licence	
Commander's Age:	53 years	
Commander's Flying Experience:	2,500 hours (of which 200 were on type) Last 90 days - 45 hours Last 28 days - 5 hours	
Information Source:	Aircraft Accident Report Form submitted by the pilot

Synopsis

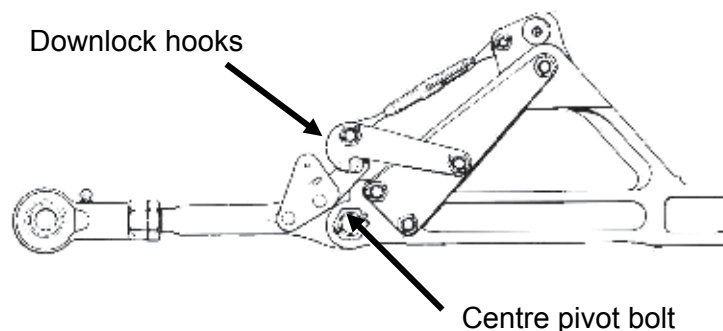
Figure 1

MLG downlock with hooks shown correctly engaged on pin

Following the accident, during recovery of the aircraft to a hangar, it was observed that the downlock hooks (Figure 1) would not engage and an improvised strut was used to secure the downlock to allow for towing to a hangar. Here the gear was retracted using a hand pump, since the aircraft electro-hydraulic pump also appeared to be inoperative, followed by a free-fall emergency extension. It was found that the nose and right main gears fell under gravity and locked normally but the left gear remained partially 'up' and had to be pulled down manually. The centre pivot bolt (Figure 1) was slightly slackened off and lubrication was applied to the downlock mechanism. Further free-fall extensions were successful inasmuch as the gear dropped fully down under gravity but the downlock hook still did not engage; levering the hook into engagement with a screwdriver was necessary to overcome stiffness caused by corrosion and lack of lubrication.

It is considered that the inability of the left MLG to lock down was the result of two separate factors: the first was the failure of the electro hydraulic pump that prevented normal extension of the landing gear, the second was the inability of the left MLG to fully lock-down under gravity because of overtightness of the pivot bolt in addition to corrosion and lack of lubrication. In the experience of the engineer who examined the aircraft post-accident, intermittent operation of the landing gear is often a symptom of excess wear of the brushes and commutator in the electro-hydraulic pump.
