**ACCIDENT**

<b>Aircraft Type and Registration:</b>	Avro 146-RJ100, G-BXAR
<b>No &amp; Type of Engines:</b>	4 Lycoming LF507-1F turbofan engines
<b>Year of Manufacture:</b>	1997
<b>Date &amp; Time (UTC):</b>	13 February 2009 at 1940 hrs
<b>Location:</b>	London City Airport
<b>Type of Flight:</b>	Commercial Air Transport (Passenger)
<b>Persons on Board:</b>	Crew - 5                      Passengers - 67
<b>Injuries:</b>	Crew - None                      Passengers - 2 (Minor)
<b>Nature of Damage:</b>	Nose landing gear fractured, internal and external damage to lower forward fuselage
<b>Commander's Licence:</b>	Air Transport Pilot's Licence
<b>Commander's Age:</b>	35 years
<b>Commander's Flying Experience:</b>	4,730 hours (of which 2,402 were on type) Last 90 days - 73 hours Last 28 days - 21hours
<b>Information Source:</b>	AAIB Field Investigation

**Synopsis**

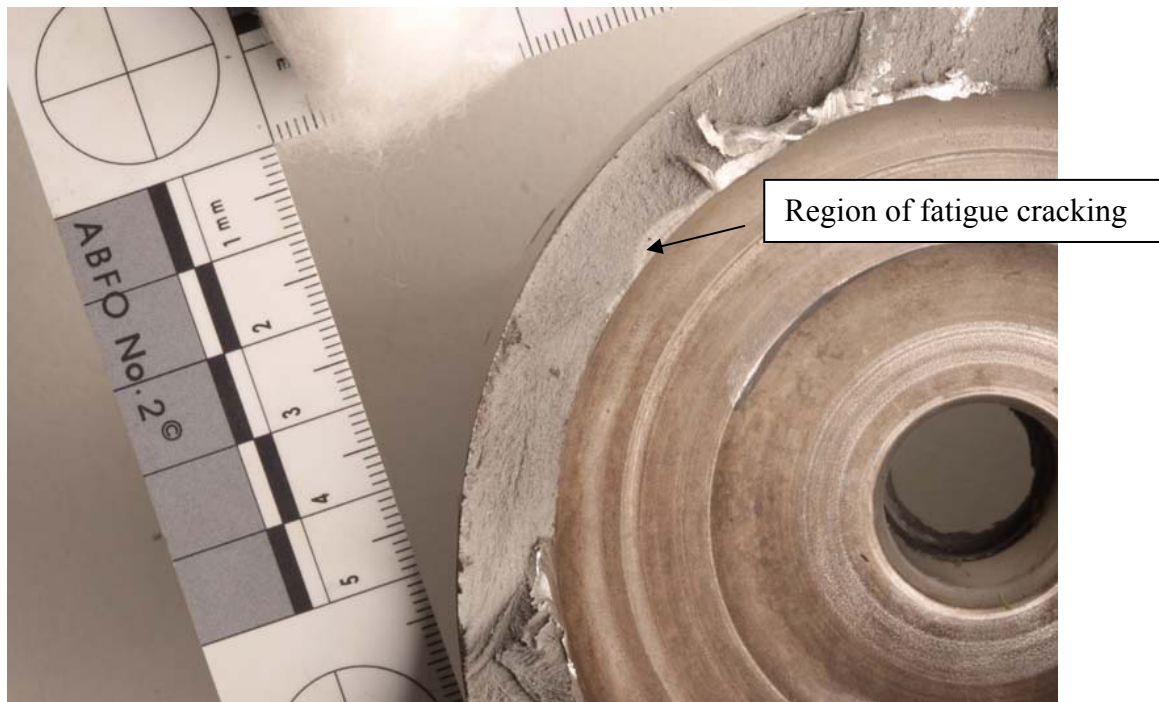
**Figure 4**  
Fracture surface of main fitting

Metallurgical examination of the main fitting confirmed that there were no material or microstructure abnormalities. However, examination of the main fitting fracture surface identified the presence of three fatigue cracks, which had become conjoined to form a single crack extending 23.2 mm around the circumference of the upper section of the internal bore, with a maximum depth of 2.21 mm, Figure 4. The location of the fatigue cracks was the same as found on the two fatigue tests.

A count of the striations within the fatigue cracks indicated that crack propagation had occurred for approximately 2,800 cycles prior to failure. The origin of these fatigue cracks was in the trough of a fine circumferential machining groove produced in the bore at the time the unit was manufactured. Smaller cracks were also found along the same groove and in adjacent grooves. Examination of the inner bore confirmed

that the shot-peening process had been carried out, in accordance with the requirements of SB 146-32-150, but that the surface roughness close to the origin of the fatigue cracks was 9.5 to 10.1 microns, in excess of the finish specified in the service bulletin.

The nose landing gear main fitting failed following the formation of multiple fatigue cracks within the upper section of the inner bore, originating at the base of machining grooves in the bore surface. These had formed because the improved surface finish, introduced by SB 146-32-150, had not been properly embodied at previous overhaul by Messier Services Inc, despite their overhaul records showing its incorporation. The operator had been in full compliance with the Service Bulletin relating to regular inspection of the main fitting, and embodiment of SB 146-32-150 at overhaul removed the requirement for these inspections by the operator.

BAE Systems Alert Service Bulletin A32-180, issued on 25 February 2009, reintroduced the repetitive in-service inspection requirements of Messier Dowty SB 146-32-149 on nose landing gear main fittings that had SB 146-32-150 embodiment claimed by Messier Services Inc. EASA Airworthiness Directive 2009-043-E, also

Messier Dowty issued Service Bulletin SB 146-32 173 on 30 September 2009, which required borescope inspection of nose landing gear main fittings overhauled by Messier Services, Sterling, Virginia, to verify the proper incorporation of Messier Dowty SB 146-32-150.
