Luscombe 8F Silvaire, G-AKUF

AAIB Bulletin No: 9/2003	Ref: EW/G2003/05/27	Category: 1.3
Aircraft Type and Registration:	Luscombe 8F Silvaire, G-AKUF	
No & Type of Engines:	1 Continental C90-12F piston engine	
Year of Manufacture:	1947	
Date & Time (UTC):	25 May 2003 at 1245 hrs	
Location:	Private landing strip at Guestling, near Hastings, Sussex	
Type of Flight:	Private	
Persons on Board:	Crew - 1	Passengers - None
Injuries:	Crew - None	Passengers - N/A
Nature of Damage:	Bent propeller and landing gear. Fuselage beyond economic repair	
Commander's Licence:	Airline Transport Pilot's Licence	
Commander's Age:	44 years	
Commander's Flying Experience:	1,599 hours (of which 347 were on type)	
	Last 90 days - 19 hours	
	Last 28 days - 17 hours	
Information Source:	Aircraft Accident Report Form submitted by the pilot

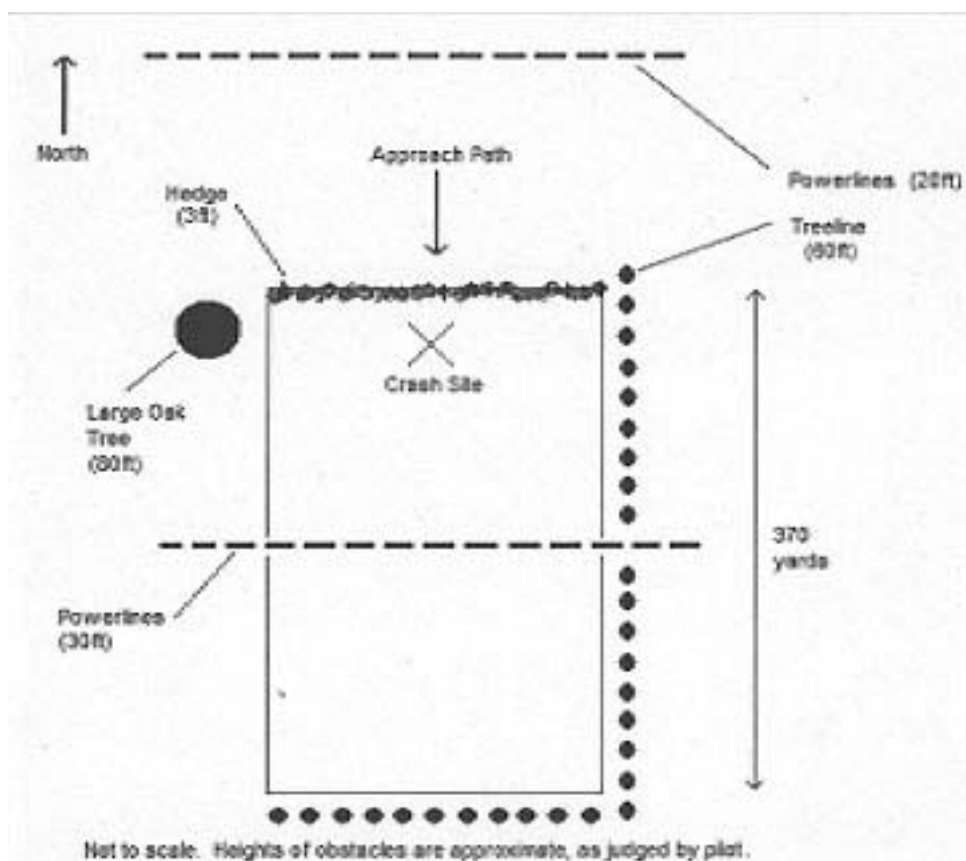
Having departed Cardington near Bedford, the pilot was attempting to land in a field surrounded by obstacles. A 3-foot high hedge ran along the northern edge of the strip, along the southern and eastern edges there were 60-foot tree lines and on the north-west corner grew an 80-foot oak tree. Power lines of height 20 feet were present north of the hedge lying across the approach while 30-foot power lines ran over the strip roughly halfway along its length. The disposition of these obstacles is shown on the diagram below; all the heights quoted were estimated by the pilot.
