INCIDENT

Aircraft Type and Registration:	Boeing 747-400, 9M-MPL	
No & Type of Engines:	4 Pratt and Whitney 4056 turbofan engines	
Year of Manufacture:	1998	
Date & Time (UTC):	18 May 2006 at 0425 hrs	
Location:	Over the Thames Estuary, England	
Type of Flight:	Public Transport (Passenger)	
Persons on Board:	Crew - 20	Passengers - 348
Injuries:	Crew - None	Passengers - None
Nature of Damage:	None	
Commander's Licence:	Airline Transport Pilot's Licence	
Commander's Age:	47 years	
Commander's Flying Experience:	13,493 hours (of which 2,804 were on type) Last 90 days - 72 hours Last 28 days - 38 hours	
Information Source:	AAIB Field Investigation

Synopsis

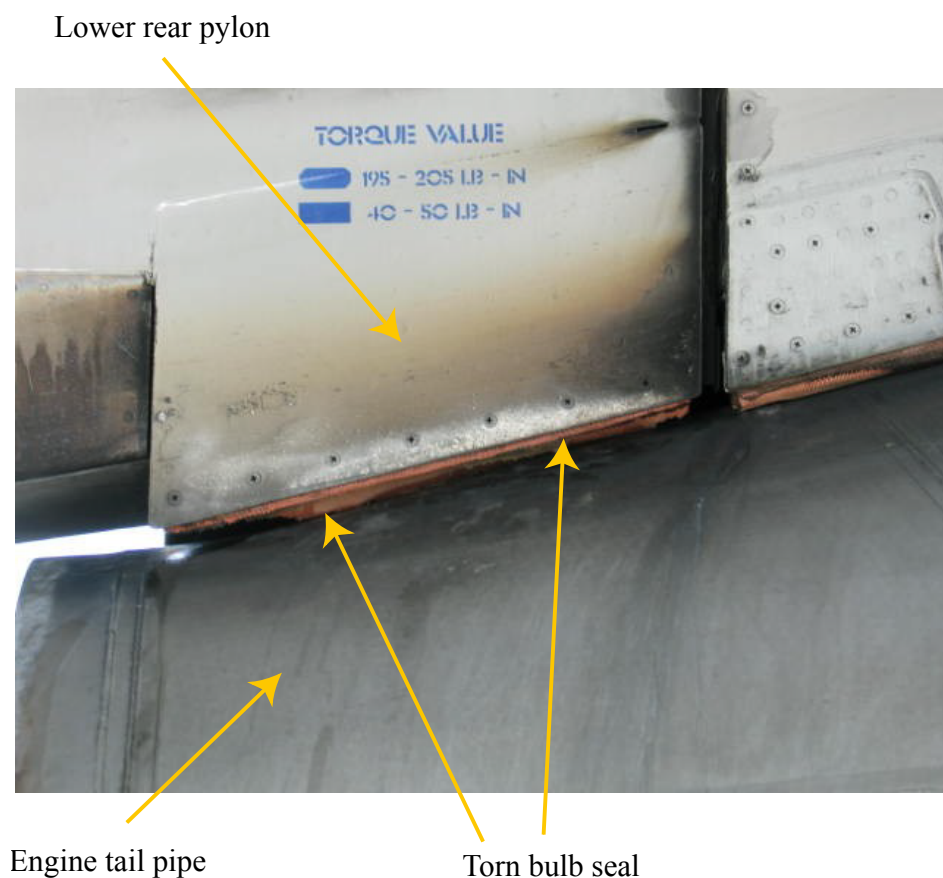
Figure 1

a number of previous incidents of reported airborne fire in the area of the lower rear pylon and the engine tail pipe. In each case extensive examination on the ground found no evidence of a fire having taken place but that the inboard 'sacrificial' bulb seal between the lower rear area of the pylon and the tail pipe had torn/failed. These bulb seals, part number 313T3371-21, are circular in cross-section, hollow, approximately 1.25 inches in diameter, 14 inches long, and made from flame-orange-coloured, high temperature, silicon rubber. Examination of the aircraft involved in this incident showed that the bulb seal on the inboard side of the No 1 lower rear pylon (Figure 1) had torn/failed along its fore/aft axis allowing the outer section to protrude into the air stream around the pylon.

airport where low and high engine power runs were carried out. During these engine runs no fluid leaks were noted and all flight deck indications were normal. An observer was placed in the seat in the cabin from where the 'cruise' co-pilot observed the flames during the aircraft's descent and he noted that during the full power run the torn bulb seal 'flapped' in the airflow in a way that could very easily be mistaken for a flame. This 'flapping' bulb seal was also seen by ground observers.

The torn bulb seal was changed and the aircraft returned to service with no further problems reported regarding airborne fires in the areas of the pylon tail pipe interface.
