INCIDENT TO G-BFVV

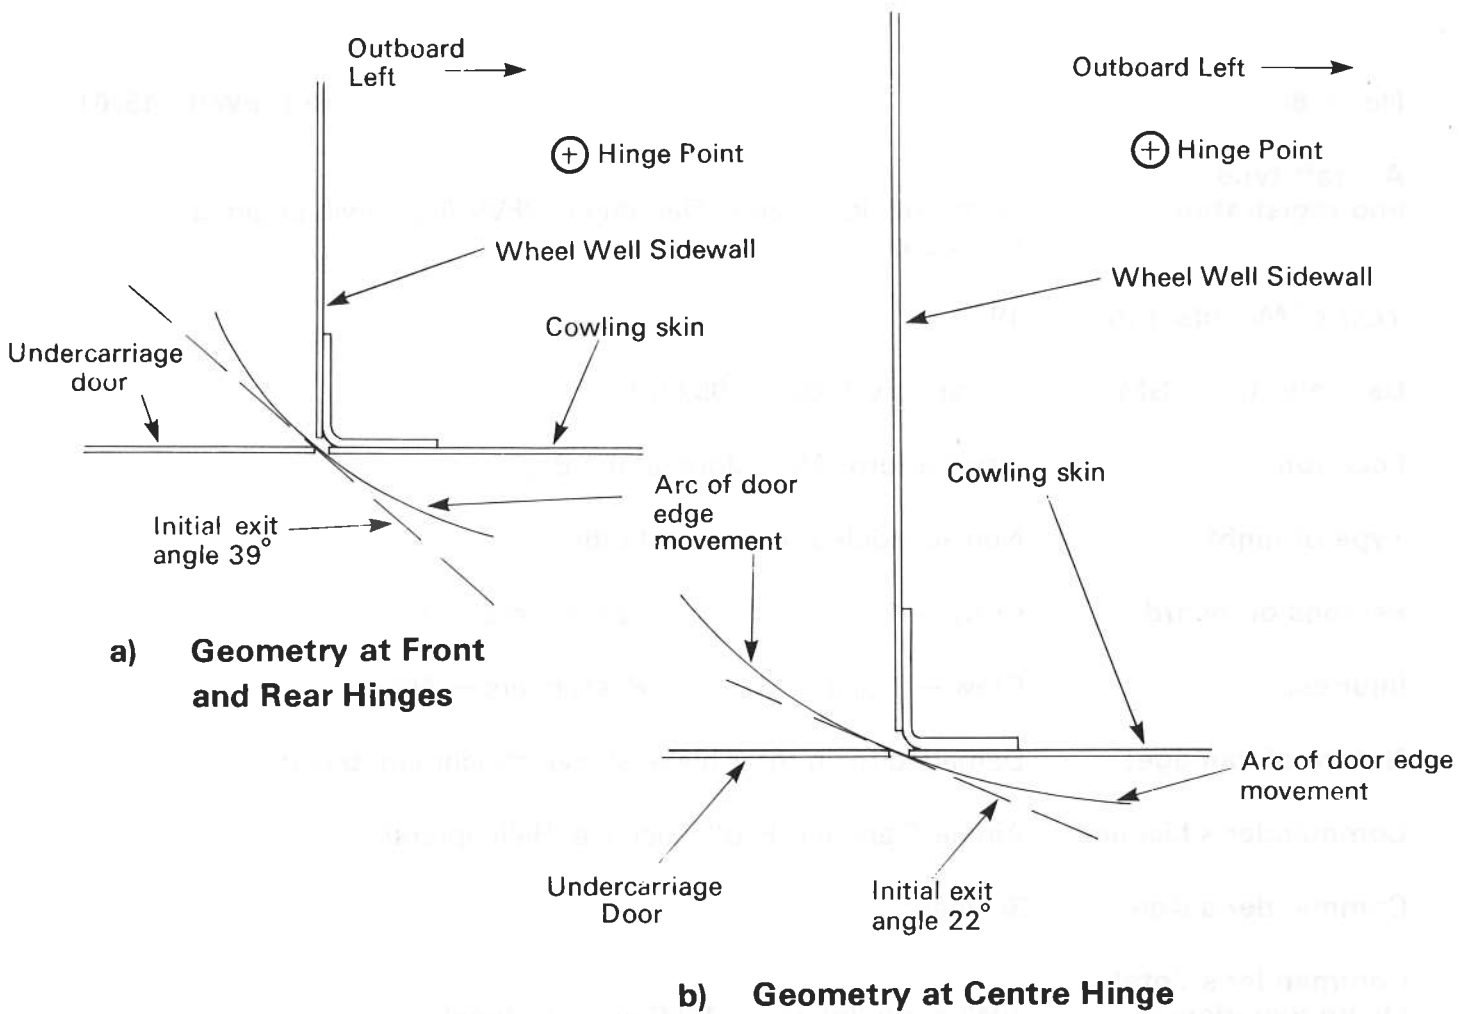
a) Geometry at Front and Rear Hinges

b) Geometry at Centre Hinge

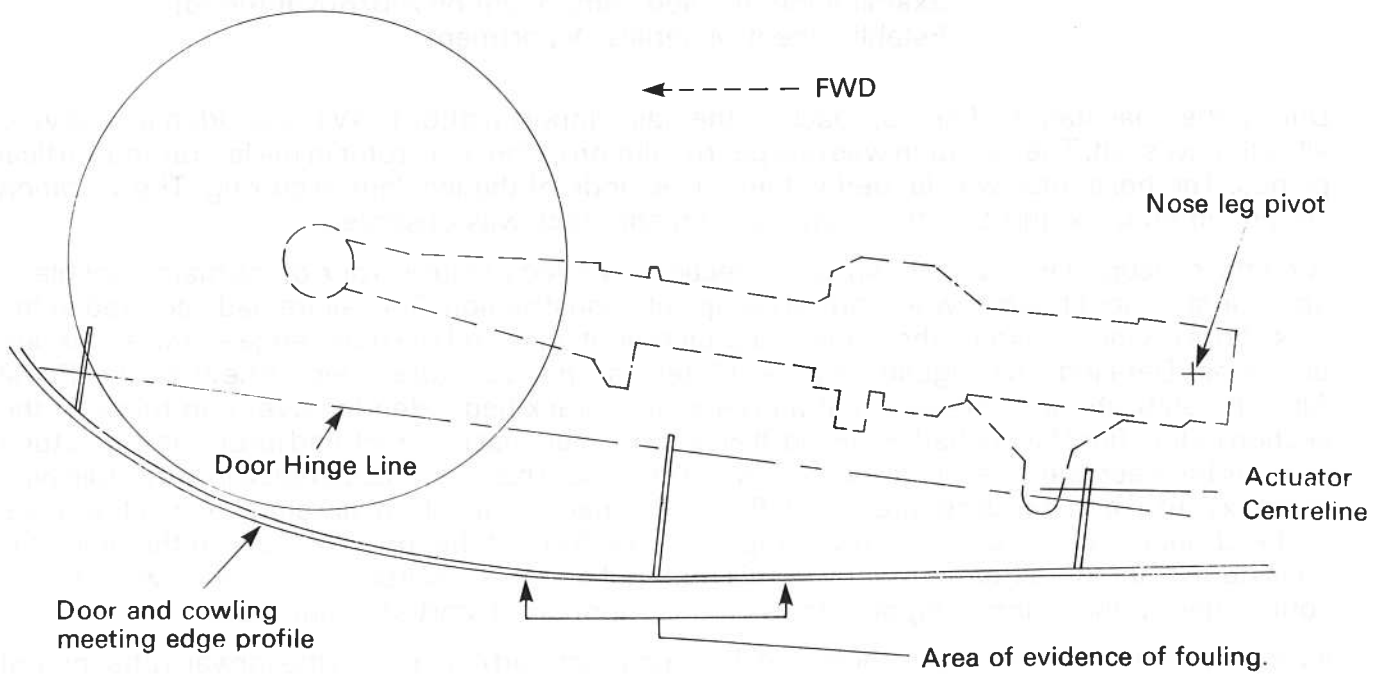
c) Side view of nose undercarriage and door

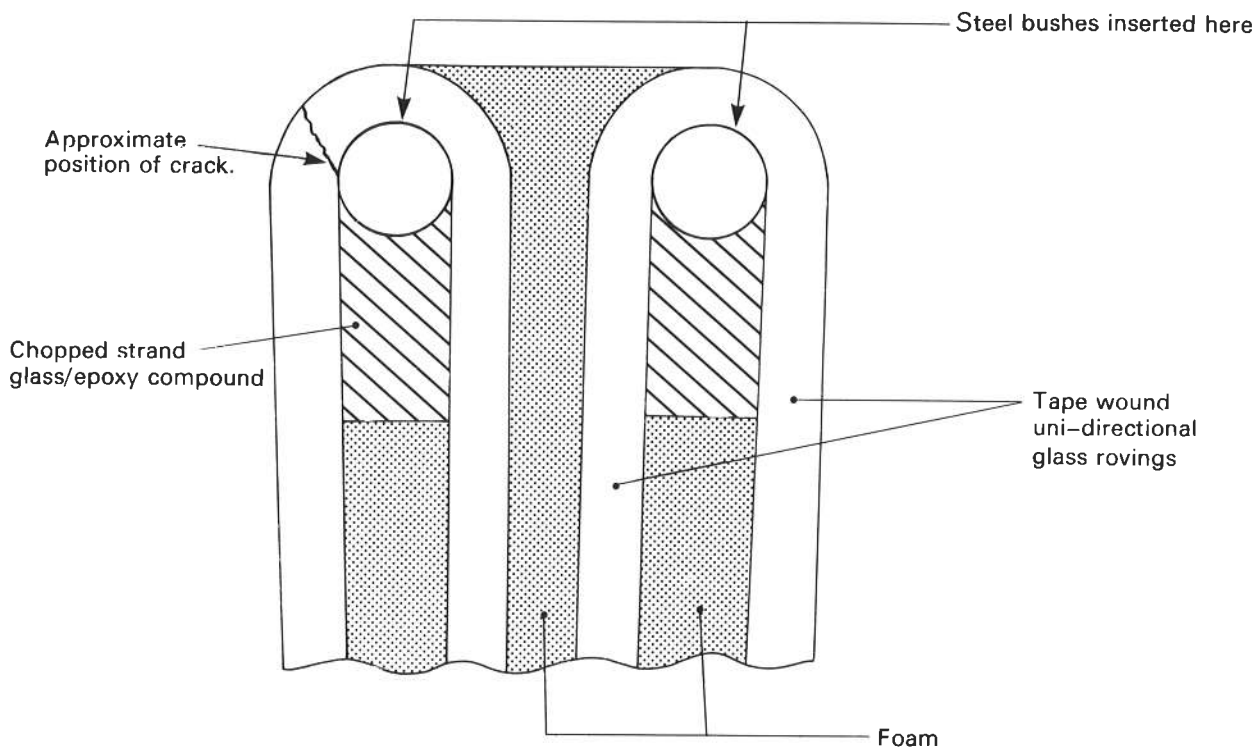
Main rotor blade attachment beam construction details

The subject helicopter had achieved more than 7200 hours and been operated on very short sectors, leading to a high number of cycles. Following the discovery of fretting damage on a number of other helicopters, the manufacturers, together with the French Airworthiness Authorities, have imposed a 3000 hour life on the component by means of an Airworthiness Directive. This has been adopted by the United Kingdom Civil Aviation Authority.
