Aircraft Details

Wreckage and Impact Information

Certification Aspects

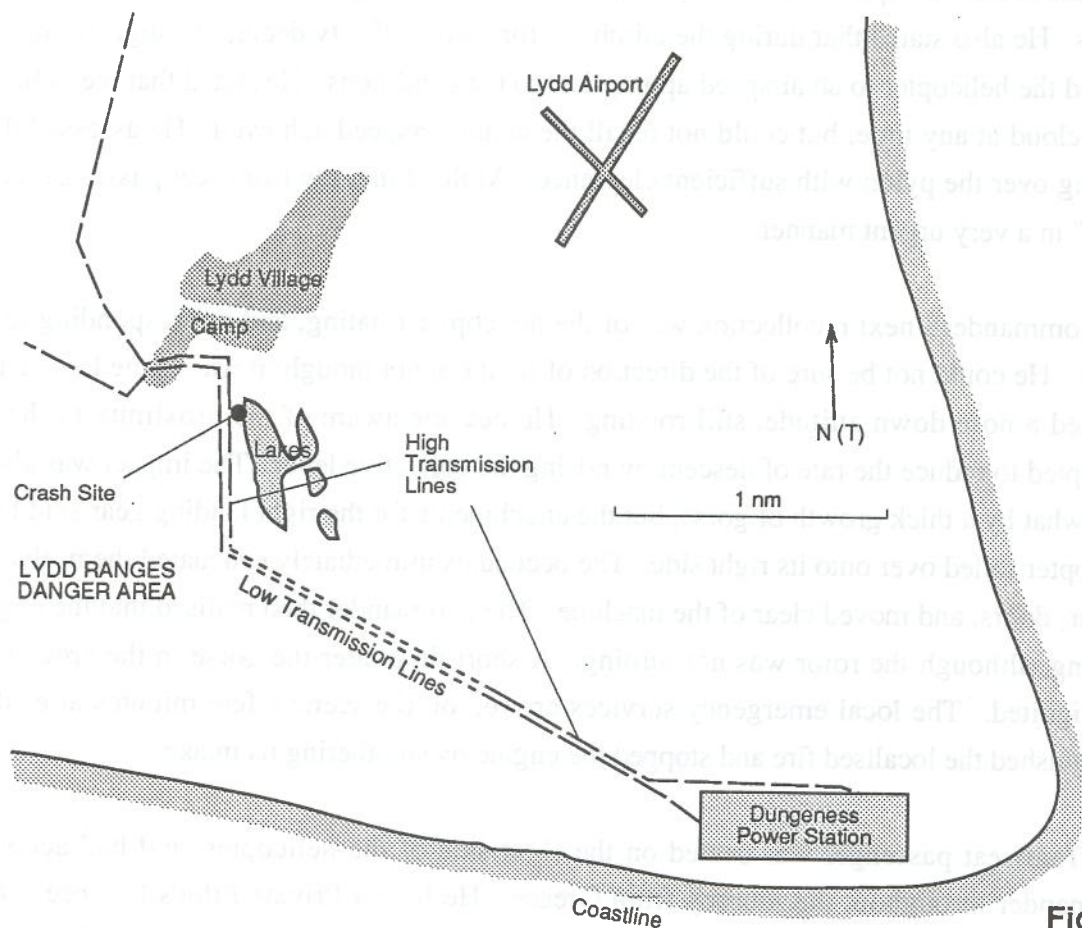
Fig 1

making a practice instrument approach and go-around. During this period, the pilot of 'OO' called 'RO' on a prearranged discrete frequency advising him of power transmission cables running just west of Lydd Airport (Fig 1). The commander of 'RO' was aware of these, having previously visited Lydd Airport on several occasions.

Two parallel sets of high voltage electricity cables supported by pylons originate from Dungeness Power Station, which is located some 2.5 nm south-southeast of Lydd Airport. In the climbout area of Runway 22, the pylons are shorter than those in normal use, in order to effect greater clearance for aircraft operating to or from Lydd. To the northwest of the climbout area, the pylons revert to the more typical structures in common use, these being approximately 185 feet in height agl. Both sets of cables exhibit two marked changes of direction in the vicinity of the accident site, in order to route around the boundaries of the Lydd Ranges Danger Area (D044).
