ACCIDENT

Aircraft Type and Registration:	Glasair RG, G-BKHW	
No & Type of Engines:	1 Lycoming O-320-D1A piston engine	
Year of Manufacture:	1989	
Date & Time (UTC):	26 April 2009 at 1706 hrs	
Location:	Cranwell Airfield, Lincolnshire	
Type of Flight:	Private	
Persons on Board:	Crew - 1	Passengers - 1
Injuries:	Crew - None	Passengers - None
Nature of Damage:	Damage to engine cowling, propeller and landing gear	
Commander's Licence:	Private Pilot's Licence	
Commander's Age:	66 years	
Commander's Flying Experience:	339 hours (of which 47 were on type) Last 90 days - 15 hours Last 28 days - 9 hours	
Information Source:	Aircraft Accident Report Form submitted by the pilot

Synopsis

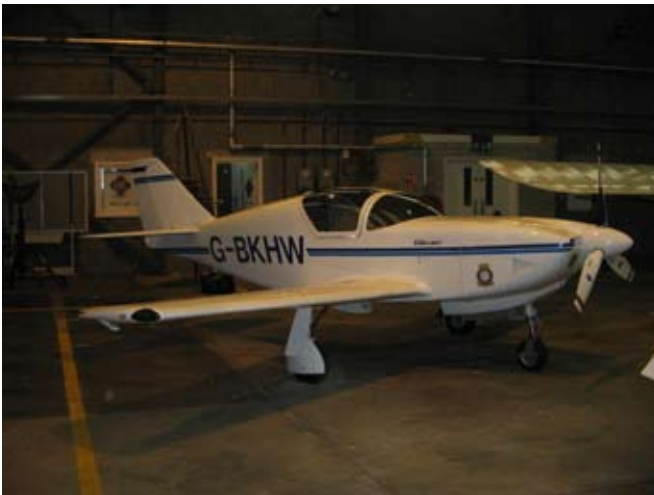
Figure 1

The aircraft, a Glasair RG (Figure 1), was being flown from Humberside to Cranwell. The pilot flying was a PPL-holder with a total flying experience of 236 hours, of which 2 hours were on type. During the takeoff roll at Humberside the aircraft started to oscillate in yaw before becoming airborne. The more experienced pilot, who was the aircraft's owner, took control but was unable to prevent the left wheel from contacting the runway and the right wheel from reportedly striking a runway edge light. Landing gear retraction after takeoff appeared normal.
