**ACCIDENT**

<b>Aircraft Type and Registration:</b>	EC225 LP Super Puma, G-REDW
<b>No &amp; Type of Engines:</b>	2 Turbomeca Makila 2A1 turboshaft engines
<b>Year of Manufacture:</b>	2009 (Serial no: 2734)
<b>Date &amp; Time (UTC):</b>	10 May 2012 at 1114 hrs
<b>Location:</b>	20 nm east of Aberdeen
<b>Type of Flight:</b>	Commercial Air Transport (Passenger)
<b>Persons on Board:</b>	Crew - 2                      Passengers - 12
<b>Injuries:</b>	Crew - None                      Passengers - 2 (Minor)
<b>Nature of Damage:</b>	Damage to be assessed following salt water immersion
<b>Commander's Licence:</b>	Airline Transport Pilot's Licence
<b>Commander's Age:</b>	To be advised
<b>Commander's Flying Experience:</b>	To be advised
<b>Information Source:</b>	AAIB Field Investigation

This Special Bulletin details the progress made in identifying the failure mechanism that caused the 360° circumferential crack, in the bevel gear vertical shaft in the helicopter's main gearbox, which was identified in the early stages of the investigation and published in AAIB Special Bulletin 2/2012 in May 2012. It also details progress on the investigation into the indicated failure of the main gearbox em

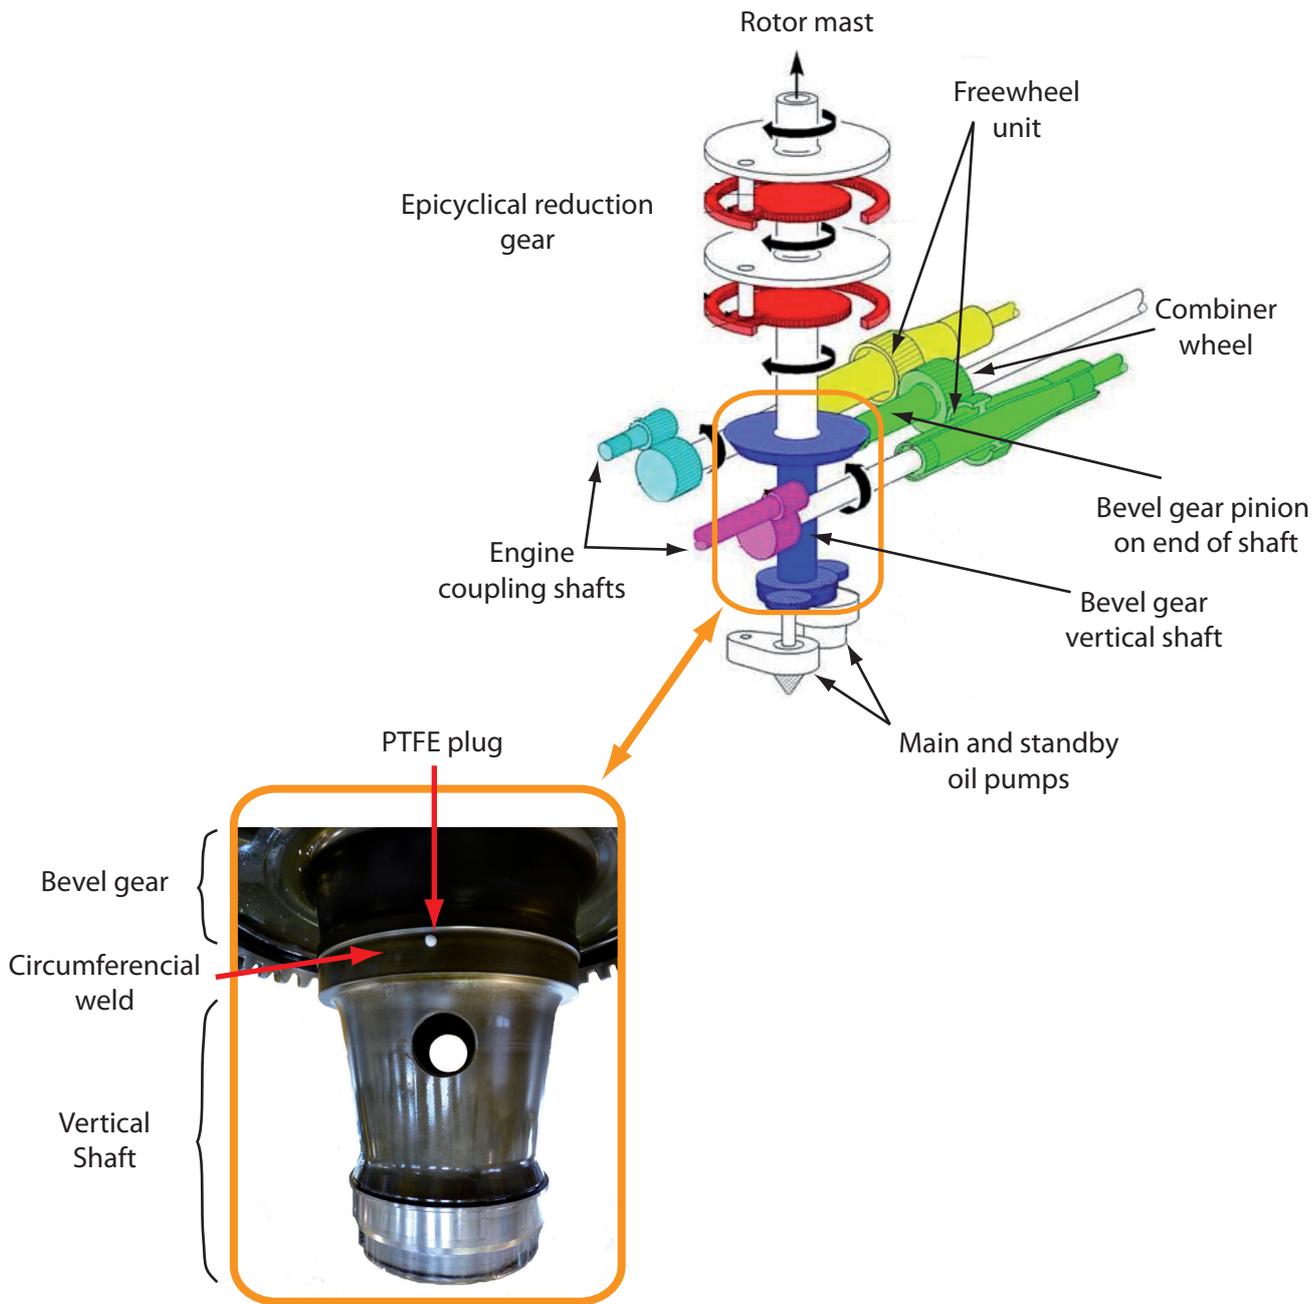
**Figure 1**  
MGB power train

bevel gear through the combiner wheel and bevel gear pinion. The majority of this power is then transmitted upwards into the epicyclical reduction gear module. Two pinion gears, mounted at the bottom of the bevel gear vertical shaft, drive the main and standby oil pumps. The power train through the gearbox is illustrated at Figure 1.
