## ACCIDENT

<b>Aircraft Type and Registration:</b>	Piper PA-28-161 Cherokee Warrior II, G-BSPM
<b>No &amp; Type of Engines:</b>	1 Thielert TAE 125-02-99 piston engine
<b>Year of Manufacture:</b>	1981
<b>Date &amp; Time (UTC):</b>	5 November 2010 at 1545 hrs
<b>Location:</b>	Ranmoor Common Road, Dorking, Surrey
<b>Type of Flight:</b>	Training
<b>Persons on Board:</b>	Crew - 2                      Passengers - None
<b>Injuries:</b>	Crew - 2 (Minor)          Passengers - N/A
<b>Nature of Damage:</b>	Damaged beyond economic repair
<b>Commander's Licence:</b>	Commercial Pilot's Licence
<b>Commander's Age:</b>	41 years
<b>Commander's Flying Experience:</b>	800 hours (of which 387 were on type) Last 90 days - 70 hours Last 28 days - 16 hours
<b>Information Source:</b>	AAIB Field Investigation

### Synopsis

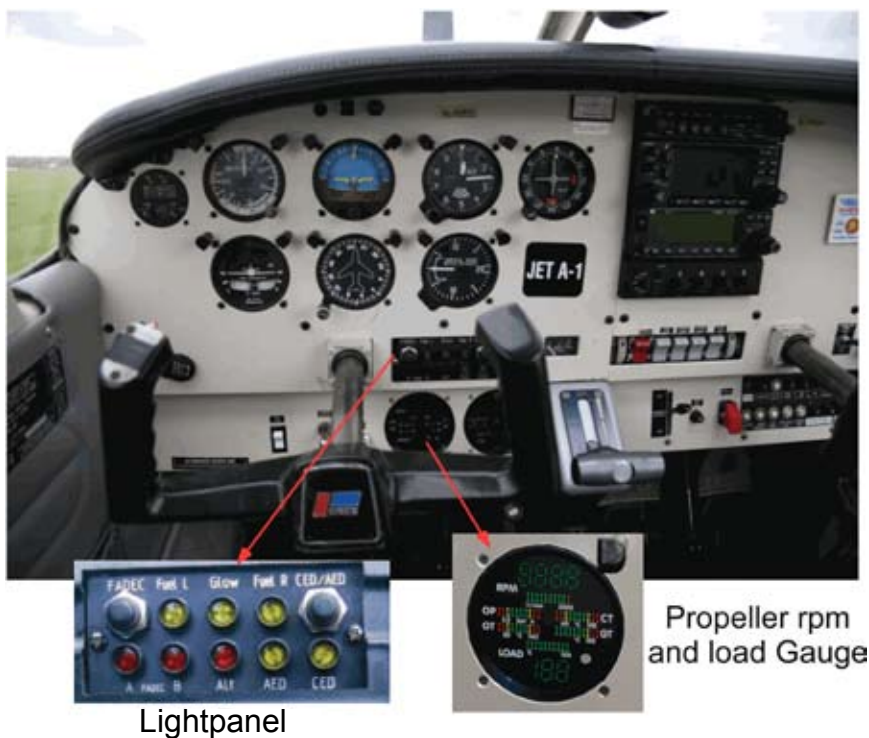
**Figure 1**  
Typical Thielert TAE 125 engine layout instrumentation

The only other indication of the overspeed condition would have been the illumination of the small red LED at the end of the rpm indication strip and the reading on the digital rpm gauge which, due to the nature of such gauges, would have been continually changing. In addition, the propeller rpm and load gauge was located low on the instrument panel, Figure 1. A review of the POH supplement confirmed that pilots are only directed to check the propeller rpm during the *'FADEC AND PROPELLER ADJUSTMENT FUNCTION CHECK'*; during all other phases of flight the 'load' gauge is the primary means of confirming engine power.
