AAIB Bulletin No: 3/95

Ref: EW/C94/12/5

Aircraft Type and Registration: Pierre Robin HR100/210 Safari II, G-TCAR

Location: Near Stapleford Tawney Airfield, Essex

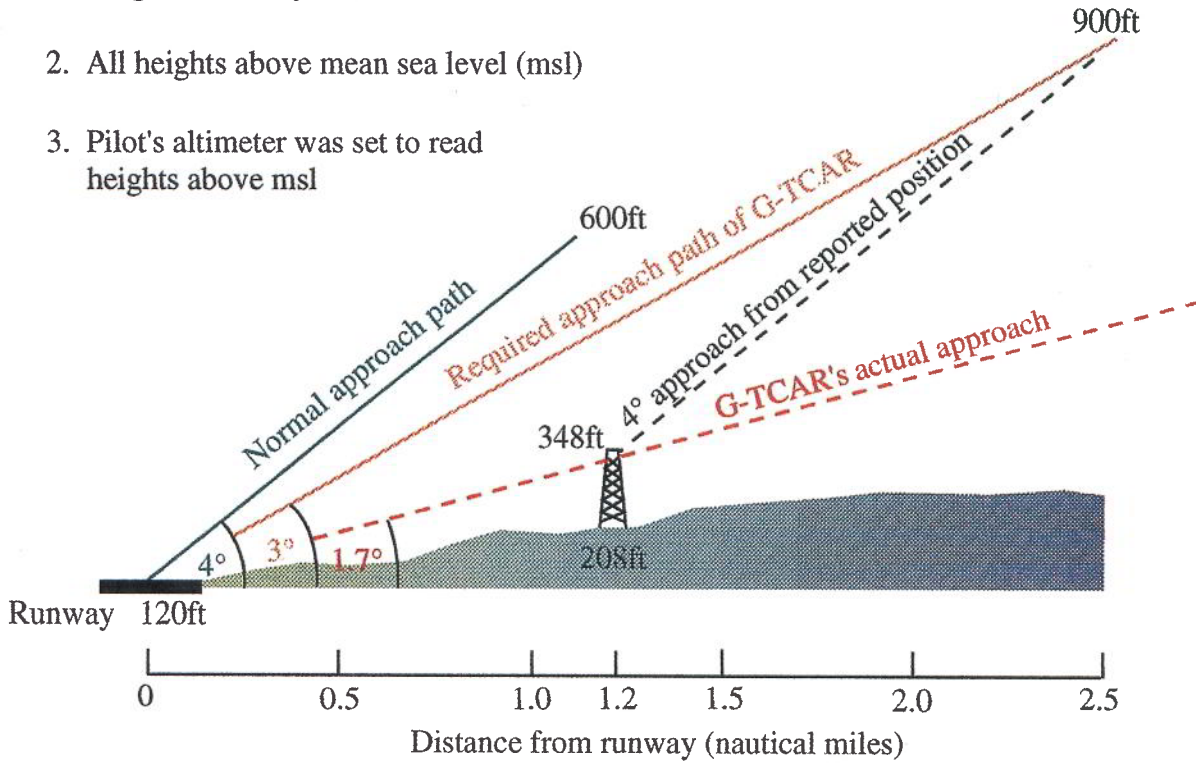
Figure 1

Common practice at Stapleford is that pilots should turn onto base leg for Runway 22 about 500 metres beyond the power cables ie 1.5 nm beyond the displaced threshold. Using standard configurations and power settings, this technique will result in a 4.0° glideslope to the runway and aircraft will pass over the power lines at an elevation of 600 feet giving a clearance of 252 feet. From its reported position on base leg, the accident aircraft would have subtended an approach angle of 3° and cleared the cables by 132 feet. An approach angle of 4° from the same position would have resulted in the aircraft striking the cables. The approach angle from the point of impact with the cables to the displaced threshold is 1.7° (see Figure 1).

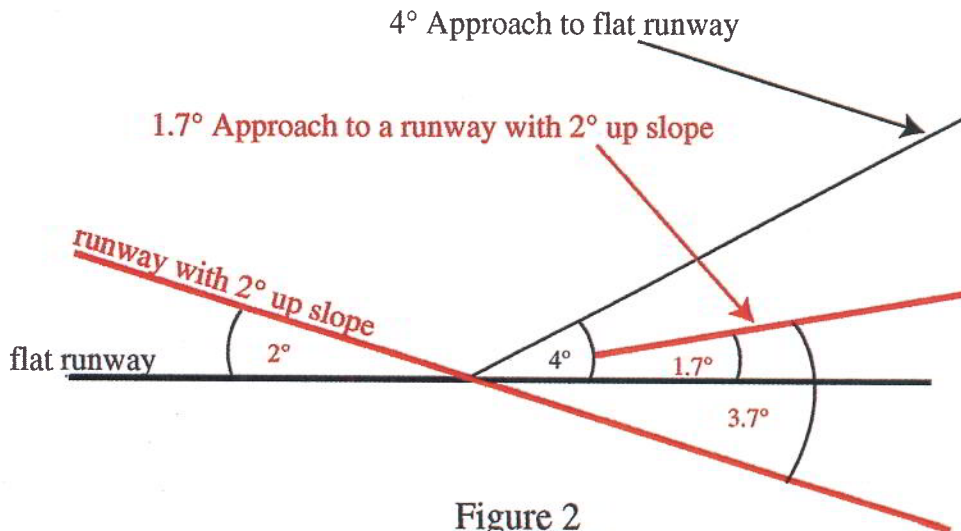
Figure 2

Runway 22 has an up-slope of 2.0° which, from a 1.7° approach, would give the same runway perspective as a 3.7° approach to a level runway (see Figure 2).
