Aerospatiale AS355 F1 Ecureuil II, G-MASK

AAIB Bulletin No: 2/2000 **Ref: EW/C98/7/7** **Category: 2.2**

Aircraft Type and Registration: Aerospatiale AS355 F1 Ecureuil II, G-MASK

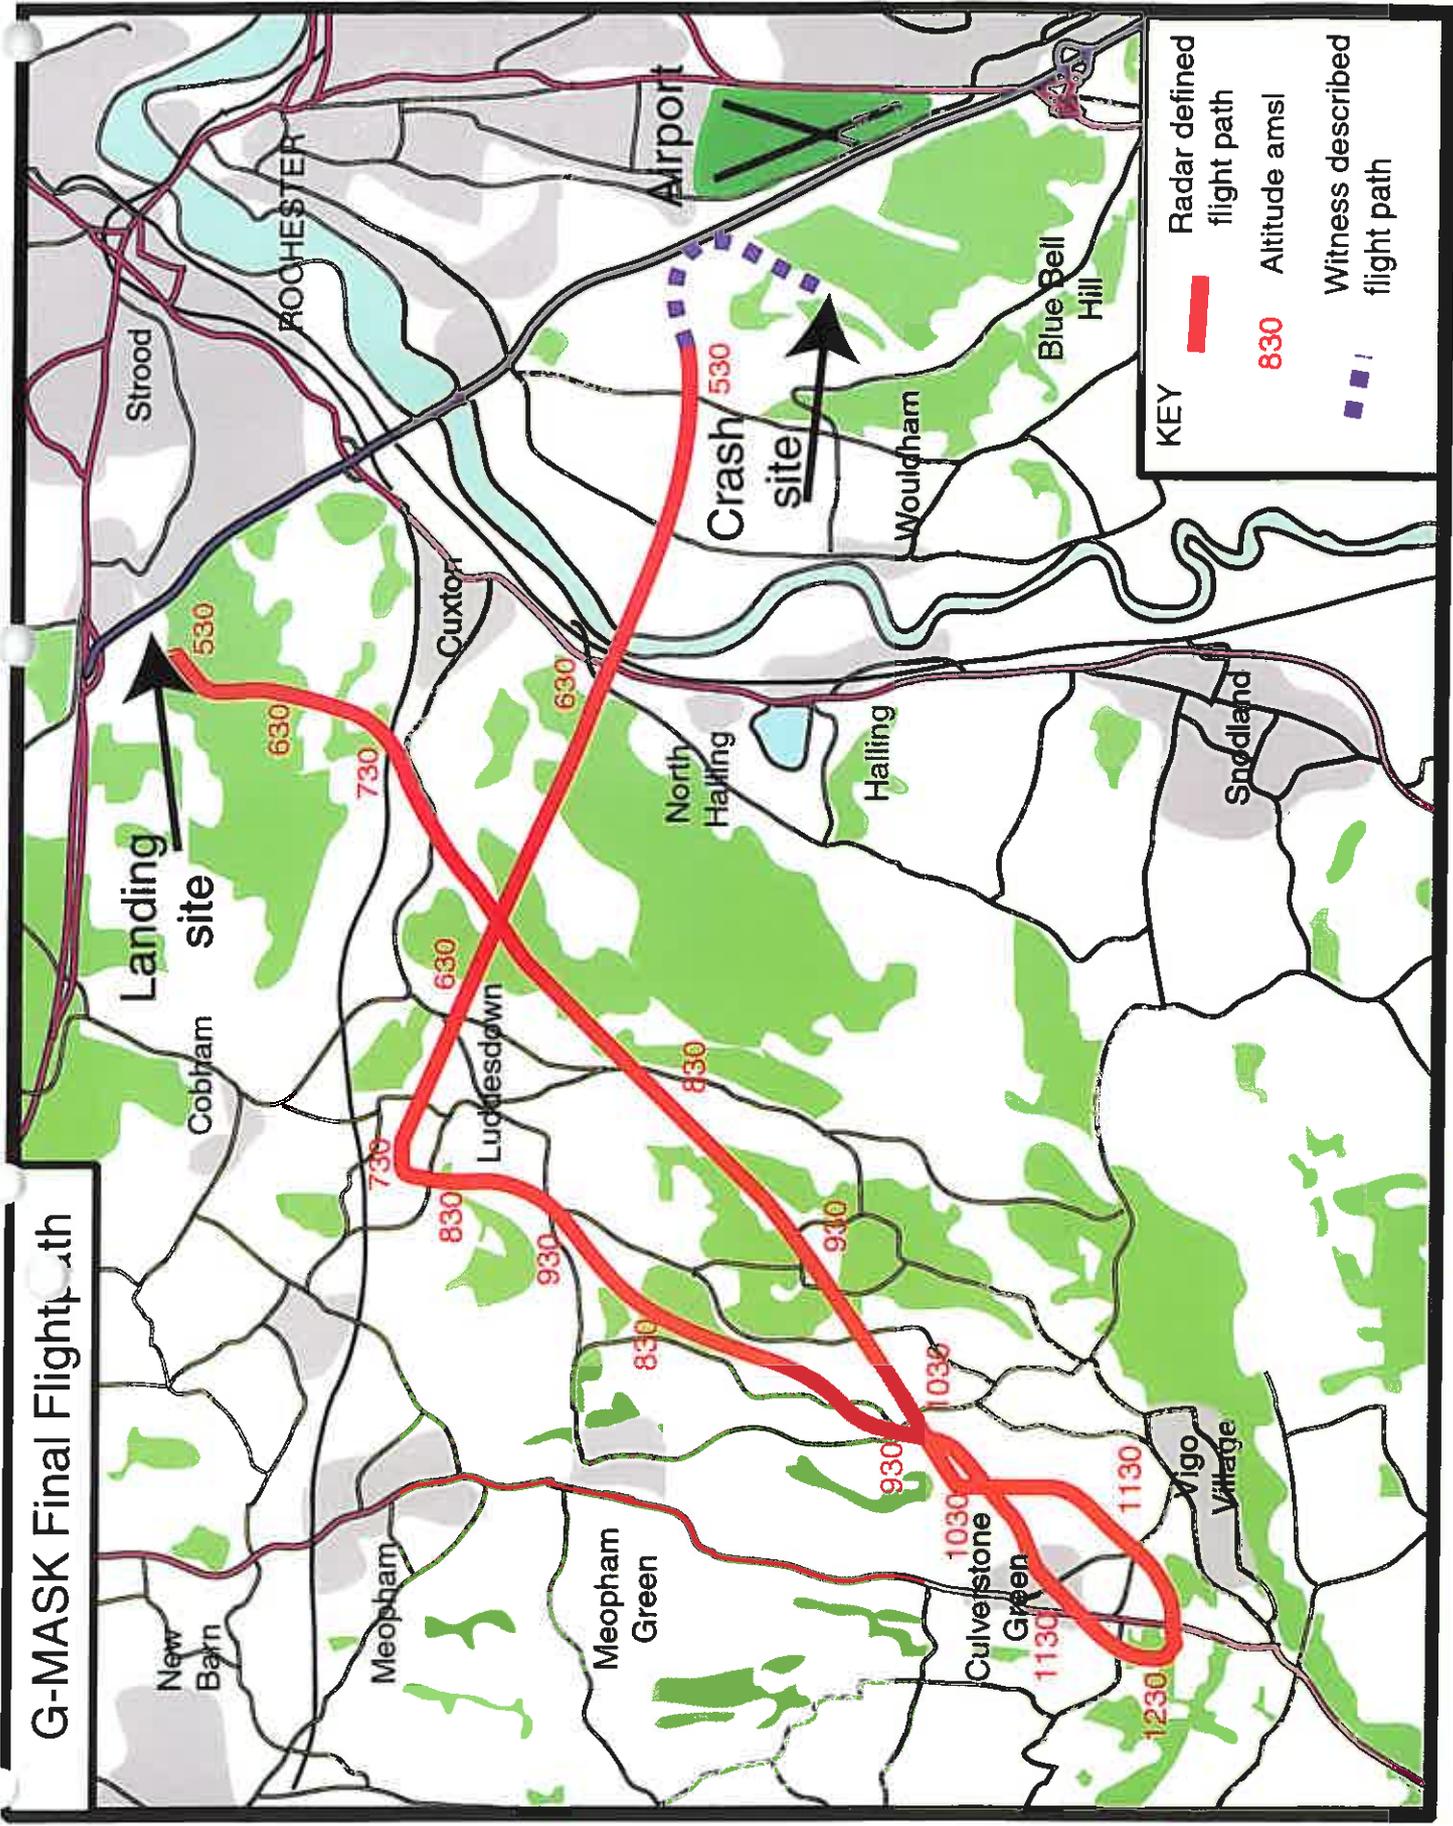
Figure 1

A direct return flight to Rochester Airport should have taken no more than two minutes and yet the helicopter was airborne for at least 12 minutes. G-MASK was fitted with a transponder which was operating on modes A and C and normally the pilots used a discrete mode A code which identified it as the Kent Air Ambulance. Mode C provided information on helicopter altitude. National Air Traffic Services were asked to search their radar recordings for any data bearing that code. Relevant data was recorded at the Debden radar head north of Stansted Airport. The data covered the time period 16:28:31 to 16:36:16 at 6 second intervals with no significant 'gaps' in coverage. The data stopped approximately 74 seconds before power in the electricity power cables at the accident site was cut. Just before the data stopped, the helicopter was in level flight travelling at about 125 kt groundspeed on an easterly heading taking it towards Rochester Airport. A plot of the radar data is attached to this report at Figure 1.

The Mode C altitude of each radar data point was corrected to show altitude above mean sea level which was then compared to the height of the terrain beneath the radar return. The points were then plotted graphically to illustrate height above ground. The graph showed that the helicopter had been flown between 400 and 500 feet above ground during the first and second legs. On the third leg it was 600 feet above the River Medway and 300 feet above the ground at the last radar return as it approached Rochester Airport.

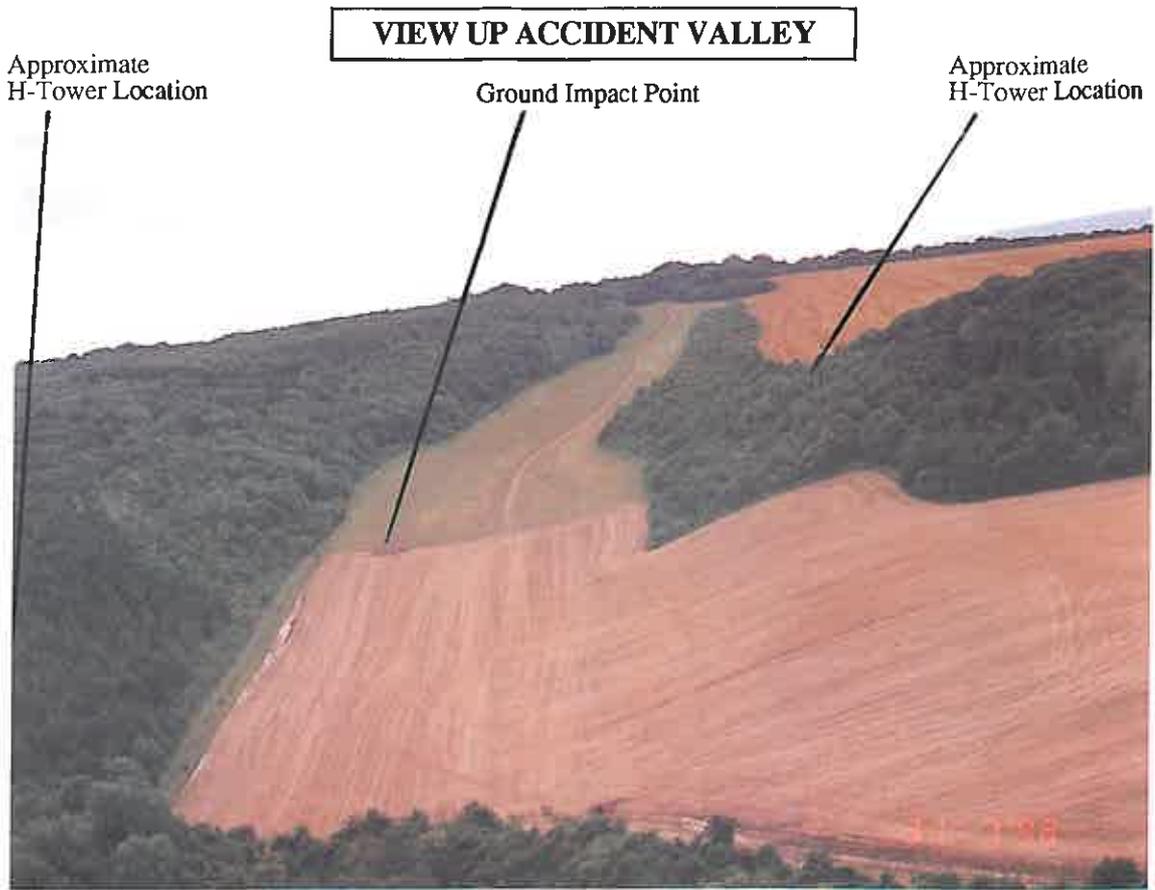
Figure 3.1

G-MASK crashed in a long narrow valley running up the north-east facing slope of the North Downs (Figure 3.1). The valley was oriented north-east to south-west and extended from the west side of the M2 motorway, at a height of 160 feet amsl, to near the top of Blue Bell Hill, at 450 feet amsl. The slope of the valley axis was 2.4° to the horizontal in the accident area and fairly constant along its length. The hillside in the vicinity of the valley was generally densely wooded but the central part of the valley floor was clear of trees, generally over a width of 100 to 120 metres. The surface of the cleared floor area in the lower portion of the valley was somewhat rough with long oilseed rape stubble and in the upper portion was relatively smooth with a cover of short grass. The surface in the ground impact area was of moderate density, dry and fairly firm earth.

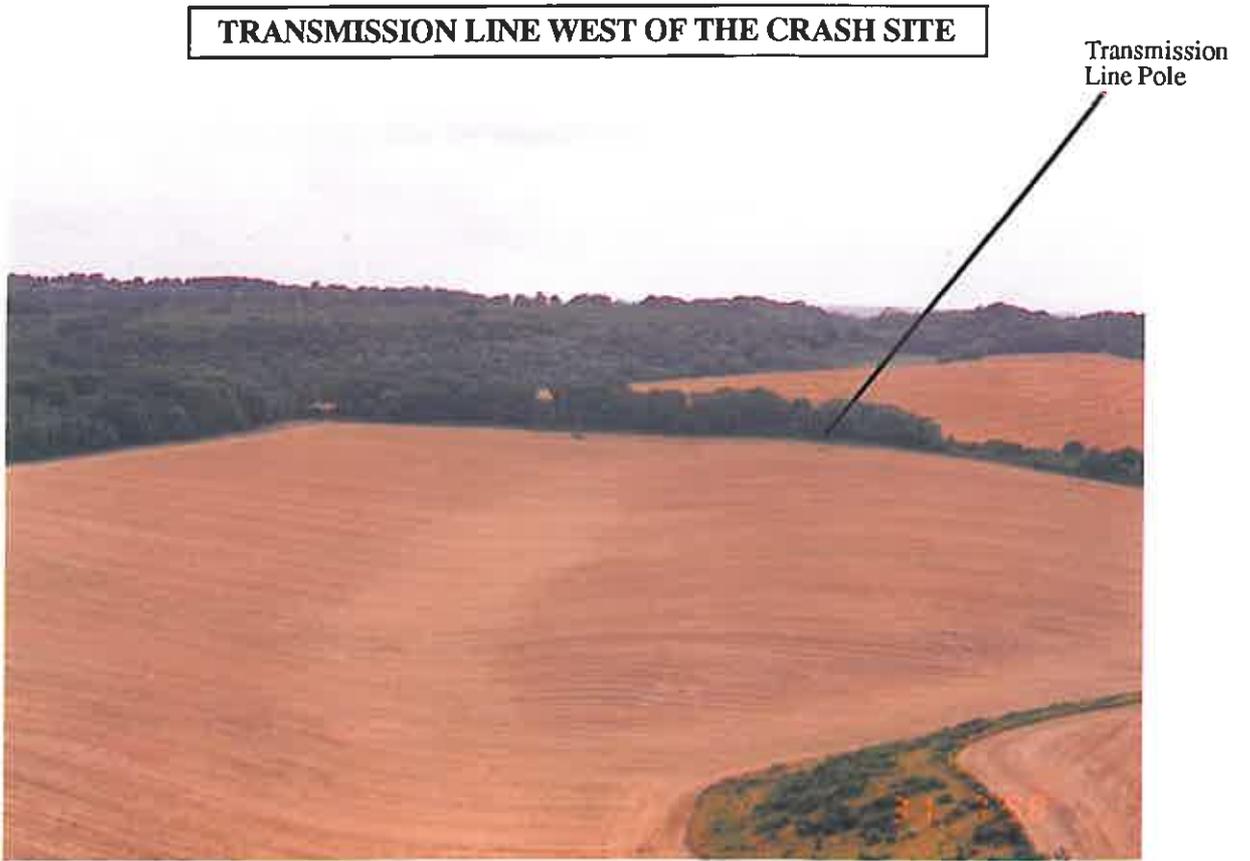
Figure 3.2

distance, even knowing their location. The line feature formed by the clearway was not apparent until virtually in line with it; the cables and poles in the woods were hidden by the trees; the small portions of the tops of the H-Towers that were not hidden tended to merge into the trees; and the cables spanning the valley were invisible at any significant range against their background of the rising ground of the valley. Additionally, the part of the line in the field to the west of the woods was quite inconspicuous against its background of the hedge of trees, with only the bottom of the poles showing (Figure 3.2).

View of Transmission Line Continuation in the Area West of the Valley

The severed cable was replaced some weeks after the accident and conical spiral markers were added to the cables across the valley to increase their conspicuity. The transmission line owner noted that no standards exist to define where cable conspicuity markers should be used and that it commonly encountered considerable opposition on environmental grounds to proposals for markers.

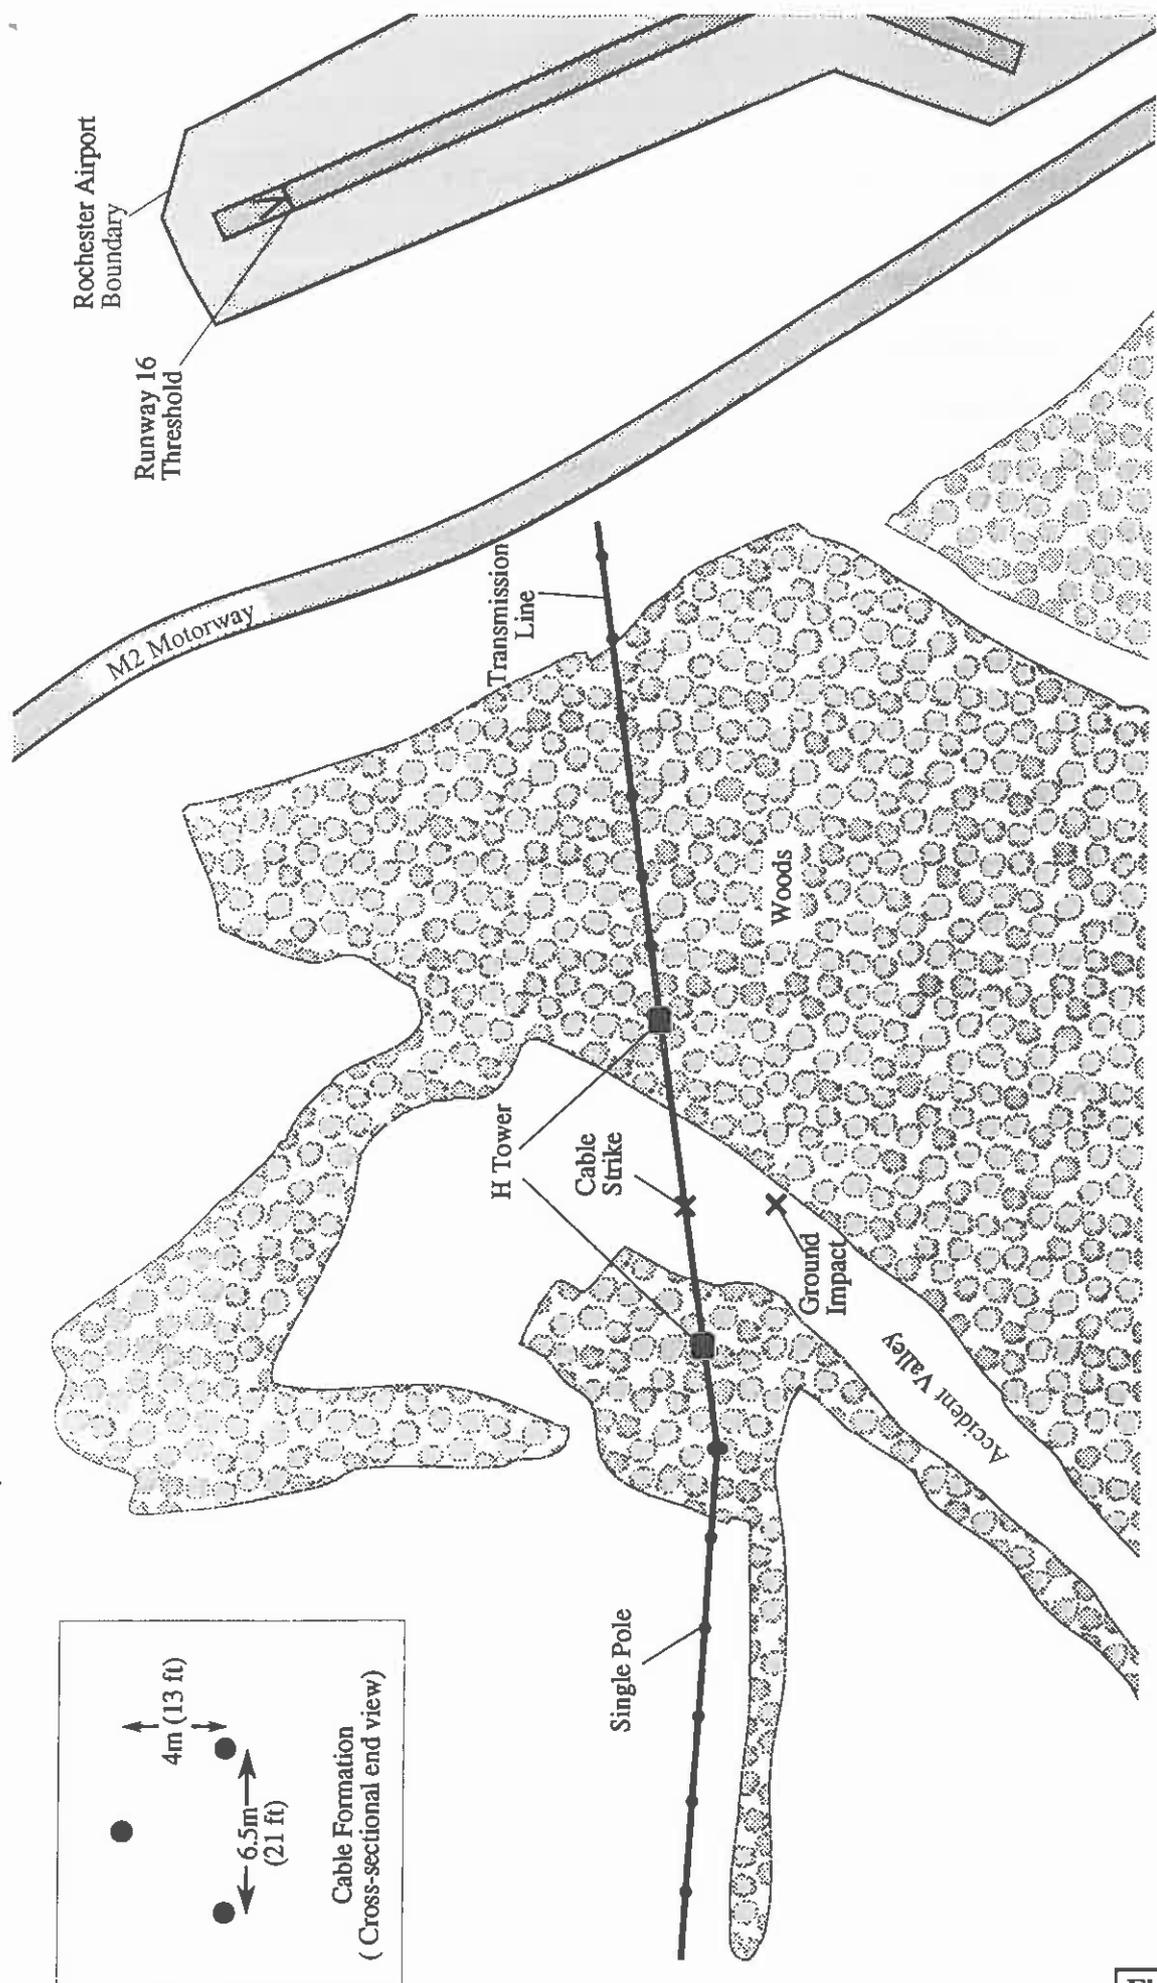
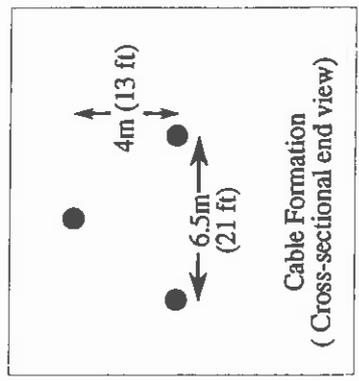
Figure 4

Examination of the accident site and the wreckage clearly showed that G-MASK had struck the upper cable of the transmission line at a position close to the centre of the valley (Figure 4) where the cable had been approximately 92 feet agl, 350 feet amsl. There was no evidence of aircraft contact with the lower cables; the possibility that contact had occurred without having caused apparent cable damage could not be dismissed. The fault logging system (see below) indicated that the first circuit breaker trip had been at 16:37:29 and that the cable had been carrying 79 amp at the time. The cable had been severed, with heavy deformation of the aluminium strands adjacent to the severance point. A few small aircraft fragments were found trapped between the strands but they had no identifying features enabling their origin to be established. Scattered wreckage was found in a trail starting beneath the line and spreading out up the valley. It consisted of small pieces of the aircraft, predominately fragments of broken transparency but including a number of items from the cabin interior, together with the cabin left rear door and the baggage compartment door located immediately behind it and the window from the cabin right forward door.

Ground marks and wreckage distribution showed that G-MASK had impacted the ground 88 metres beyond the cable strike point. It had struck towards the eastern margin of the valley floor immediately beyond the stubble/grassland boundary. The evidence indicated that it had contacted the ground while pitched approximately 90° nose down, with moderate vertical speed and low horizontal speed. The forward end of both landing gear skids buried themselves in the ground and broke off and one main rotor blade sustained a heavy ground strike normal to the ground surface, ie while rotating in an approximately vertical plane. The blade penetrated the ground to a maximum depth of 0.3 metres. The helicopter came to rest upright, heading approximately south-west up the valley.
