ACCIDENT

Aircraft Type and Registration:	Beech B200 Super King Air, G-BYCP	
No & Type of Engines:	2 Pratt & Whitney PT6A-42 turboprop engines	
Year of Manufacture:	1981	
Date & Time (UTC):	24 March 2007 at 1635 hrs	
Location:	Southend Airport, Essex	
Type of Flight:	Commercial Air Transport (Passenger)	
Persons on Board:	Crew - 2	Passengers - 5
Injuries:	Crew - None	Passengers - None
Nature of Damage:	Damage to nose fuselage, the nose landing gear and doors, and propeller tips	
Commander's Licence:	Commercial Pilot's Licence	
Commander's Age:	44 years	
Commander's Flying Experience:	3,800 hours (of which 2,200 hrs were on type) Last 90 days - 137 hours Last 28 days - 30 hours	
Information Source:	AAIB Field Investigation

Synopsis

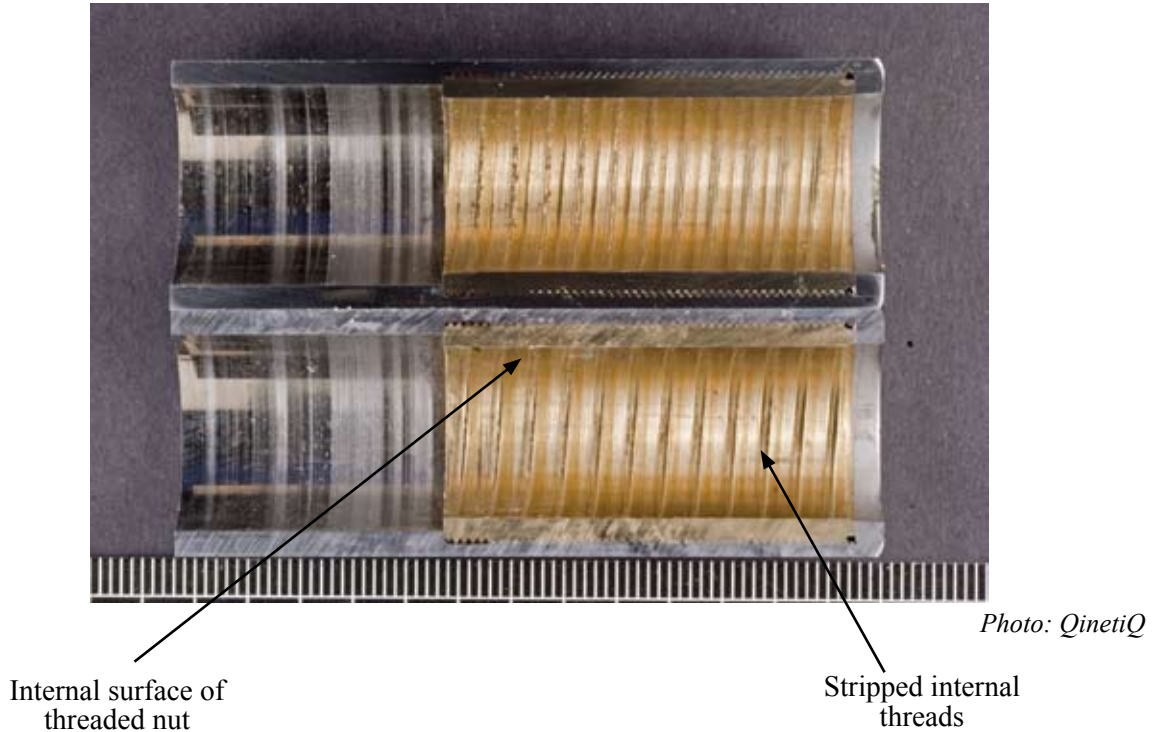
The actuator was disassembled and the aluminium bronze nut assembly sectioned, to allow its interior to be examined. This revealed that the internal threads of the threaded nut (screw insert) assembly had been stripped, Figure 2.

There was evidence of compacted grease between the threads of the steel actuator screw thread along its length, and a considerable amount of aluminium bronze debris was found within this grease. Close examination of the screw showed that corrosion pitting damage was present, and that this was more extensive at the upper and lower ends of the screw, Figure 3. Corrosion was present on the apex, roots and flanks of the threads, and also observed on the internal surface of the gears within the aluminium housing.

Figure 2
Internal surface of threaded nut (screw insert) assembly showing stripped internal threads

Examination of the nose landing gear actuator revealed that a complete failure of the internal threads in the aluminium bronze nut had occurred. The threads had stripped and, hence, the input from the landing gear motor/gearbox could not cause the nut assembly to traverse the screw. A considerable amount of aluminium bronze wear debris was present in the grease on the screw thread, which suggested that the nut had been wearing over a period of time prior to failure. Examination of the grease showed that it was contaminated with water, which is likely to have reduced its lubrication properties, leading to increased wear and corrosion damage of the screw. Also, the corrosion pits formed were likely to have increased the roughness of the screw and accelerated wear of the nut. This wear would have progressively reduced the load bearing capacity of the thread to a point when it could no longer support normal operating loads, leading to a failure of the remaining thread profiles. As the problem with the nose landing gear actuator was downstream of the emergency system input, it was not possible to lock the nose landing gear down.

It is recommended that the Federal Aviation Administration require Raytheon (Beechcraft) to review the maintenance requirements of the nose landing gear actuator fitted to the Beech B200 King Air series of aircraft, and any other model using a similar design of actuator, with regard to the requirement of periodic lubrication and the periodicity of inspections.

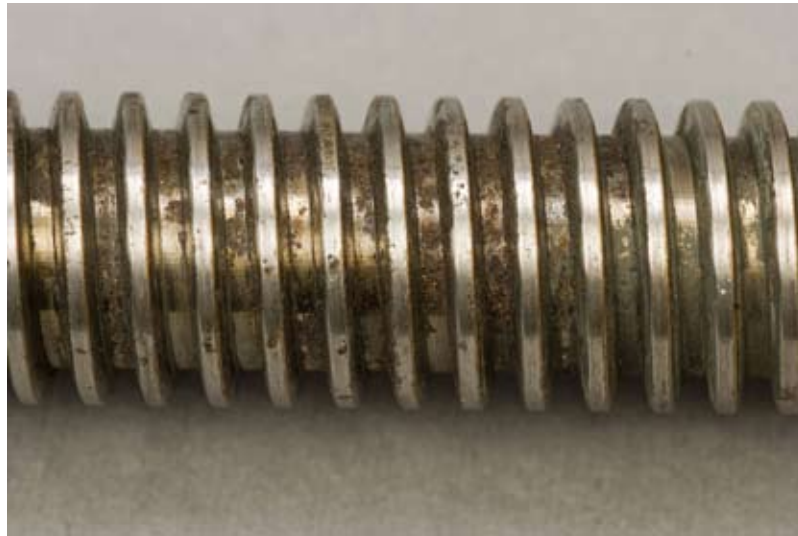
Figure 3

Corrosion observed on upper end of screw.
