AAIB Interim Report

Accident to Boeing 777-236ER, G-YMMM at London Heathrow Airport on 17 January 2008

ACCIDENT

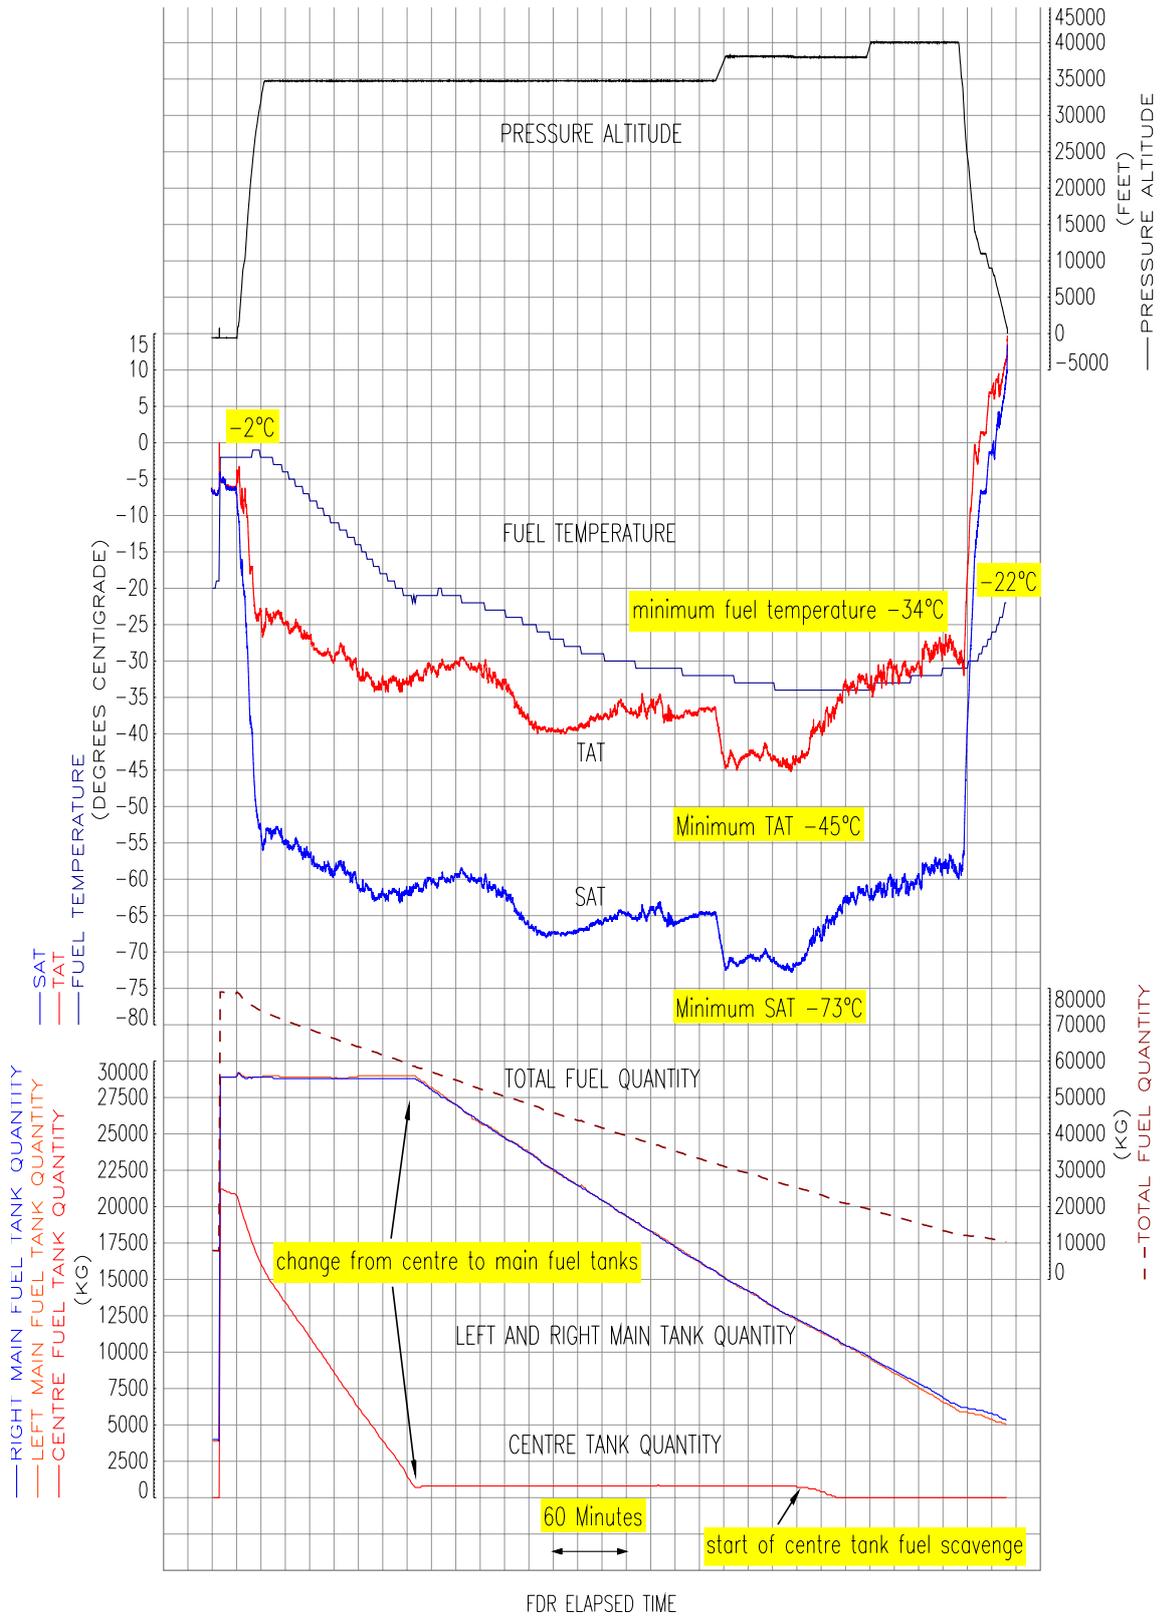
Figure 1
Temperatures

A time history of Total Air Temperature (TAT), Static Air Temperature (SAT), fuel temperature and other salient parameters during the accident flight are shown in Figure 1. Figure 2 shows a time history of the relevant parameters during the final approach and the accident sequence.

Whilst taxiing out at Beijing the TAT was -6°C (21°F), and the fuel temperature, measured in the left main fuel tank, was -2°C (28°F). The aircraft took off at 0209 hrs. The total fuel quantity at takeoff was 78,700 kg, with 28,900 kg in both the left and right main tanks and 20,900 kg in the centre tank. The aircraft climbed to a pressure altitude of 10,590 m (34,750 ft), where, at 0232 hrs, it levelled off into the cruise portion of the flight. The TAT had reduced to -25°C (-13°F) with the fuel temperature remaining at -2°C (28°F) at this time. Engine fuel flows during the takeoff phase had peaked at 24,176 pounds per hour (pph) for the left engine and 23,334 pph for the right engine, with both

Two hours into the cruise the TAT had progressively reduced to -33°C (-27°F) and the left main tank fuel temperature was about -22°C (-8°F). At this point the engines fuel feed supply switched from the centre tank to their respective main fuel tanks; the total fuel quantity at this point was 58,600 kg, with fuel being distributed 29,000 kg, 800 kg and 28,800 kg across the left main, centre and right main fuel tanks respectively.

During the next three and a half hours the fuel temperature reduced further from -22°C (-8°F) to -32°C (-26°F), in line with further reductions in TAT.

At 0931 hrs, fuel temperature reduced to its lowest recorded value of -34°C (-29°F). It remained there for about 80 minutes during which the lowest value of TAT of -45°C (-49°F) was recorded.

Just over two hours from touchdown the TAT started to rise, in response to the increasing SAT; this was followed by an associated rise in fuel temperature. About twenty minutes later, the aircraft made its second and final step climb from FL380 to FL400. This was also completed using the VS mode of the autopilot, but with a slightly higher vertical speed of 600 fpm set. During this climb the peak fuel flow was 8,896 pph for the left engine and 8,704 pph for the right engine.

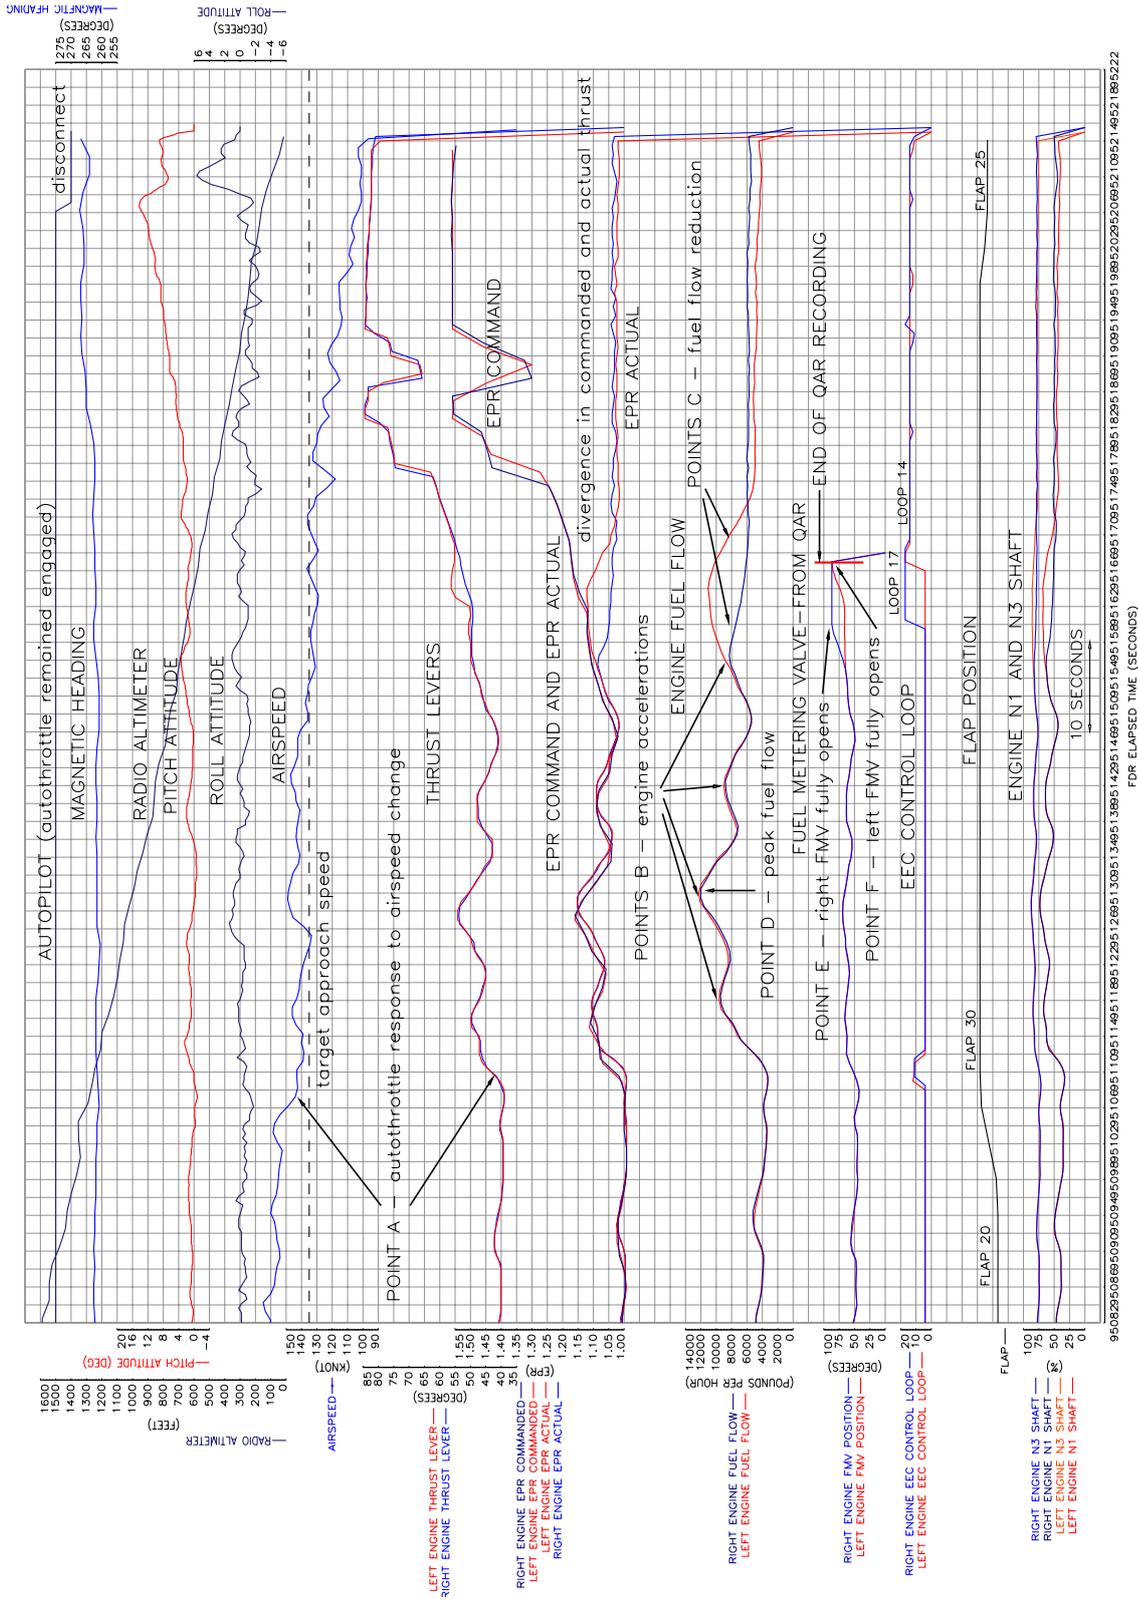
Figure 2
Final approach

As the flaps reached the 30° position the airspeed had reduced to the target approach speed of 135 kt and the autothrottle commanded additional thrust to stabilise the airspeed (Figure 2 Point A). In response to variations in the wind velocity and associated airspeed changes, there followed a series of four, almost cyclic, thrust commands by the autothrottle (Figure 2 Points B). It was during the fourth acceleration, and as additional thrust was being commanded, that the right engine, followed some seven seconds later by the left engine, experienced a reduction in fuel flow (Figure 2 Points C). The right engine fuel flow reduction occurred at a height of about 720 ft and the left engine at about 620 ft.

Of the four thrust commands it was the second that resulted in the highest delivery of fuel flow, reaching a peak of 12,288 pph for the left engine and 12,032 pph for the right (Figure 2 Point D). These peaks occurred about 26 seconds prior to the reduction in fuel flow to the right engine. Peak fuel flows during the first and third thrust commands were lower, at about 9,500 pph and 9,000 pph respectively.

During the fourth thrust increase, the right engine fuel flow had increased to 8,300 pph before gradually reducing. The recorded EPR then started to diverge from the commanded EPR and the right engine FMV was then fully opened (Figure 2 Point E). Some seven seconds later, the left engine fuel flow, which had increased to 11,056 pph, also started to reduce and the left engine FMV was also moved to its fully open position (Figure 2 Point F). Following the reduction in fuel flow, the left engine fuel flow stabilised at about 5,000 pph and the right at about 6,000 pph. Both engines continued to produce thrust above flight idle. The autothrottle and the flight crew commanded additional thrust, with both thrust levers ultimately being placed fully forward, but there was no increased thrust available from either engine. The actual fuel flows continued to remain significantly below that being commanded.

At 240 ft the aircraft commander selected flap 25 in an attempt to reduce the drag. As the autopilot attempted to maintain the aircraft on the ILS glideslope the airspeed reduced and by 200 ft had reached 108 kt. The stick shaker activated at approximately 170 ft, and shortly afterwards the First Officer made a nose down pitch control input which reduced the aircraft pitch attitude and caused the auto pilot to disconnect. The aircraft's initial impact was at a descent rate of about 1,400 fpm and a peak normal load of about 2.9g. The aircraft then bounced, before commencing a ground slide, during

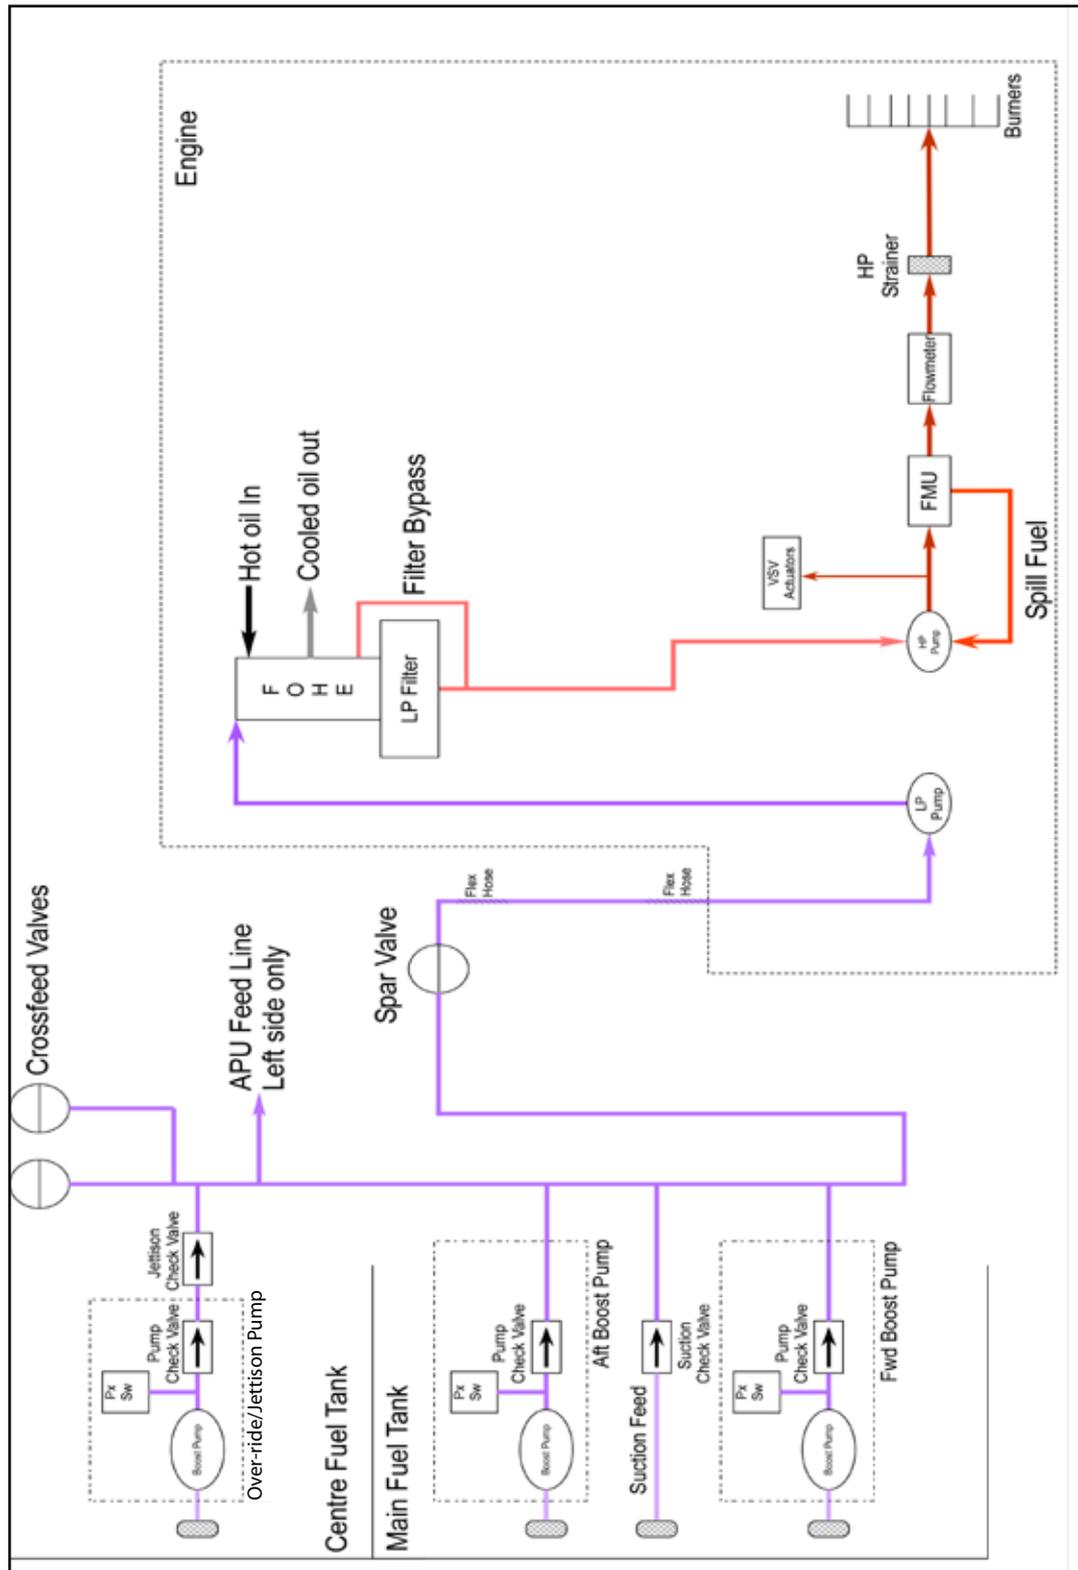
Figure 3

The fuel on the Boeing 777-200ER is stored in three fuel tanks: a centre tank, a left main tank and a right main tank; see Figure 3. The centre tank contains two override / jettison pumps (OJ) and each main fuel tank contains two boost pumps, identified as forward (fwd) and aft. Each of the pump inlets is protected by a mesh screen and the pumps are also equipped with a check valve fitted in the discharge port, to prevent fuel in the fuel feed manifold flowing back through the pump. A pressure switch, mounted between the pump's impeller and check valve, monitors the fuel pressure and triggers a warning in the flight deck if the pressure rise across the pump drops to a value between 4 and 7 psi.
