ACCIDENT

Aircraft Type and Registration:	Piper PA-34-200T Seneca II, G-BEVG	
No & Type of Engines:	2 Continental Motors Corp TSIO-360-E piston engines	
Year of Manufacture:	1975	
Date & Time (UTC):	12 December 2007 at 1210 hrs	
Location:	Sibson Airfield, Peterborough	
Type of Flight:	Private	
Persons on Board:	Crew - 1	Passengers - 2
Injuries:	Crew - None	Passengers - None
Nature of Damage:	Damage to propellers and nose	
Commander's Licence:	Airline Transport Pilot's Licence	
Commander's Age:	55 years	
Commander's Flying Experience:	6,500 hours (of which 500 were on type) Last 90 days - 30 hours Last 28 days - 10 hours	
Information Source:	Aircraft Accident Report Form submitted by the pilot, with additional AAIB enquiries

Synopsis

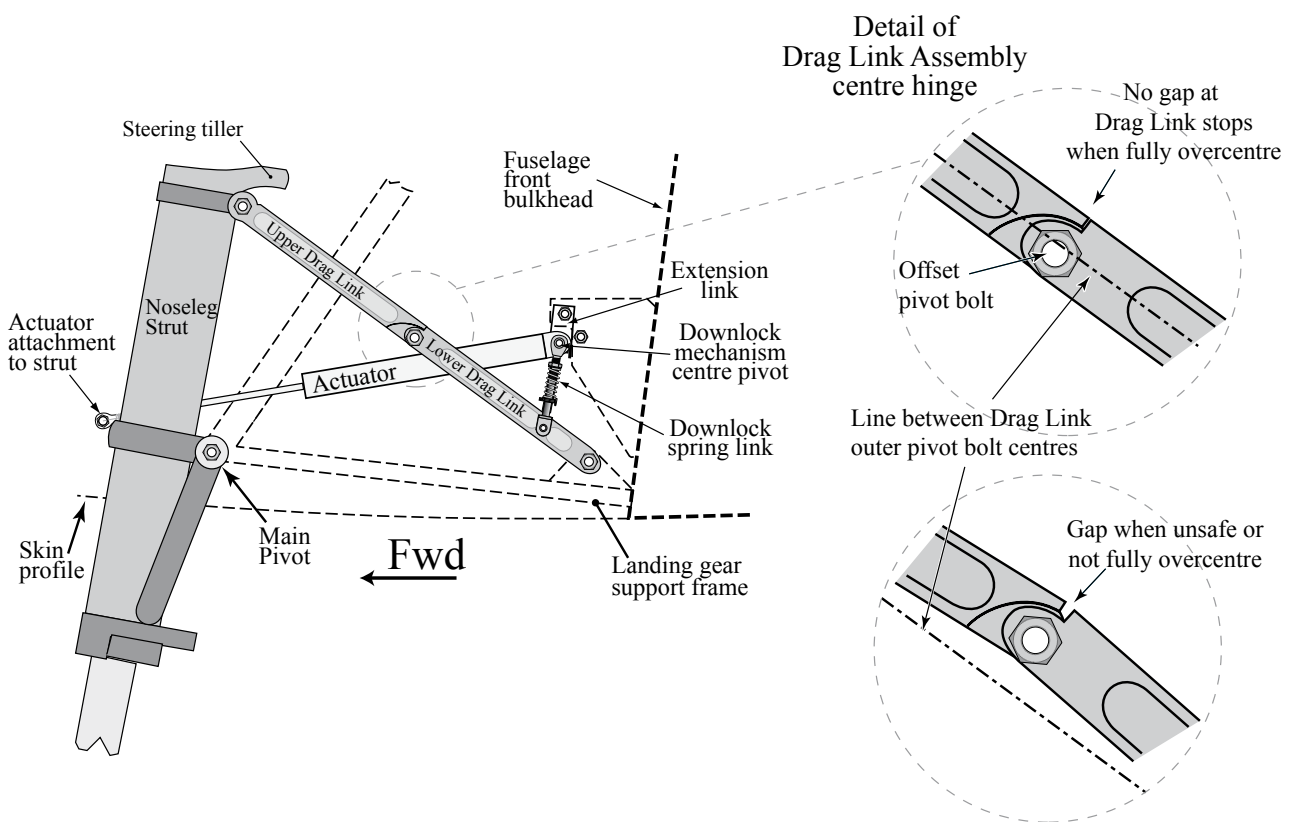
Figure 1

The nose landing gear (NLG) of the Piper Seneca is of the forward retracting type and is hydraulically operated. When retracted, the leg is held up by hydraulic pressure in the actuator and, when extended, it is held in the down position by a geometric downlock mechanism. There are no locking hooks for either position. When the NLG is fully extended, it is prevented from collapsing by the drag link assembly, Figure 1. The offset drag link centre pivot is below the line between the drag

link outer pivot bolt centres and prevents the drag link assembly folding when the landing gear is under load. The geometry of the NLG is such that the aircraft’s weight on the nosewheel applies a compressive load to the drag link assembly which tends to drive it more firmly into the safe overcentre condition when the gear is properly extended. Conversely, it will tend to cause the drag link to fold, and the NLG to retract, if the load is applied when the drag link assembly is not fully overcentre.

showed that all three landing gear assemblies operated satisfactorily. A subsequent, detailed examination of the landing gear by a local maintenance organisation revealed no broken or damaged components, although a degree of wear was observed in the bushings and bolts in the drag link and in the aft attachment of the actuator to the structure. Additionally, it was observed that the grease on the gear components appeared old, which may have caused a degree of stiffness in the linkage.

Although the wear on the individual bushes and bolts in the nose landing gear of G-BEVG was not deemed excessive by the maintenance organisation tasked with repairing the aircraft, the cumulative effect of such wear, plus the stiffness in the linkage resulting from what appeared to be inadequate and/or old grease, may

have combined to restrict the drag link's movement to the overcentre position, resulting in the NLG collapse. Additionally, it is possible that an exacerbating effect was provided by the undulating nature of the grass runway during the landing roll.
