**ACCIDENT**

<b>Aircraft Type and Registration:</b>	Extra EA 300/L, G-IIEX	
<b>No &amp; Type of Engines:</b>	1 Lycoming AEIO-540-L1B5 piston engine	
<b>Year of Manufacture:</b>	1995	
<b>Date &amp; Time (UTC):</b>	26 May 2008 at 1351 hrs	
<b>Location:</b>	Hastingleigh, near Ashford, Kent	
<b>Type of Flight:</b>	Private	
<b>Persons on Board:</b>	Crew - 1	Passengers - 1
<b>Injuries:</b>	Crew - 1 (Minor)	Passengers - 1 (Serious)
<b>Nature of Damage:</b>	Extensive - aircraft damaged beyond economic repair	
<b>Commander's Licence:</b>	Commercial Pilot's Licence	
<b>Commander's Age:</b>	41 years	
<b>Commander's Flying Experience:</b>	1,716 hours (of which 204 hours were on type) Last 90 days - 119 hours Last 28 days - 47 hours	
<b>Information Source:</b>	AAIB Field Investigation

**Synopsis**

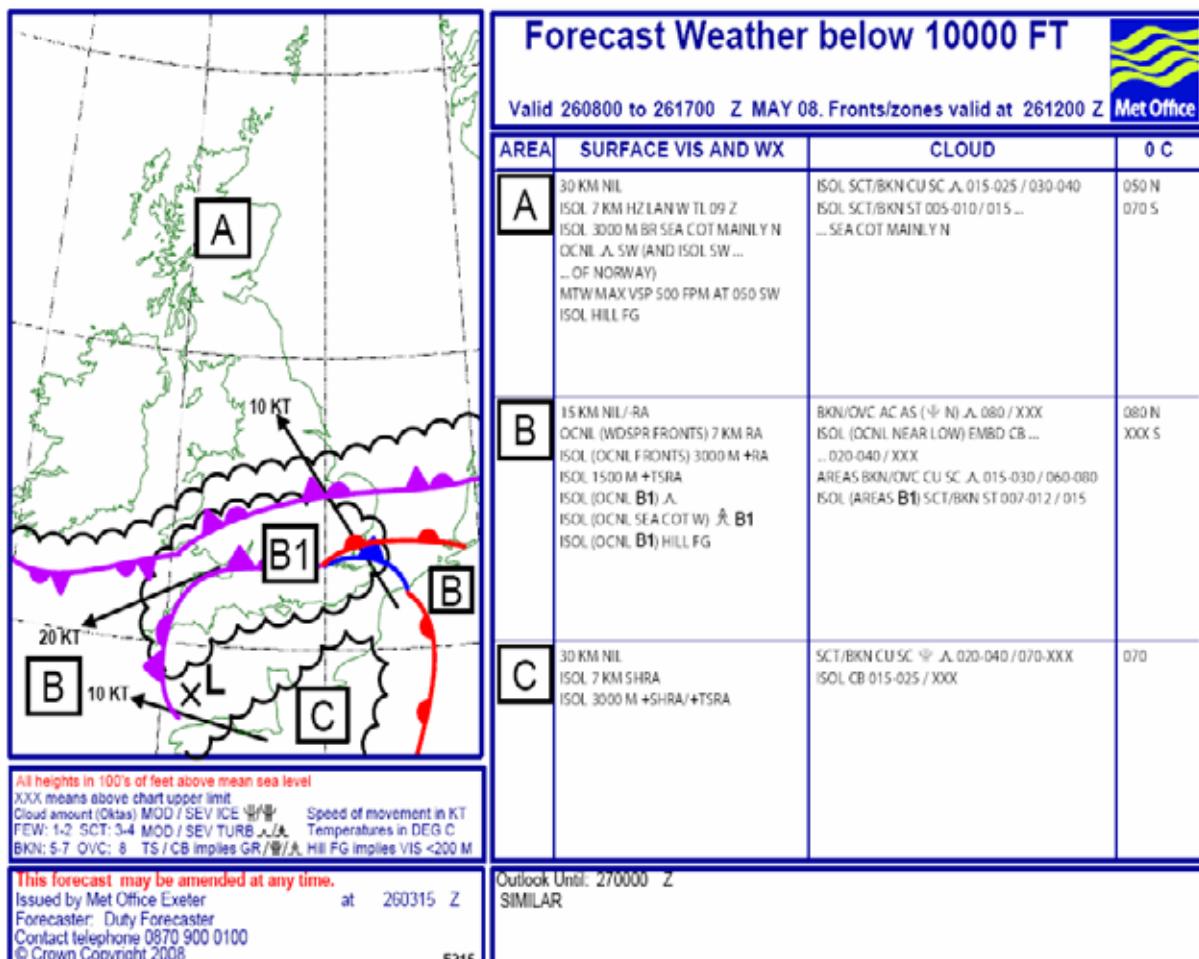
**Figure 1**  
UK Forecast Weather, Form F215

No record of precisely which forecasts and reports the pilot consulted before flight was available. However, a selection of relevant forecasts and reports are reproduced in Figure 1.

It is clear that the weather conditions in the south-east of England on the day of the accident were changeable and inclement. The Met Office Form F215, showed an occluding frontal system lying along the Thames Estuary, and described the associated weather in detail. It showed fronts valid at 1200 hrs and gave an indication that they would pass over the Southend area at about 1200 hrs.

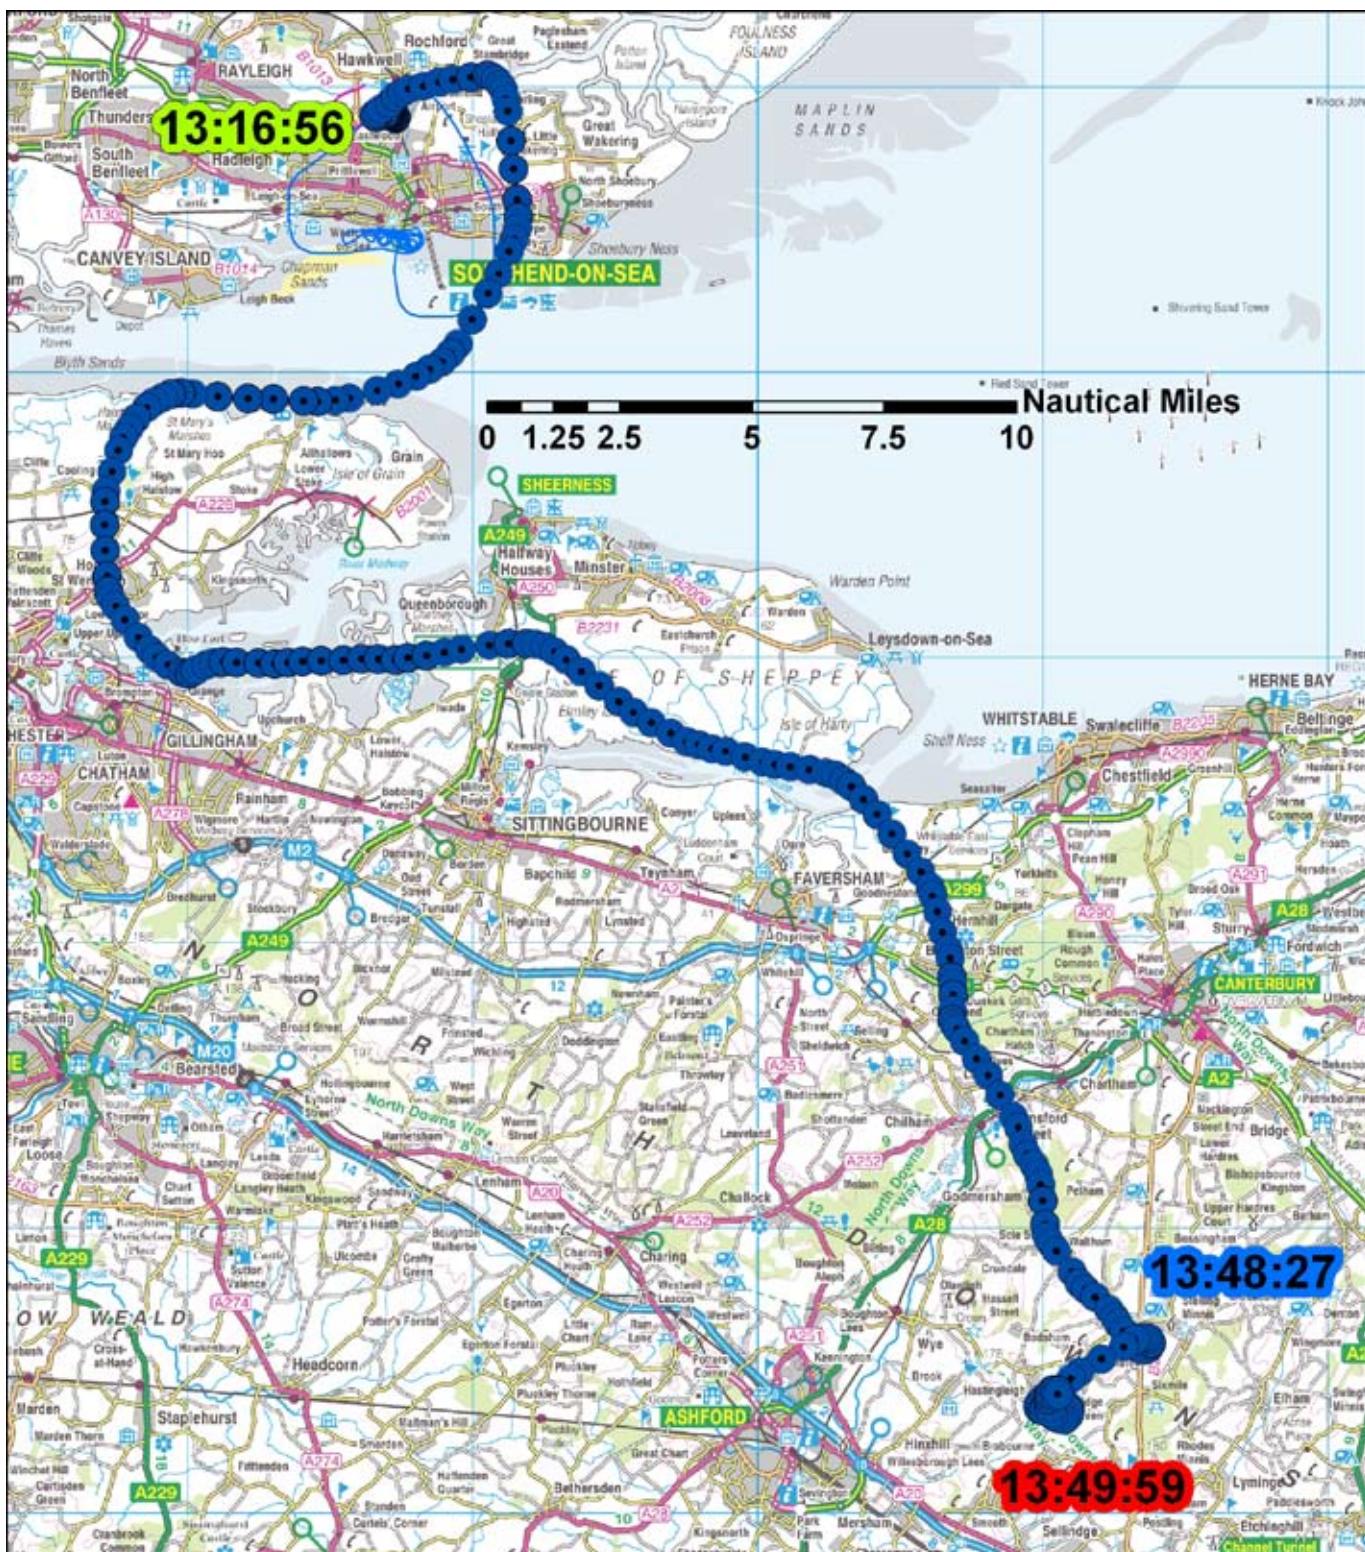
**Figure 2**  
Garmin GPS Pilot III final logged track for G-IIEX

No radar data was available for the accident flight; however, the pilot was using a Garmin GPS Pilot III that recorded position and time, but no height information. Processing of this data allowed the average ground speed between recorded points to be calculated, ie, based on the horizontal straight-line distance between successive points. The accident track is illustrated in Figure 2.

The first recorded point from the accident track was at 13:15:56, as the aircraft departed from Southend Airport. At 13:48:27, about six nm east of Ashford, the aircraft turned through 270°, to the left, before heading towards Ashford. The last recorded point was at 13:49:59, just prior to ground impact.

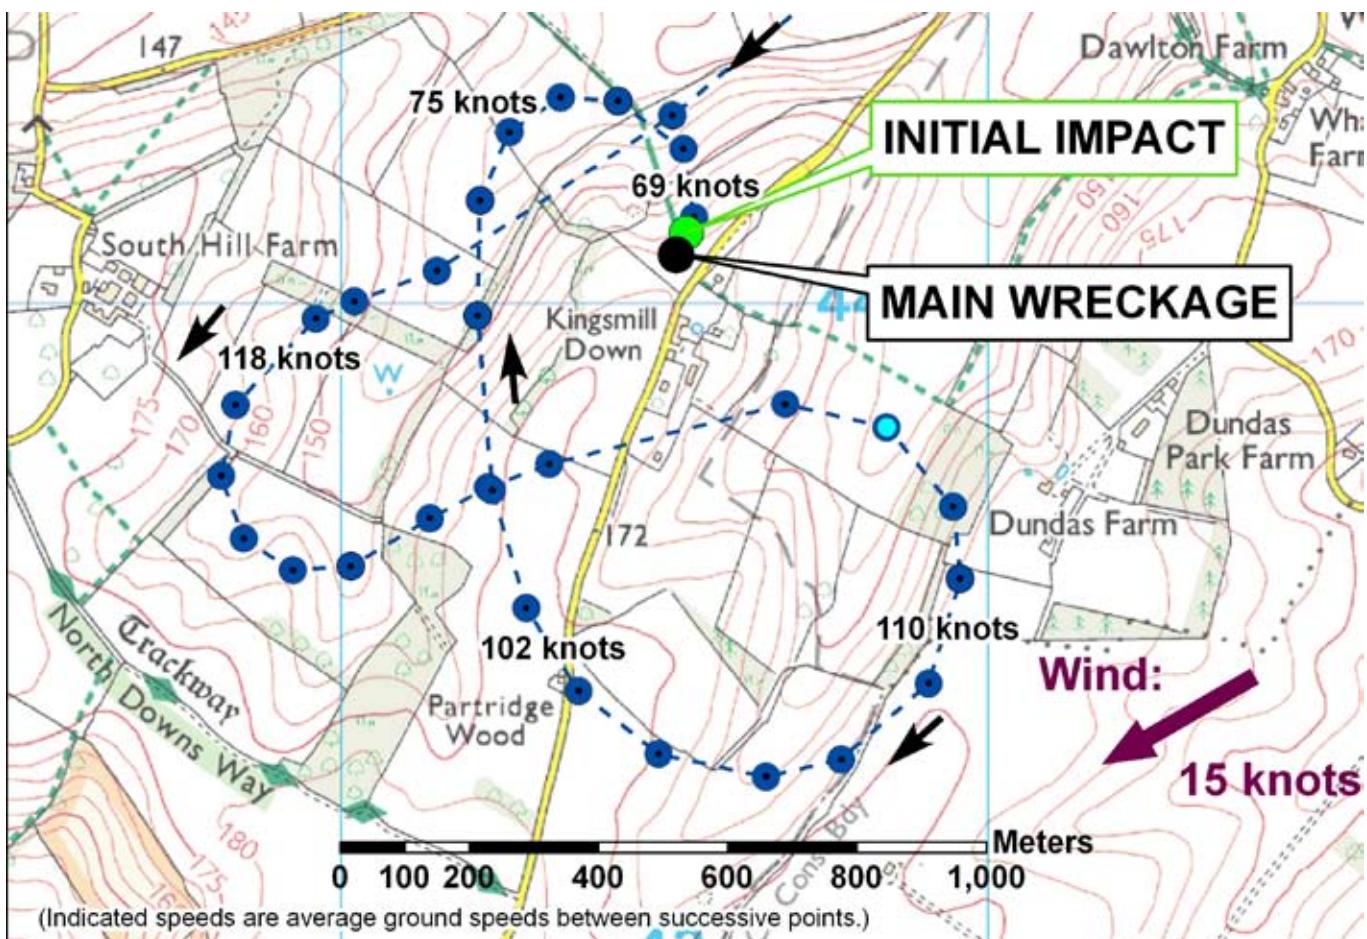
**Figure 3**  
G-IIEX precautionary landing track

Figure 3 illustrates the last minute of the aircraft's track, together with the position of the initial ground-impact mark and main wreckage. The last two points recorded on the GPS unit were three seconds apart, suggesting an average ground speed of 69 kt between these points, and the last GPS point, initial ground-impact mark and main wreckage lie on a line with a track of 208°.

Figure 3 also shows the direction and strength of the wind taken from the Met Office aftercast, which illustrates a large tailwind component of the wind along the track from the last GPS point to the wreckage. The effect of such a tailwind with a groundspeed of 69 kt results in an airspeed of 56 kt.

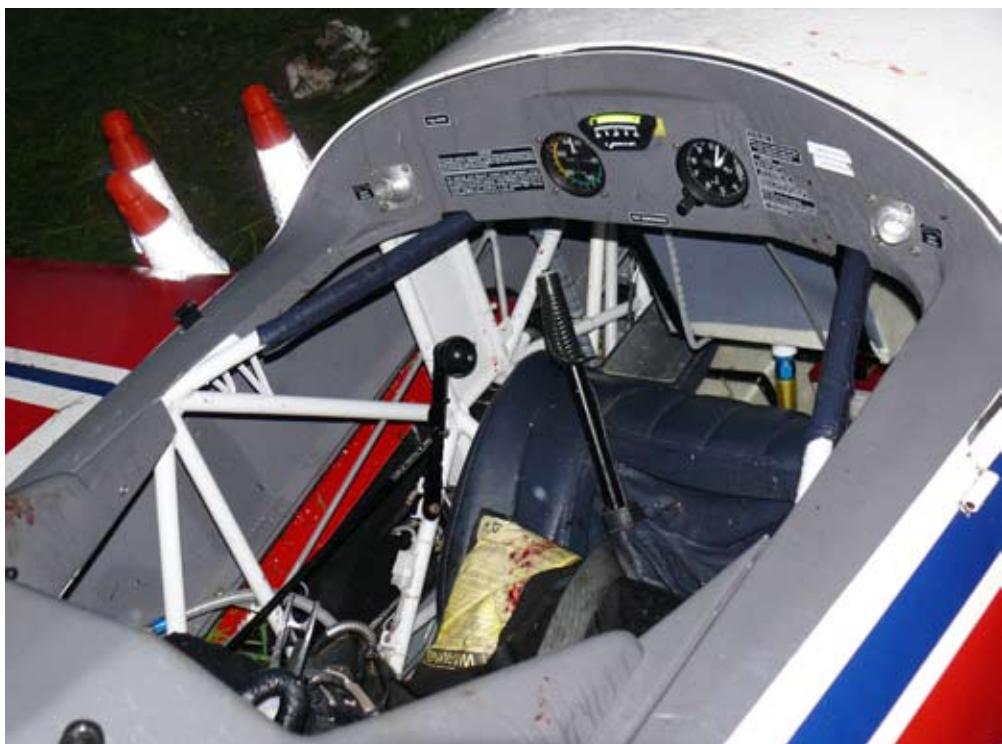
**Figure 5**  
G-IIEX front cockpit

The front seat and its attachments were undamaged. Although no evidence was found that the passenger had struck any part of the structure or equipment in the front cockpit, there were numerous hard points adjacent to both sides of the seat in the form of the exposed fuselage framework and various controls. It also appeared possible that, even with the occupant restrained by the harness, violent longitudinal, vertical and/or lateral aircraft deceleration could cause head contact with the diagonal bracing tubes at the forward corners of the cockpit, and/or with the cockpit coaming.

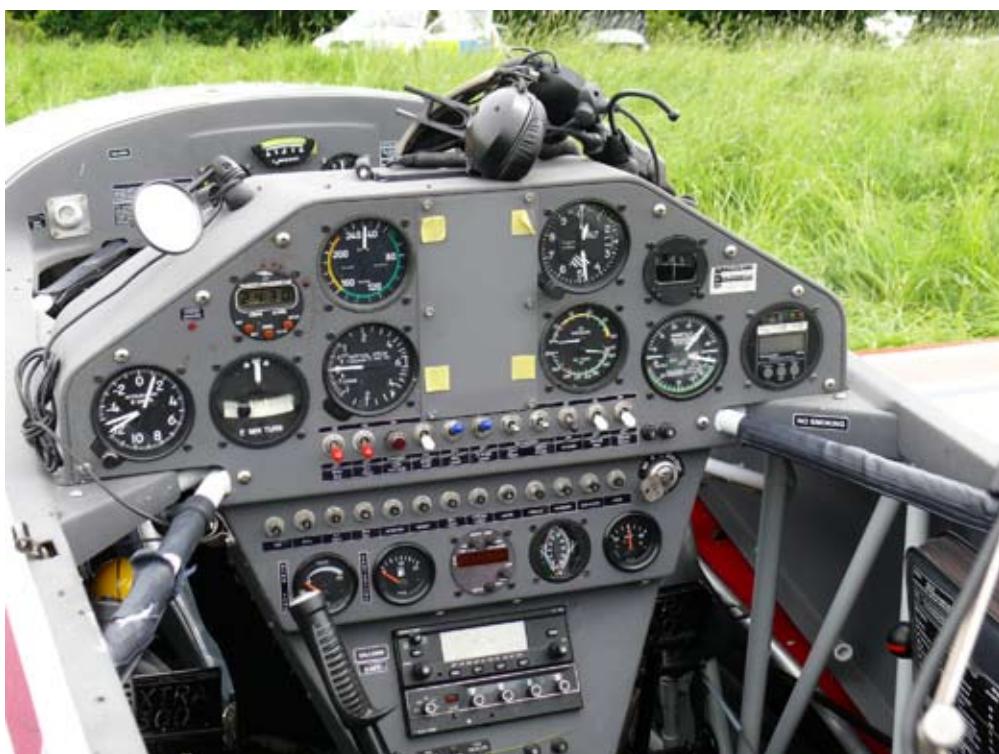
**Figure 6**  
G-IIEX rear cockpit

The harnesses in both cockpits remained attached to the aircraft and with all buckles intact. In the rear cockpit, the seat pan had partially fractured near its right side, reducing the vertical stiffness of the pan. The seat attachments remained intact. The pilot's helmet exhibited a number of areas of substantial impact damage and the visor had fractured in two. Red smears on the front left of the helmet corresponded with the colouring of the canopy release handle, which had broken off. Cuts in the leather sheath on the diagonal bracing tube at the left forward corner of the

cockpit were consistent with the effects of a strike by the helmet and visor. Impact markings on the left rear of the helmet indicated that it had forcibly contacted a vertical steel tubular A-framework located just behind the normal head position.
