AIRCRAFT ACCIDENT REPORT 2/2005

**Report on the accident to
Pegasus Quik, G-STYX
at Eastchurch, Isle of Sheppey, Kent
21 August 2004**

Air Accidents Investigation Branch

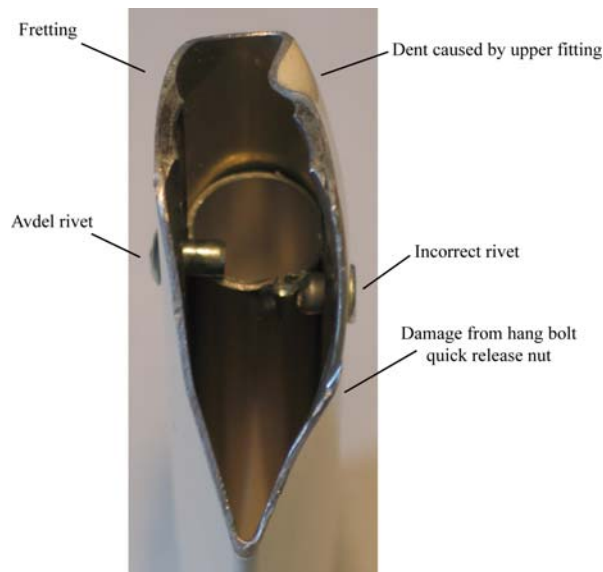
Figure 3 Right upright

Inspection of the failed upper joints revealed that whilst the original 'Monel' rivets fitted in the upright had failed, the additional 'Avdel' rivets, introduced by Service Bulletin 116, were still intact. Significantly, not only had the additional rivets been fitted in the wrong position, but two of the additional rivets were of the incorrect type. There was also evidence of fretting between the top edge of both upright extrusions and the lower face of the upper fittings (Figure 3).

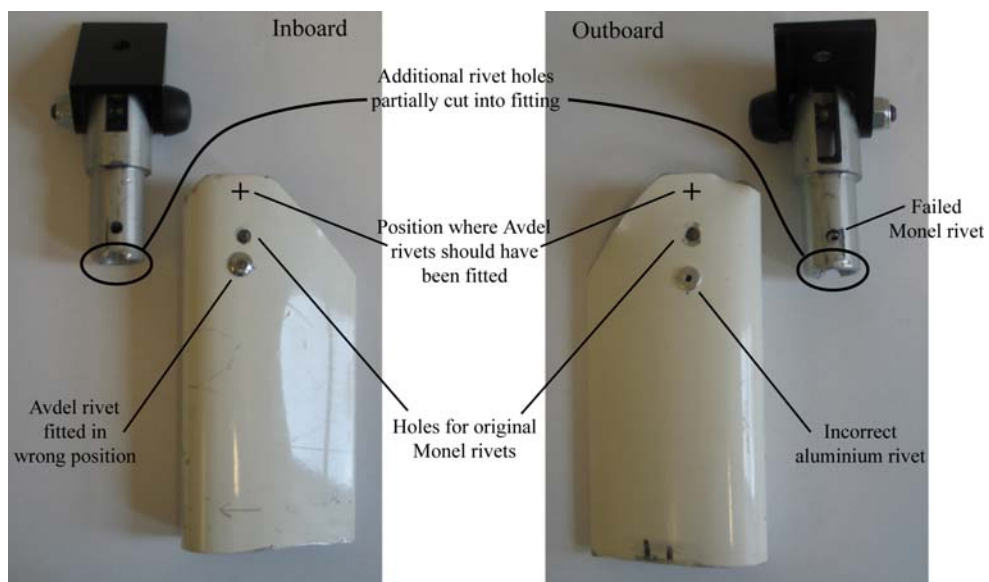
Figure 4 Positioning of rivet holes in right upright

The Service Bulletin (at Annex B) called for the additional steel Avdel rivets to be fitted either side of the upright, 7 mm below the top of the extrusion and above the existing Monel rivets. However, on both uprights the additional rivets were fitted below the Monel rivets. On the left upright the additional rivets had been fitted at 38 mm from the top of the extrusion and on the right they had been fitted at 36 mm and 42 mm from the top of the extrusion. The distance between the rivet holes on each side of the extrusion was 13 mm, 12.7 mm, 11.5 mm and 17 mm. What appeared to be an aluminium pop rivet had been fitted on the outboard position on both uprights instead of the Avdel rivets supplied by the manufacturer. On the right upright the hole for the outboard rivet had missed the shank on the upper fitting. The other three holes for the additional rivets had been drilled such that the holes only partially cut into the shank (Figure 4).

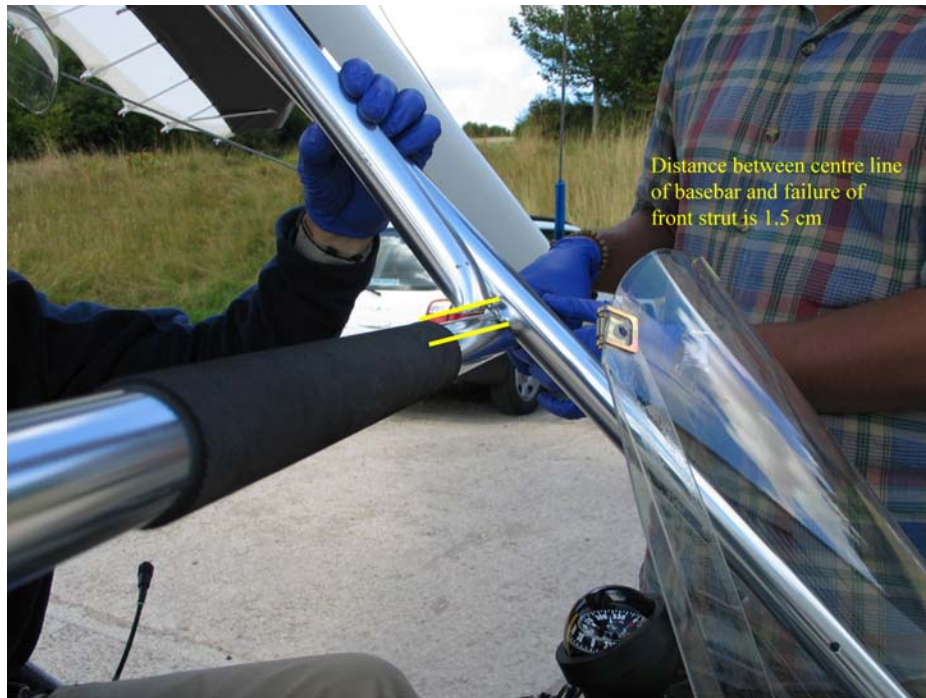
Figure 5 Contact point between basebar and front strut

To determine if the uprights failed before or during the tumble, the front strut was fitted to a new Pegasus Quik and the contact point between the basebar and front strut was compared. It was found that on the intact aircraft the basebar contacted the front strut at a position 1.5 cm lower than the failure position on the accident aircraft (Figure 5). There were also scratch marks on the basebar caused by the broken end of the front strut. All the marks could be made to line up by moving the right upright fitting slightly backwards and upwards. This indicated that the right upright upper fitting had failed prior to the basebar hitting the front strut. Consideration was given to the possibility that the upper fittings failed when the basebar made contact with the pilot, which would result in the upper fitting rolling towards the leading edge of the extrusion; however

there were no witness marks to indicate that this had happened. The likelihood that the discrepancy of the position of the basebar was the result of flight loads distorting the structure was considered and discounted, as any resulting movement was likely to be negligible in comparison with the amount the basebar had moved up the front strut.

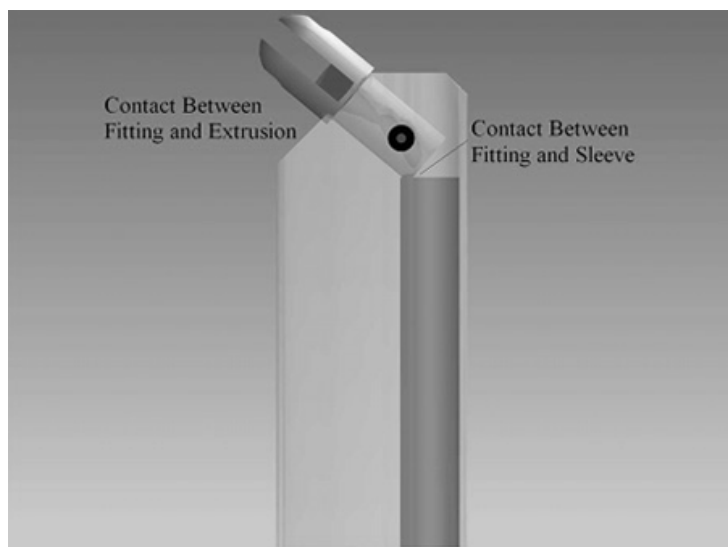
Figure 6 Rotation of upper fitting

A compressive load was applied to the original two-rivet configuration. At 500 kg (3.3g) the fitting started to rotate around the rivets until at 600 kg (4g) it had rotated by approximately 40°. At this point, the compressive load was being reacted by the rivets and the contact between the fitting and the trailing edge of the extrusion (Figure 6).

The load was removed and the original rivets were found to be loose; there was also noticeable movement in the joint. To replicate the addition of the Avdel rivets, as per the Service Bulletin under field conditions, a handheld cordless drill and ruler were used to position and drill the holes. The additional Avdel rivets were fitted and a load was incrementally applied up to 3,000 kg (20g). At each increment the load was removed and the joint checked for looseness. Whilst the gap between the top of the extrusion and the fitting closed when the load was applied, the joint remained firm with no evidence of the rivets working loose. The joint did not fail even when the extrusion was hit repeatedly in both directions with a soft face hammer whilst under a compressive load of 3,000 kg. This test indicated that the addition of two correctly formed Avdel rivets 7 mm from the top edge of the extrusion is sufficient to stabilise the joint even when the original Monel rivets are loose. The test however, did not prove the long-term airworthiness of the joint.

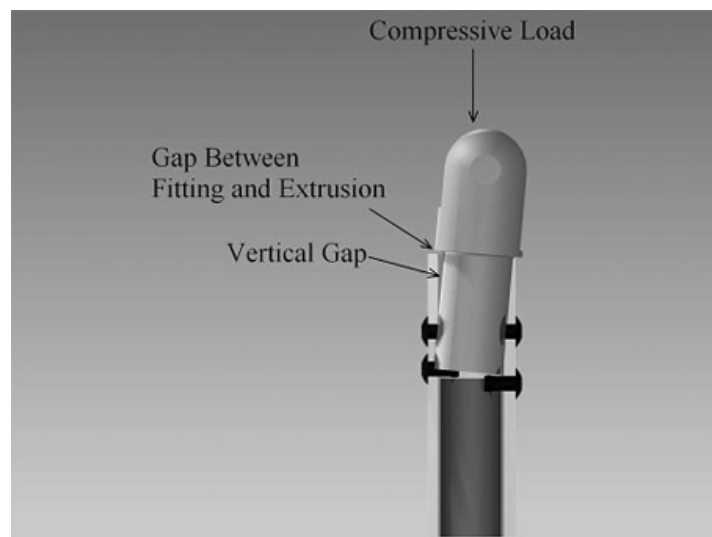
Figure 7 Effect of applying a comprehensive load on right upright with incorrectly fitted rivets

The test fitting was subjected to compressive loads in 150 kg (1g) steps up to 1,000 kg (6.7g) and the rivets and joint were checked for looseness. At 300 kg (2g) the vertical gap opened to 0.5 mm and it was noticeable that the fitting was rotating outboard and slightly backwards. At 1,000 kg (6.7g) the joint appeared to be going unstable by starting to roll to the right and backwards; this was a different failure mode to the first sample. The load was removed and 6 cycles from 30 to 300 kg (2g) were applied. The vertical splaying occurred earlier on each cycle until after the fifth cycle the splaying started to occur at 125 kg (0.8g) (Figure 7).

There was no evidence of looseness of the joint, or rivets throughout this test. A load of 1,500 kg was reapplied and the joint was encouraged to fail by pushing the leading edge forward. The original Monel rivets failed as the joint rotated. Inspection of the joint revealed that rotation of the fitting around the existing rivets had resulted in damage to the top of the sleeve, Avdel rivets and the interior of the extrusion. Further tests supported the finding that rotation of the fitting around the Monel rivets resulted in damage to the inner sleeve, Avdel rivets and inside of the extrusion (Figure 6). No such damage was found on the right upright on the accident aircraft. This lack of damage to the inner sleeve

and Avdel rivet indicates that on the upright fitted to the accident aircraft the Monel rivets failed first leaving the fitting perched on the Avdel rivet. The fitting would then be held in place by the side forces from the extrusion, which had been splayed, and the compressive force that would push the fitting against the top edge of the extrusion.

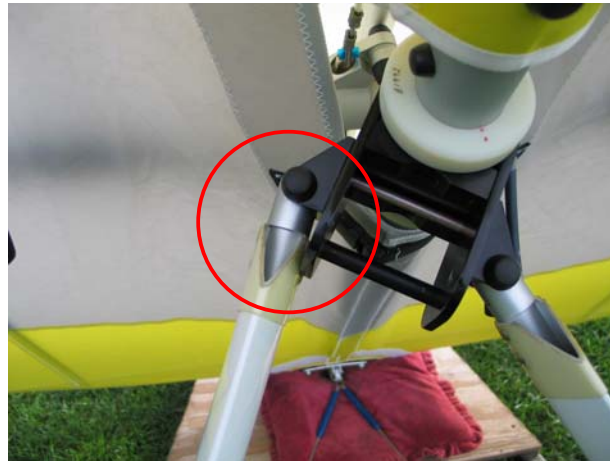
Figure 8 Contact between hang bracket and upright

In Service Bulletin 116 Issue 1, the reason given for the splaying of the extrusion and loosening of the rivets was the load resulting from the contact of the upright with the hang bracket when the Quik is parked wing down in windy conditions. Tests on another Quik showed that in the fully rigged condition the upright will contact the front strut before contact is made between the hang bracket and upright. It is therefore, unlikely that parking the wing down in a strong wind was the mechanism by which the joint was originally weakened. It is probable that the most likely mechanism was when the wing was rigged and sat on the ground with the original Monel rivet on the upright contacting the edge of the hang bracket (Figure 8). A load applied to the wing would be transmitted through the kingpost which, if large enough, could cause the extrusion to splay and a tensile load to be applied to the rivet. Calculations

subsequently carried out by the manufacturer indicated that in this position a strong gust of wind on the wing would result in a load sufficient to splay the extrusion and weaken the Monel rivets. The manufacturer also calculated that the modified design, with four correctly fitted rivets, would be strong enough to cope with such a load. The CAA reviewed the manufacturer's calculations and considered that the four rivet configuration is an acceptable solution to prevent the extrusion from splaying.
