Bell 206L Longranger, G-IANG

AAIB Bulletin No: 3/2004	Ref: EW/C2003/04/05	Category: 2.3
Aircraft Type and Registration:	Bell 206L Longranger, G-IANG	
No & Type of Engines:	1 Allison 250-C20B turboshaft engine	
Year of Manufacture:	1977	
Date & Time (UTC):	30 April 2003 at 1432 hrs	
Location:	Longfagh Farm near Pathhead, Midlothian	
Type of Flight:	Private	
Persons on Board:	Crew - 1	Passengers - 2
Injuries:	Crew - 1 (Minor)	Passengers - 1 (Minor)
Nature of Damage:	Damaged beyond economic repair	
Commander's Licence:	UK Airline Transport Pilot's Licence	
Commander's Age:	48 years	
Commander's Flying Experience:	4,469 hours (of which 2,269 were on type)	
	Last 90 days - 32 hours	
	Last 28 days - 9 hours	
Information Source:	AAIB Field Investigation

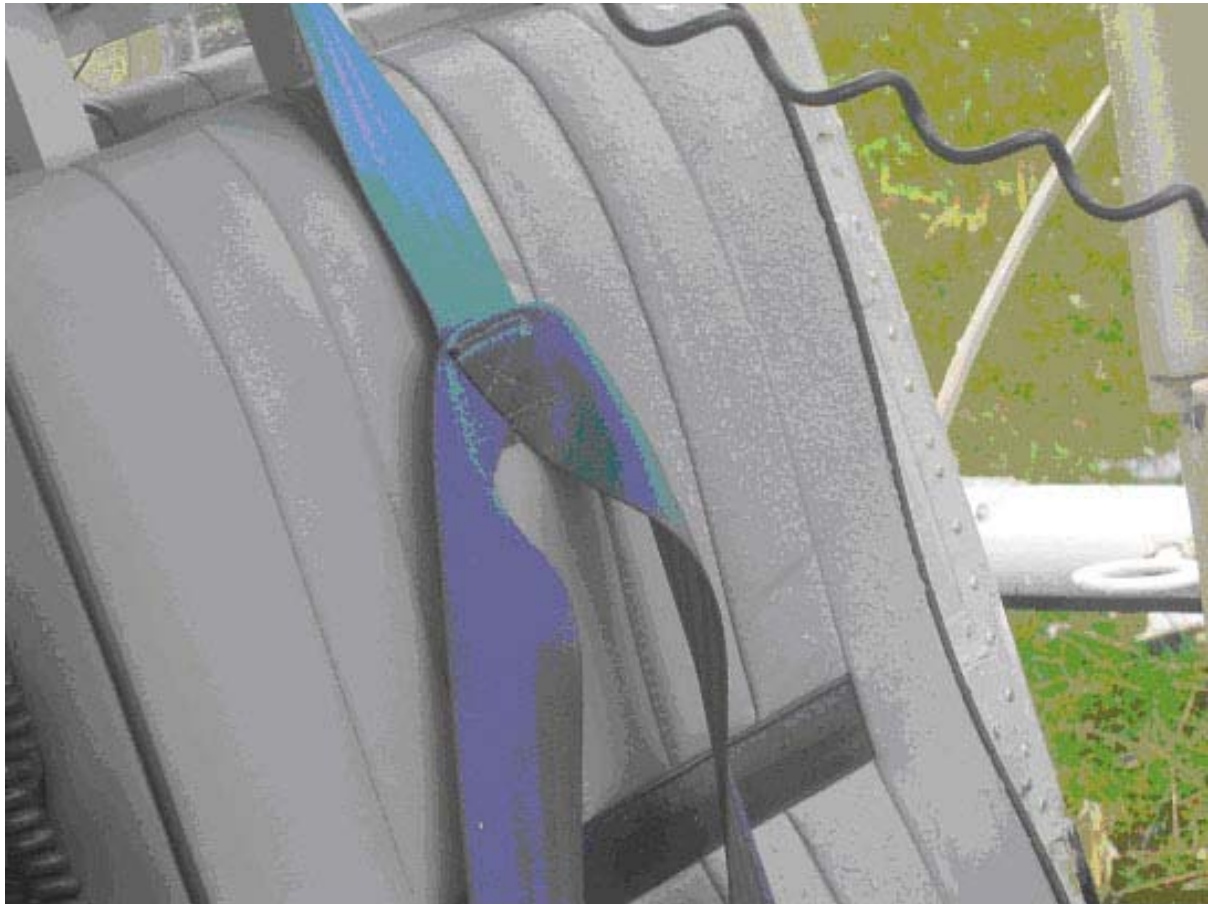
Figure 1

Numerous main rotor blade ground strikes were found and both blades had been badly fragmented, with blade debris scattered around the accident site. The main rotor mast had been bent and partially fractured but had not quite detached. Examination of the cockpit and cabin showed that the latter was undamaged whilst the former had been distorted with both windscreens destroyed. All the seats were intact but it was noted that the pilot's upper torso restraint stitching had failed at the point where it emerged from the inertia reel mechanism located behind his neck, Figure 1.

Photograph of intact left front seat upper torso restraint

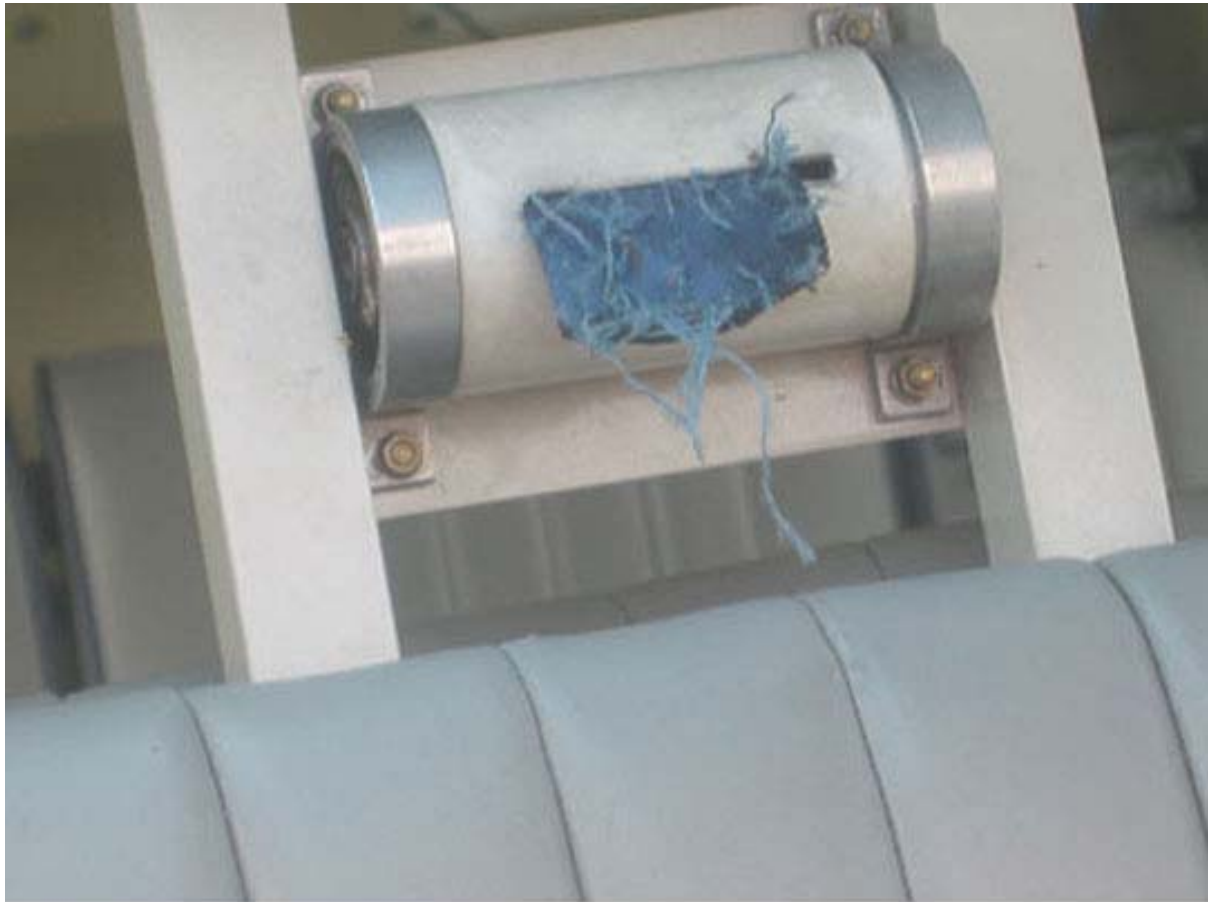
Figure 2

The accident was clearly survivable and the major impact forces were almost certainly in a predominantly aft direction, followed by lateral forces during the helicopter's gyrations on the ground. It was thus surprising that the pilot's upper torso restraint had failed. It was unclear whether his head injuries were directly caused by the failure of the restraint, or even which part of the aircraft structure contacted his head, but it was considered, subjectively, that the stitching had failed at a very low loading.

As shown in Figure 2, the upper torso restraint comprises an inertia reel unit behind each front seat occupant's neck. A single webbing strap is wound around the reel and emerges as a tongue from the unit. To achieve the inverted 'Y' shape strap, which divides either side of the occupant's neck, a second strap is folded at 45° and stitched to the tongue. The quality of this stitching was generally poor and irregular on both of the front seat restraints fitted to G-IANG.

**Photograph of failed stitching on front right seat
upper torso restraint**

Examination of a similarly-designed torso restraint system from a Bell 206 helicopter, and made by an original equipment manufacturer (OEM), exhibited a label identifying the various conformance standards under which it had been manufactured, and a figure of 1,500 lbf which identified the rated strength of the safety belt system in accordance with TSO C22g. No such label was found on the restraints from G-IANG. It was therefore decided to organise a destructive test of the intact front passenger upper torso restraint assembly, using this loading figure as a guide. The equipment employed was of the type used to perform tensile tests on material samples, and the method of gripping the anchor points ensured that all the stitched joints would be loaded. At a load of about 900 lbf, the stitched joint at the bifurcation failed, i.e. at the same location as on the pilot's restraint.

The figure of 1,500 lbf on the label attached to the OEM's restraint of the other Bell 206 helicopter examined, indicated its rated strength; the replacement item fitted to G-IANG achieved only some 60% of this value, but at failure, which indicated that its ultimate strength, relative to an OEM restraint, would be lower than 60%. However, the belt tested from G-IANG was not new and, presumably, some reduction in strength in-service would be anticipated, even for an OEM-supplied item. The right seat (pilot's) restraint system would experience the most use and hence likely experience the greatest deterioration.

The CAA should re-emphasise to the aeronautical community in general, and licensed engineers in particular, the importance of ensuring that any occupant restraint systems already fitted, or to be replaced, on an aircraft or helicopter, comply with the relevant airworthiness requirements.
