No: 4/91

Ref: EW/G91/01/09

**Aircraft Type and Registration:** Beech D55, G-AWAD

**Date and Time (UTC):** 19 January 1991 at 1015 hrs

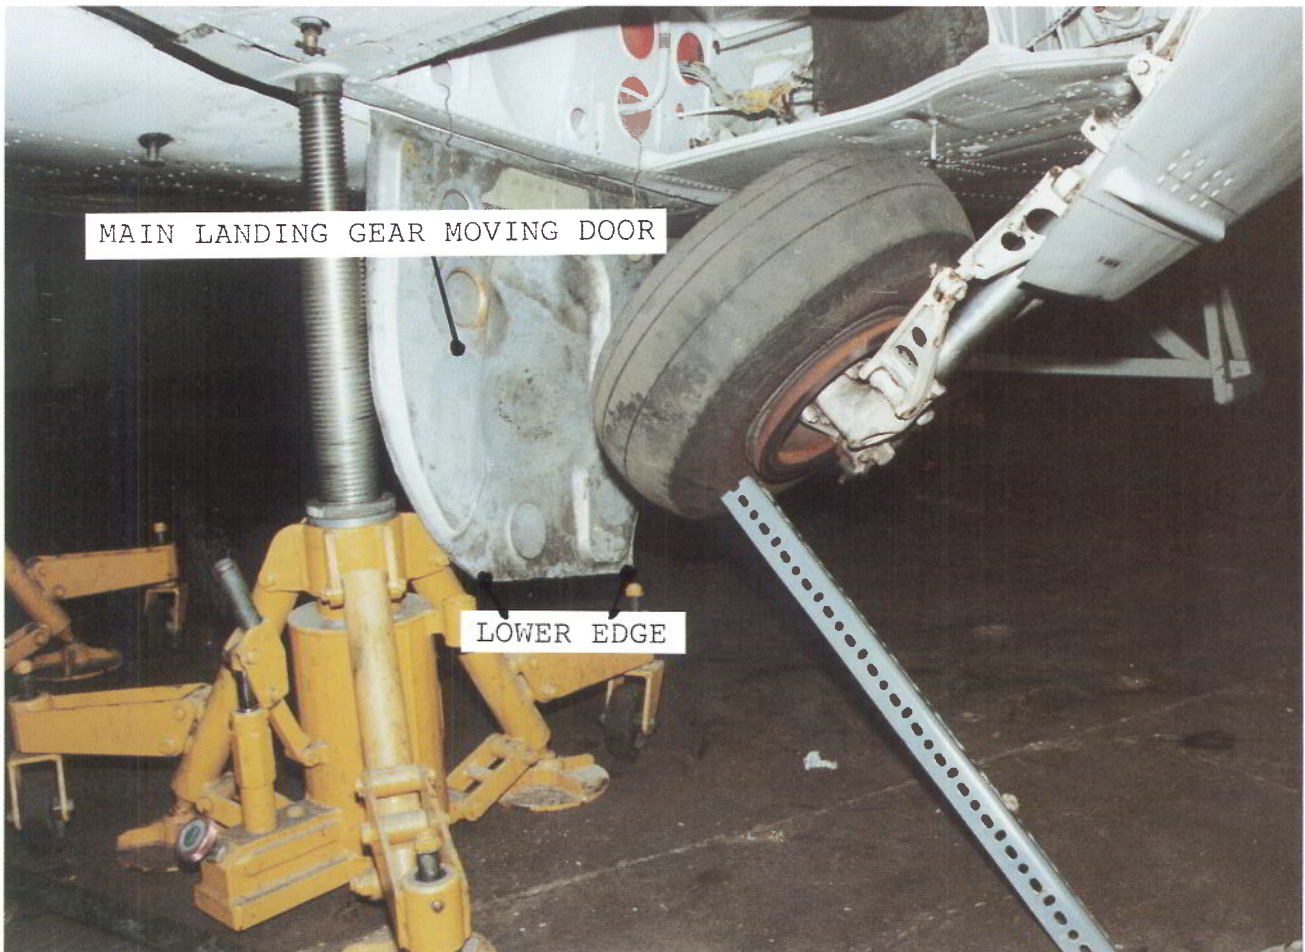
Bournemouth Airport showed that the propellers had contacted the surface during the aircraft's take-off. Both main landing gear inboard doors had approximately  $\frac{1}{4}$  in. of their lower edges (that is the lower edges with the doors open) abraded away. This damage was uniform over the length of each door, indicating that the aircraft had been in a fairly level attitude when it occurred. There was no damage to any other part of either main landing gears. As shown in the accompanying photograph, this damage to the doors could only have occurred when the main landing gears had partially retracted. Measurement of ground clearances on an identical aircraft showed that the main landing gear inboard doors had  $1\frac{1}{2}$  ins. of clearance and the propeller blades had  $8\frac{1}{2}$  ins. Examination of the nose landing gear showed that part of the retract/extend mechanism had partially failed such that the nose landing gear appeared able to transit but that a full uplock, or downlock, would not be achieved. The damage to this linkage was assessed as having been caused by a large upward force applied to the nose wheel whilst the nose landing gear was in transit. This had caused one bolt to fail in shear and another to have large shear forces applied to it. The 'weight-on' wheel switch actuation rod, which was located on the nose landing gear, was bent. Examination of this actuating rod indicated that the damage had been caused at the same time as that which had occurred to the retract/extend mechanism. To date, no functional testing of the aircraft's landing gear retract/extend mechanism has been carried out, but further visual inspection has revealed no other faults.

PHOTOGRAPH SHOWING MAIN LANDING GEAR PARTIALLY RETRACTED
