INCIDENT

Aircraft Type and Registration:	Boeing 737-528, G-GFFE	
No & Type of Engines:	2 CFM56-3C1 turbofan engines	
Year of Manufacture:	1995	
Date & Time (UTC):	3 September 2005 at 0920 hrs	
Location:	Stand 110, North Terminal, London Gatwick Airport	
Type of Flight:	Public Transport (Passenger)	
Persons on Board:	Crew - 6	Passengers - None
Injuries:	Crew - None	Passengers - N/A
Nature of Damage:	APU failure with extensive axial ejection of turbine debris	
Commander's Licence:	Airline Transport Pilot's Licence	
Commander's Age:	Not known	
Commander's Flying Experience:	18,500 hours (of which 9,400 were on type)	
Information Source:	AAIB Field Investigation

Synopsis

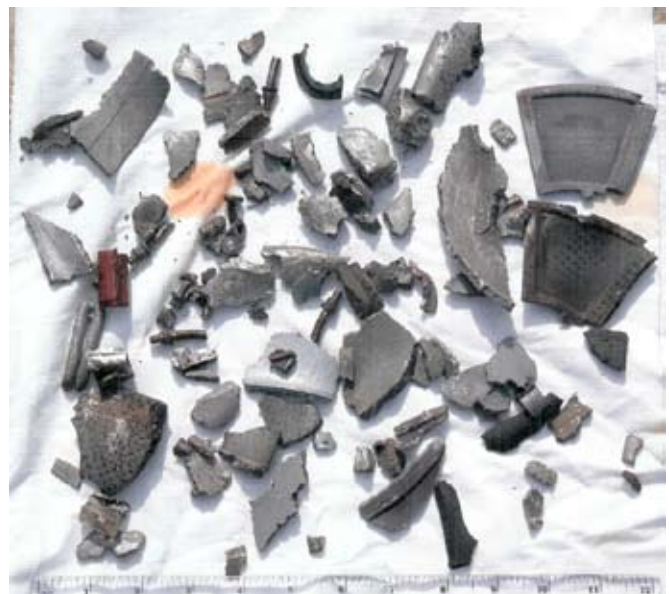
Figure 2

below the rear of the aircraft. A sketch diagram of the distribution of the remaining debris was made on part of a large-scale chart of the apron area before the smaller debris was swept up by the airport authority to bring the taxiway back into use. The diagram and some debris items were subsequently passed to the AAIB. It was noted that the general distribution formed a fan-shaped pattern extending behind the aircraft. A few fragments had travelled as far as the northern part of Stand 135 but none reached Stand 134. A photograph of the fragments collected is shown at Figure 2.

No airframe damage had occurred but on opening the APU access door, it could be seen that an internal failure had bulged and partly split the external casing of the unit. One of the two side-mounts had separated from the unit as a result of the deformation of the casing. Looking down the jet-pipe it could be seen that the turbine was damaged and displaced from its axis, whilst the exhaust duct within the APU had been seriously deformed by contact with high energy rotating turbo-machinery.

APU fragments

The damaged APU was removed from the aircraft and shipped to the European service and overhaul centre for the type. It was subjected to a strip examination in the presence of an AAIB Inspector. The gearbox and compressor section of the unit had suffered light damage but the turbine wheel was in two halves. Most of the housing, external casing and combustion chamber were severely damaged. The containment ring was severely deformed into an approximately oval shape but had successfully prevented any in-plane departure of turbine debris. Following separation from the wheel, most extremities of the inflow turbine had exited via the exhaust duct. This was the result of multiple impacts of the wheel casting halves with adjacent boundaries of the flow path. The two halves of the core of the turbine casting remained in the unit, were of approximately equal size and had separated as a result of a fracture at a face parallel with the casting axis.

The main fracture faces of the turbine appeared to exhibit overload characteristics. It was noted, however, that the failure appeared to have developed radially across the fracture face from a point on the centreline approximately mid-way along the longitudinal axis of the component. This was at or close to the centre of mass of the casting.

Examination of all the failed wheels returned to the manufacturer confirmed that the failures originated at small film inclusions of aluminium-magnesium oxides within the core of the casting. These led to initial fatigue crack growth before rapid failures occurred across the remainder of the cross-sections. Both failures involving separation into two approximately equal halves (bi-wheel) and into three approximately equal sized portions (tri-wheel failures) have occurred. In all instances the containment rings performed as designed.
