ACCIDENT

Aircraft Type and Registration:	YAK-52, RA-3585K	
No & Type of Engines:	1 Ivchenko M14P piston engine	
Year of Manufacture:	1990	
Date & Time (UTC):	28 April 2011 at 1150 hrs	
Location:	Langford, near Maldon, Essex	
Type of Flight:	Training	
Persons on Board:	Crew - 2	Passengers - None
Injuries:	Crew - 2 (Fatal)	Passengers - N/A
Nature of Damage:	Aircraft destroyed	
Commander's Licence:	Private Pilot's Licence	
Commander's Age:	43 years	
Commander's Flying Experience:	673 hours (of which 66 were on type) Last 90 days - 20 hours Last 28 days - 10 hours	
Information Source:	AAIB Field Investigation

Synopsis

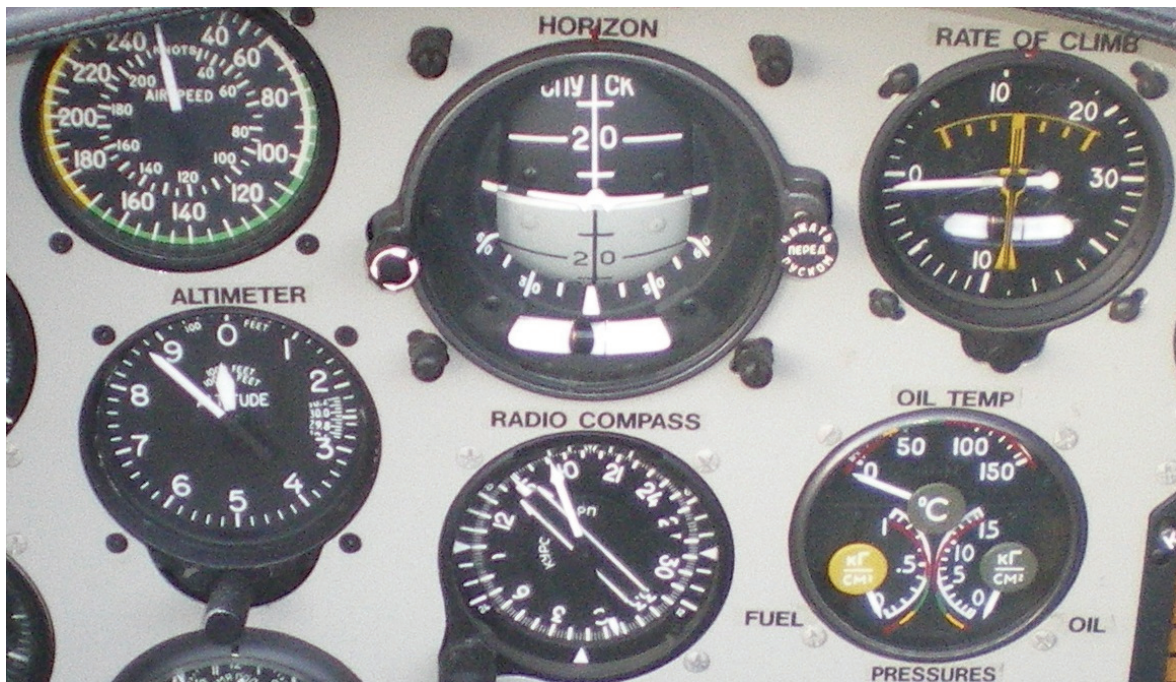
Figure 1

Instrument panel similar to that fitted to RA-3585K showing gyro horizon (top centre) and combined VSI and turn/bank indicator (top right)

indicator presented information in a different style to the instruments typically found in the aircraft with which the instructor was familiar. Had he consulted these instruments around the time at which the spin entry occurred, or endeavoured to determine the direction of spin from the turn co-ordinator, the presentations may have confused him or delayed his action.
