INCIDENT

Aircraft Type and Registration:	DHC-8-402 Dash 8, G-JEDI
No & Type of Engines:	2 Pratt & Whitney Canada PW150A turboprop engines
Year of Manufacture:	2001
Date & Time (UTC):	21 December 2009 at 1052 hrs
Location:	London Gatwick Airport
Type of Flight:	Commercial Air Transport (Passenger)
Persons on Board:	Crew - 4 Passengers - 72
Injuries:	Crew - None Passengers - None
Nature of Damage:	Damage to a wiring loom, and structure, in the left centre-wing section
Commander's Licence:	Air Transport Pilot's Licence
Commander's Age:	33 years
Commander's Flying Experience:	4,241 hours (of which 2,677 were on type) Last 90 days - 108 hours Last 28 days - 35 hours
Information Source:	AAIB Field Investigation

Synopsis

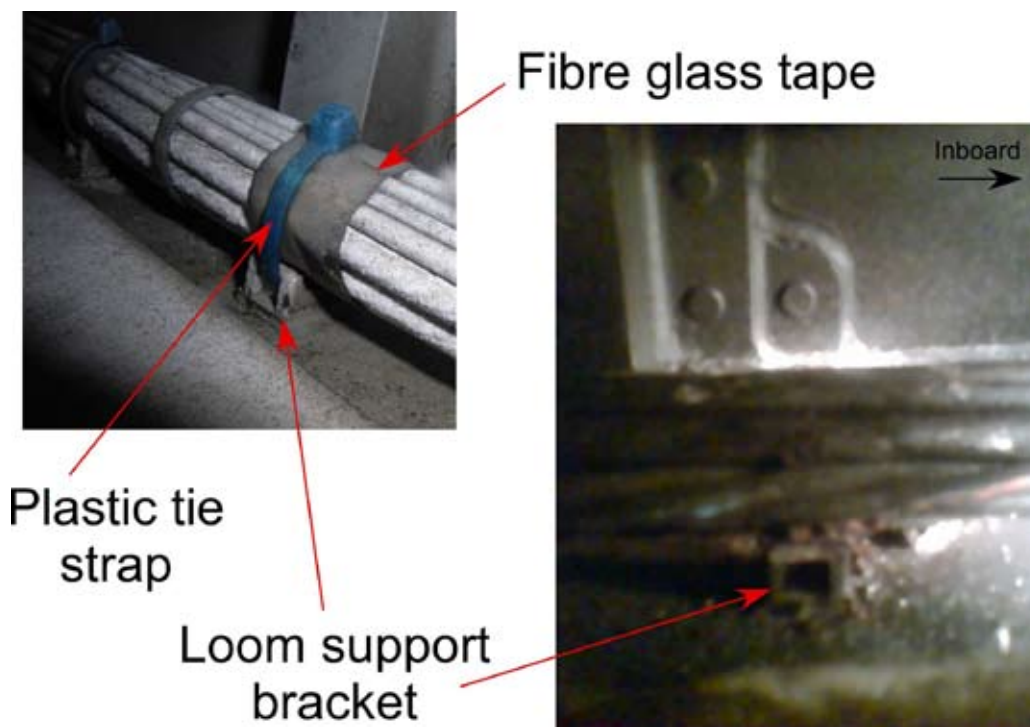
Figure 2

A wiring loom routed in the left centre-wing section had sustained extensive fire and overheat damage and was localised to an area where the loom was supported by the use of plastic tie straps attached to a support bracket riveted to the lower wing skin. The plastic tie strap and protective fibreglass tape, used to protect the loom from damage from the tie strap, were no longer attached to

the loom and the plastic support bracket had melted (Figure 2).

Loom support bracket

The examination of the wiring loom indicated that the failure resulted from chafing by the head of the blind rivet that secures the loom support bracket to the aircraft structure. The action of inserting a blind rivet causes a shear lip on the inner stem. The loom sits upon the loom support bracket and the tie wrap is inserted around the loom and over the head of the rivet and its stem. Over time the relative movement of the wiring loom to the fixed support bracket caused localised chafing, firstly, of the tie strap and then of the wiring loom itself. The stem of the rivet is cadmium plated and particles of cadmium were found in the tie strap and wiring recovered from the area of the fire. There are no other items in the affected area that are cadmium plated and therefore the particles can only have come from the blind rivet stem.

Based on the findings of this investigation the aircraft manufacturer issued a modification for operators to replace the blind rivets on the loom support bracket with solid rivets, and to inspect the wiring for damage. Transport Canada has since issued Airworthiness Directive CF-2010-08 which mandates the rivet replacement and wiring inspections.

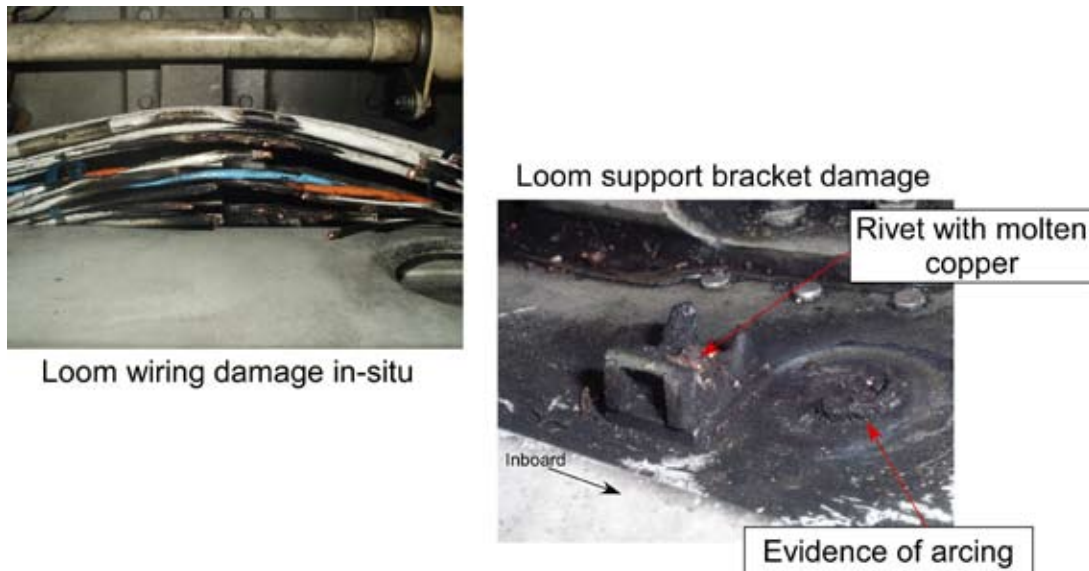
Figure 3

There was evidence of arcing between the wires within the loom, as well as between the wiring and the aircraft structure close to the loom support bracket. Arcing had also taken place between the wiring and the head of the cadmium-plated blind rivet that attached the loom support bracket to the structure (Figure 3).

Wiring damage and evidence of arcing

The wiring loom and the remains of the tie straps, fibreglass tape and the loom support bracket were sent to a forensic laboratory for a detailed examination. The loom contained 22 wires, some of which had fused due to the arcing and fire, this had resulted in the loss of most of the evidence of the original mode of failure. The wires were analysed using various methods of microscopy, which showed that they had signs of localised mechanical damage, with one wire showing abrasion with a sharp object. Later examination of the abrasions on the wire showed them to contain particles of cadmium and iron.

The chafing reached an extent where the insulation of one of the wires was compromised and a short, with associated arcing, occurred between the wire and rivet stem, which would have had a ground potential. This arcing would have led to localised heating and damage to the other wire's insulation and eventual arcing between wires as well as the structure.
