**ACCIDENT**

<b>Aircraft Type and Registration:</b>	Piper PA-28-140 Cherokee, G-BXPL	
<b>No &amp; Type of Engines:</b>	1	Lycoming O-320-E2A piston engine
<b>Year of Manufacture:</b>	1968	
<b>Date &amp; Time (UTC):</b>	10 December 2010 at 1520 hrs	
<b>Location:</b>	1.5 miles south-east of Wellesbourne Mountford Airfield, Warwickshire	
<b>Type of Flight:</b>	Training	
<b>Persons on Board:</b>	Crew - 1	Passengers - None
<b>Injuries:</b>	Crew - None	Passengers - N/A
<b>Nature of Damage:</b>	Extensive	
<b>Commander's Licence:</b>	Student Pilot	
<b>Commander's Age:</b>	50 years	
<b>Commander's Flying Experience:</b>	12 hours (of which 12 were on type) Last 90 days - 7 hours Last 28 days - 1 hour	
<b>Information Source:</b>	Aircraft Accident Report Form submitted by the pilot

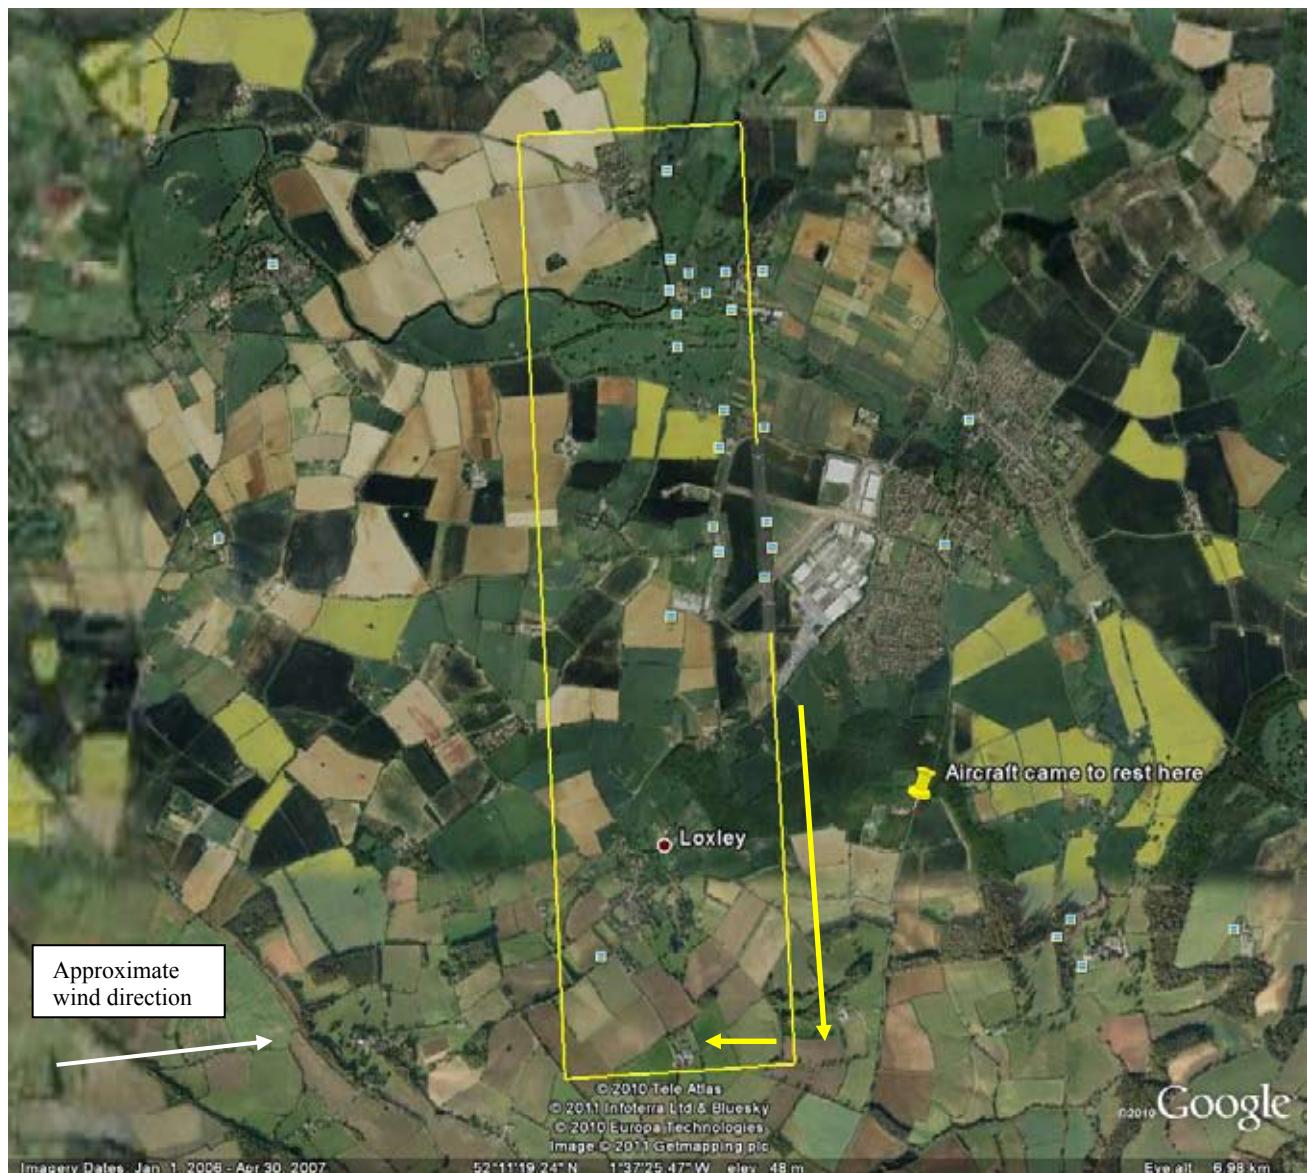
**Figure 1**  
Circuit plan and accident site

aircraft and throttling back the engine. Immediately the engine lost power and the rpm dropped to 1,200. The pilot applied carburettor heat and switched fuel tanks. Although the engine responded to throttle position, the changes were small and no significant increase in power was evident. The pilot selected a field to the north-east of his position (Figure 1) and attempted a forced landing. However, the aircraft touched down at the far end of the field, hitting the boundary hedge at over 20 kt and came to rest on the road behind. The landing caused extensive damage to the aircraft and the hedge, but the pilot was uninjured and exited the aircraft without assistance through the door. Traffic using the road was brought safely to a halt without collision.
