AIRCRAFT ACCIDENT REPORT 2/2004

**Report on the accident to
Sikorsky S-61N, G-BBHM
at Poole, Dorset
on 15 July 2002**

Air Accidents Investigation Branch

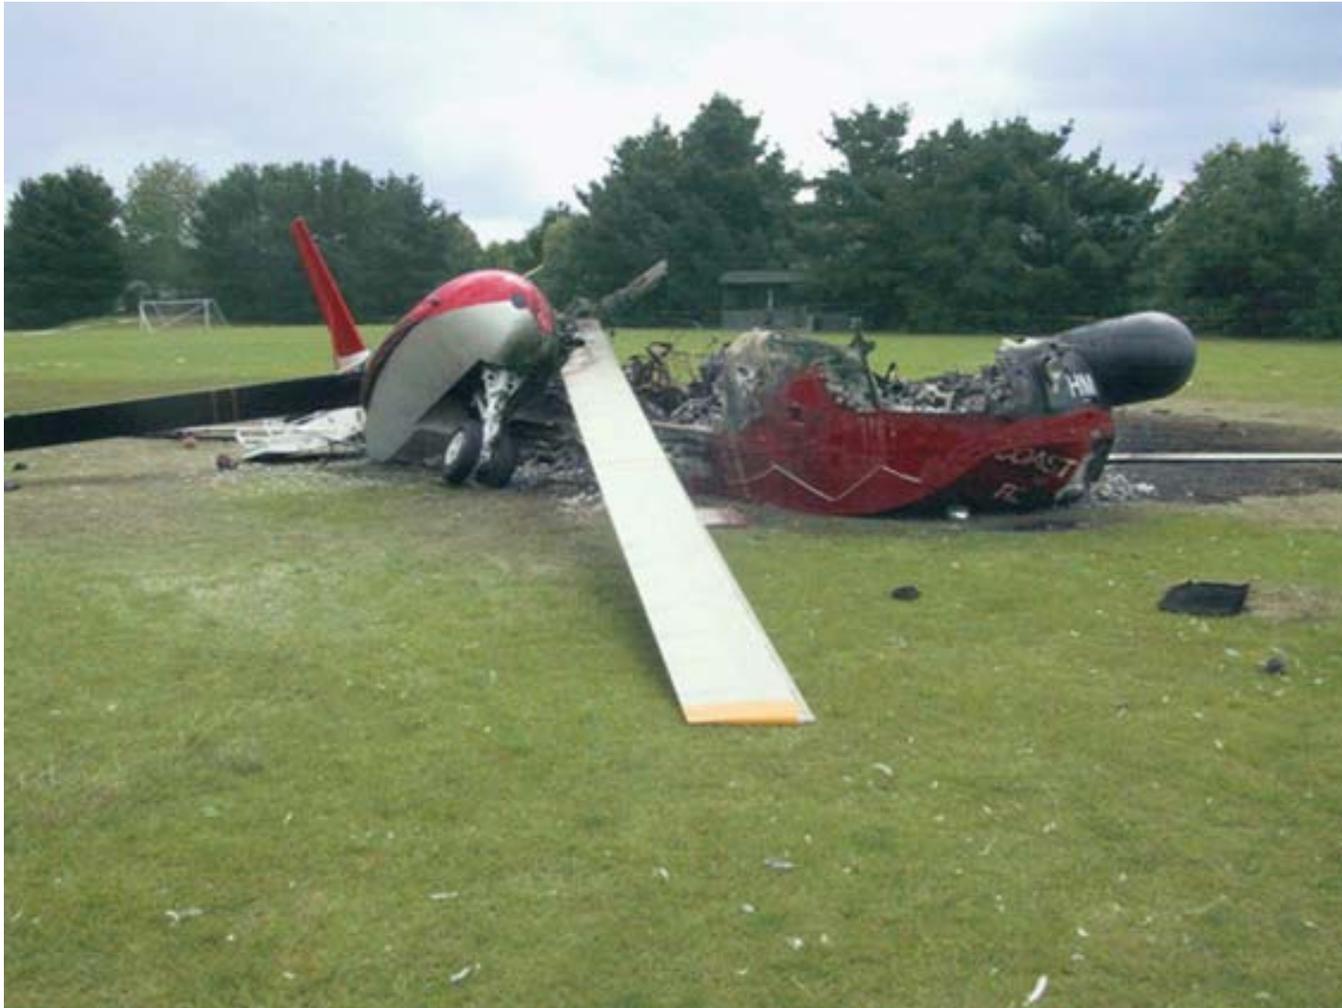
Sikorsky S-61N G-BBHM, Poole 16 July 2002
