AAIB Bulletin S2/2002

Ref: EW/C2002/07/03

Aircraft Type and Registration:	Sikorsky S-61N, G-BBHM
Serial Number:	61713
Year of Manufacture:	1973
Date & Time (UTC):	15 July 2002 at 1515 hrs
Location:	Poole Harbour, Dorset
Type of Flight:	Public Transport (SAR)
Persons on Board:	Crew - 4 Passengers - Nil
Injuries:	Crew - Nil Passengers - N/A
Nature of Damage:	Helicopter destroyed
Commander's Licence:	Airline Transport Pilot's Licence (Helicopters)
Commander's Flying Experience:	4,600 hours (of which 2,750 hours were on type)
Information Source:	AAIB Field Investigation

Safety Recommendations: Accident to Sikorski S61N at the Royal Marines Barracks, Poole, Dorset, on 15 July 2002

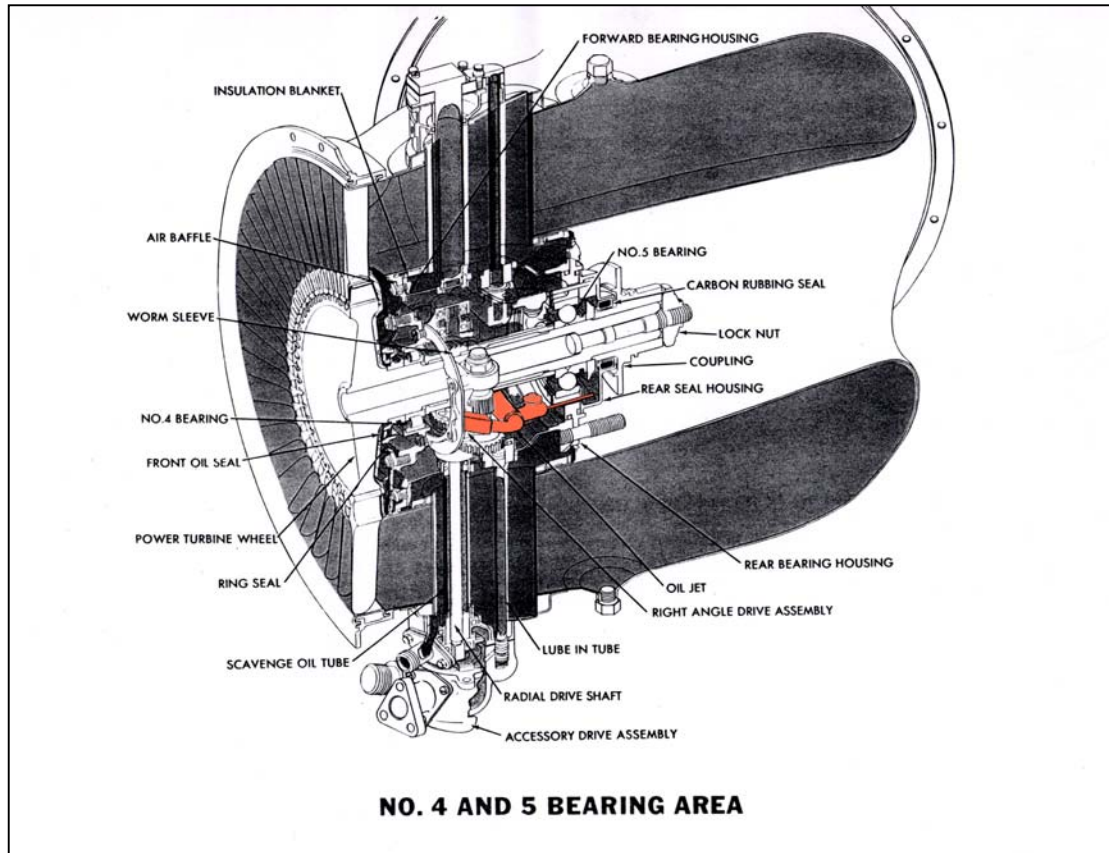
OIL JET DETAILS

ABOVE: Diagram of the Nos 4 and 5 bearing area showing the location of the oil jet

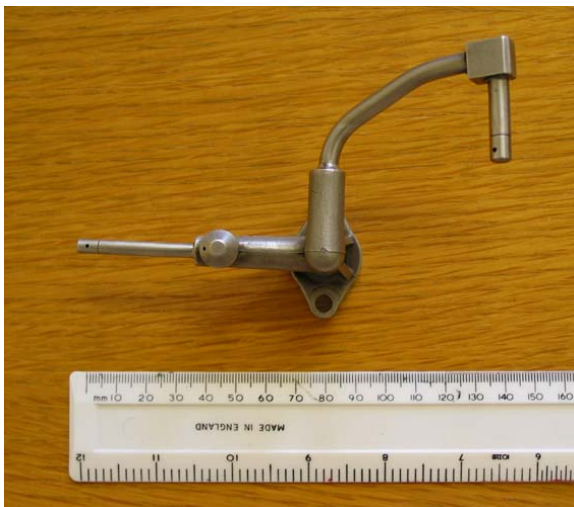
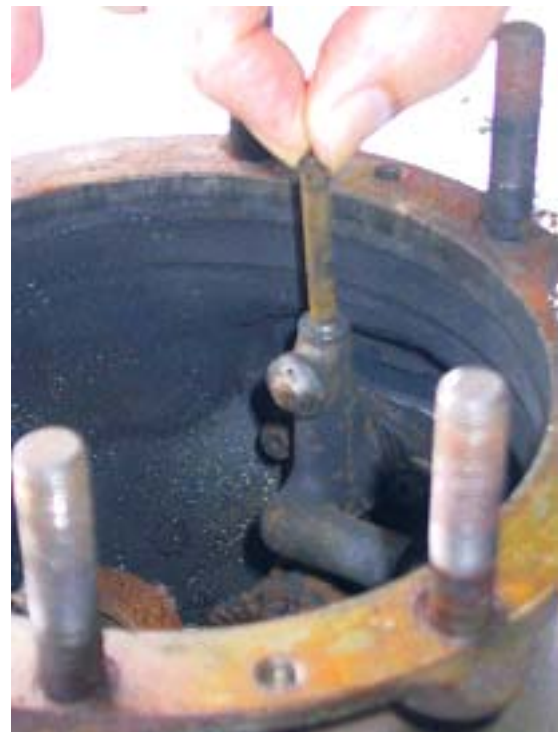
RIGHT: The broken oil jet in the bearing chamber

BELOW: a new oil jet

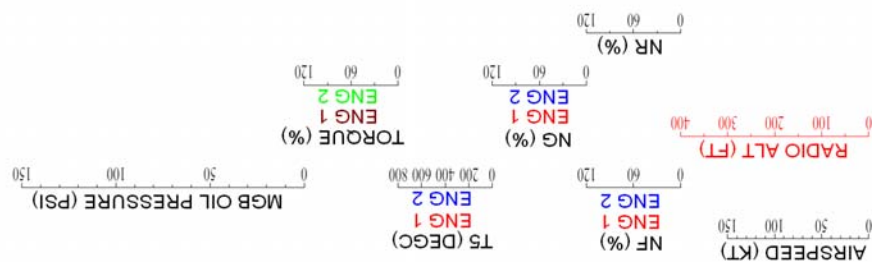
Plot of N_f 'jitter'
