ACCIDENT

Aircraft Type and Registration:	Bolkow 208C Junior, D-EGFU	
No & Type of Engines:	1 Roll-Royce/Continental 0-200-A engine	
Year of Manufacture:	1967	
Date & Time (UTC):	2 September 2011 at 1314 hrs	
Location:	Peterborough Sibson Airfield, Cambridgeshire	
Type of Flight:	Private	
Persons on Board:	Crew - 1	Passengers - None
Injuries:	Crew - 1 (Fatal)	Passengers - N/A
Nature of Damage:	Aircraft destroyed	
Commander's Licence:	Private Pilot's Licence	
Commander's Age:	52 years	
Commander's Flying Experience:	675 hours (of which 22 were on type) Last 90 days - 6 hours Last 28 days - 0.3 hours	
Information Source:	AAIB Field Investigation

Synopsis

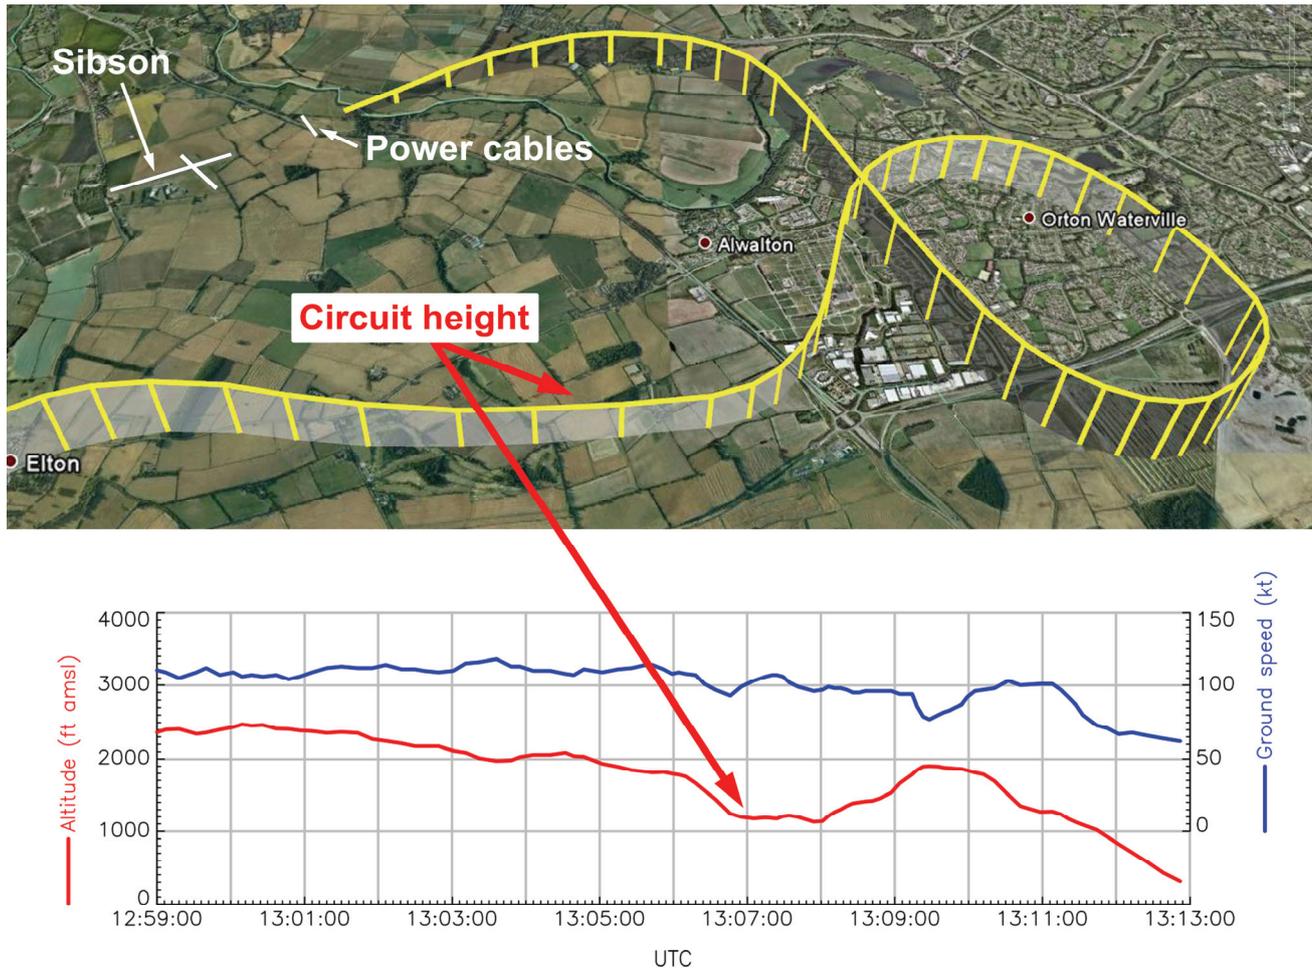
The unit recorded the aircraft taking off from Long Marston Airfield at 1224 hrs and flying in a direct track to Sibson Airfield at an altitude of about 2,300 ft. South of Sibson, the aircraft descended to about 1,200 ft and then tracked to the east before briefly turning north and then carrying out a climbing turn in a wide orbit over the area of Orton Waterville. Halfway through the orbit, the aircraft started to descend once more and joined the left base for Runway 24. The pilot then flew a gentle descending turn onto the final approach, establishing on the runway centreline at about 1.2 nm from the Runway 24 threshold. The last recorded point was approximately 300 m east of the power lines at 1312:52 hrs. Figure 1 shows the GPS recording in the vicinity of Sibson Airfield.

GPS track in the vicinity of Sibson Airfield

Sibson Airfield provides various challenges to pilots, not least the inability to join overhead. This denies pilots the opportunity to survey the runway properly prior to landing, which is of particular importance if unfamiliar with the airfield. It is possible that the recorded flight path showing the aircraft descending to circuit height, then climbing again prior to carrying out an orbit, was due to the pilot losing sight of the airfield and trying to re-orientate himself with the runway.

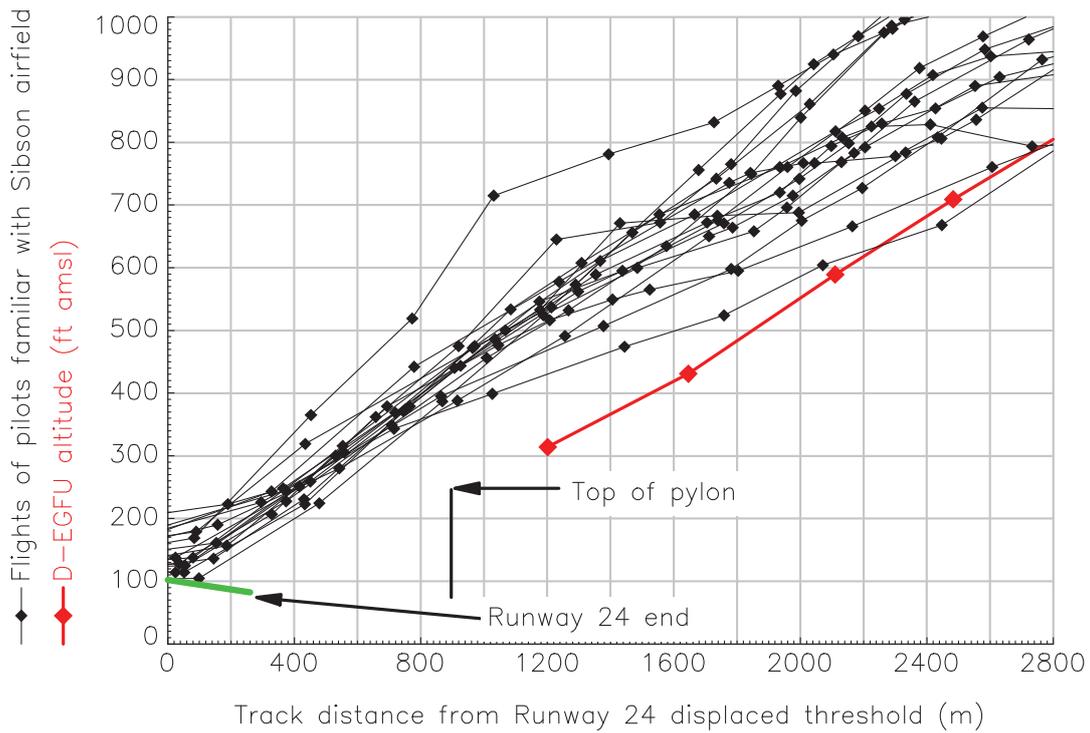
Figure 2 compares aircraft GPS height with track distance from the Runway 24 displaced threshold. Superimposed on the chart is the representative position and height of the pylon towers running closest to the runway and the part of Runway 24 between the start of the prepared runway surface and the displaced threshold. The tracks depicted in black were recorded on a number of aircraft flown by pilots familiar with Sibson Airfield. These flights cleared the pylon towers by approximately 150 ft or more. The red track is of the accident aircraft.

Comparison of the D-EGFU accident approach with approaches made to the same runway by pilots familiar with the airfield

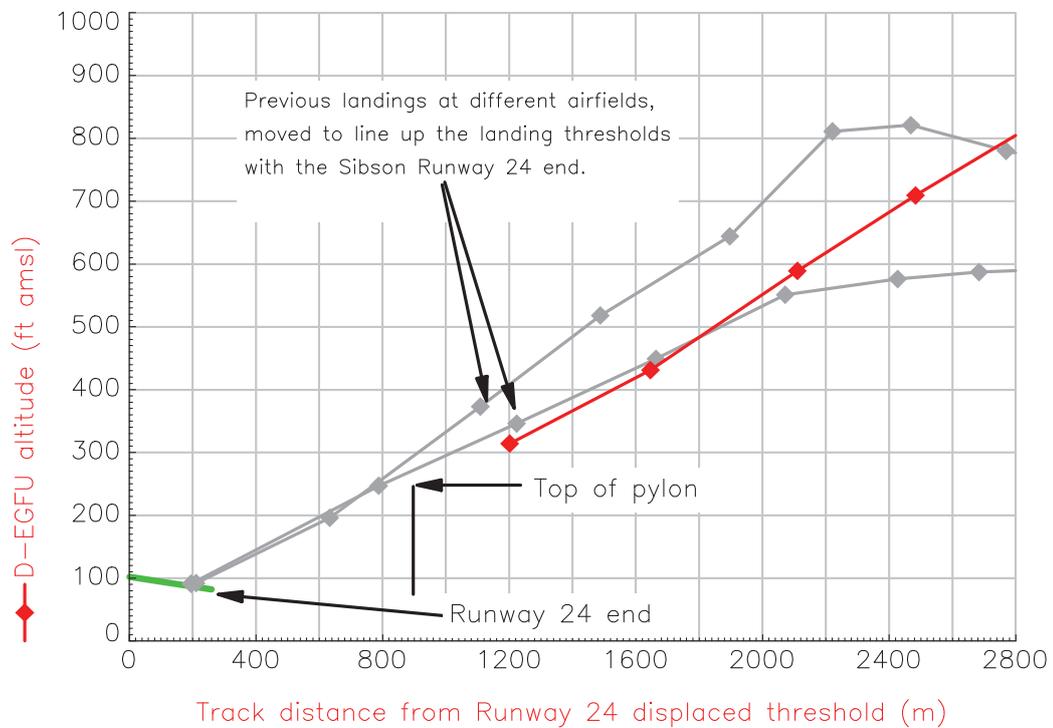
Two of the previous landings recorded by the GPS unit recovered from D-EGFU had been to runway thresholds that could be clearly referenced. Figure 3 overlays these approaches, together with the approach from the accident flight, aligning the other runway thresholds with the start of the prepared runway surface (not the displaced threshold) of Runway 24 at Sibson. The comparison, whilst not statistically robust, indicates a possibility that the aiming point for the landing may have been the start of the runway and not the displaced threshold.

Comparison of the accident approach with approaches at other airfields disregarding the displaced threshold

From the limited evidence available, it appears the pilot flew a normal approach path angle, but towards the start of the prepared runway surface rather than the displaced threshold. The pilot's unfamiliarity with the airfield and the unusual appearance of the runway created by significantly displaced thresholds at both ends might have contributed to him choosing this approach path. The pilot might have also have been drawn to the start of the runway by the presence of the Cessna Caravan taxiing towards the runway for takeoff.
