INCIDENT

Aircraft Type and Registration:	Airbus A319-131, G-DBCI	
No & Type of Engines:	2 International Aero Engines V2522-A5 turbofan engines	
Year of Manufacture:	2006	
Date & Time (UTC):	18 April 2007 at 0944 hrs	
Location:	Amsterdam Schiphol Airport, The Netherlands	
Type of Flight:	Commercial Air Transport (Passenger)	
Persons on Board:	Crew - 5	Passengers - 112
Injuries:	Crew - None	Passengers - None
Nature of Damage:	None	
Commander's Licence:	Airline Transport Pilot's Licence	
Commander's Age:	53 years	
Commander's Flying Experience:	11,123 hours (of which 3,493 were on type) Last 90 days - 132 hours Last 28 days - 44 hours	
Information Source:	AAIB Field Investigation

Synopsis

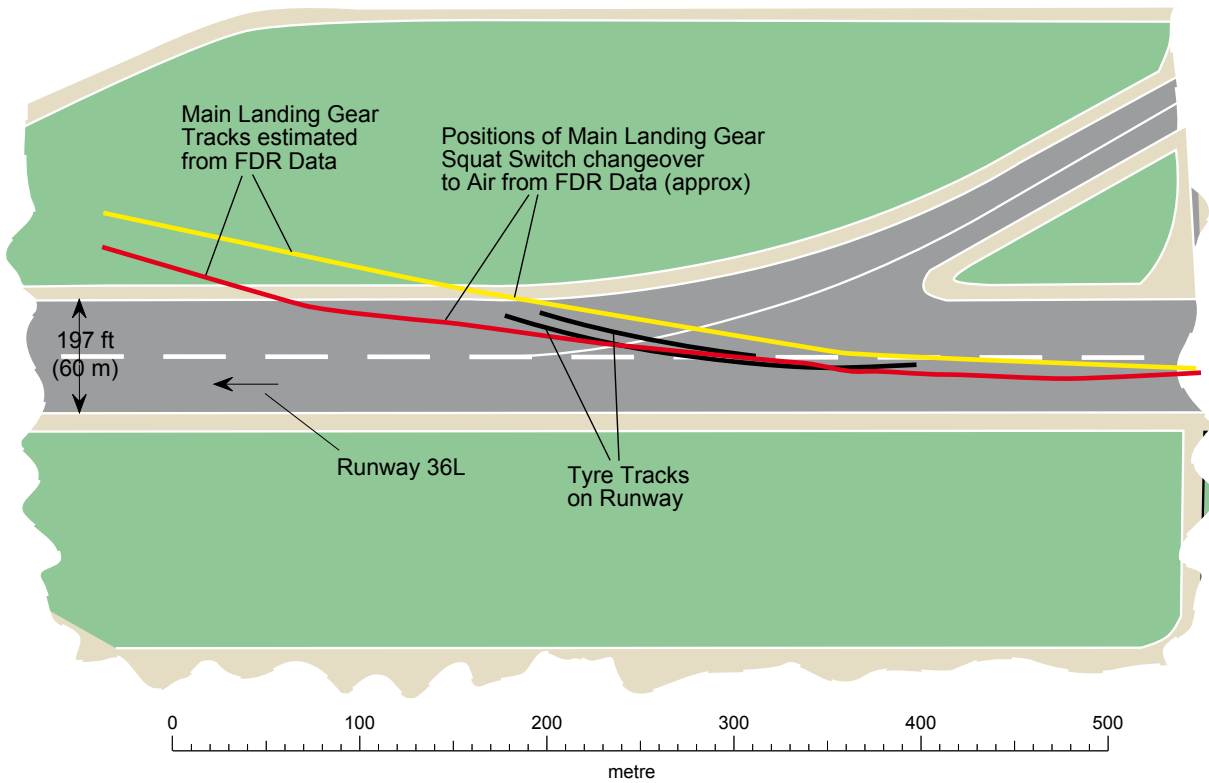
Figure 3

Inspection of Runway 36L at Amsterdam by the Dutch authorities shortly after the incident identified two pairs of tyre track marks that appeared likely to be associated with G-DBCI's takeoff ground roll deviation. The Dutch Safety Board supplied photographs of the marks and their approximate dimensions and AAIB subsequently examined the runway. The marks were found to consist of pronounced black rubber deposits on the light-coloured asphalt surface of the runway. Their lateral spacing corresponded to the A319 main landing gear wheeltrack and their position (Figure 3) corresponded closely to the aircraft track estimated from FDR data. It was therefore concluded that G-DBCI's mainwheel tyres had made the marks during the takeoff ground run.

The track marks from the left main wheel tyres commenced approximately 1,035 m from the start of Runway 36L, adjacent to a turnoff (V2 turnoff) from the reciprocal Runway 18R, with the aircraft near to the centreline. The marks indicated a brief slight turn to the left, followed by a sustained right turn, during which track marks from the right mainwheel tyres became evident. After turning approximately 20° right of the runway heading, both the left and right track marks ceased, at points respectively 9 m and 6 m from the runway edge. No signs were found to indicate that any of the tyres had run on the runway shoulder or the grass surround.

Plan view of runway tyre marks and main landing gear tracks estimated from FDR

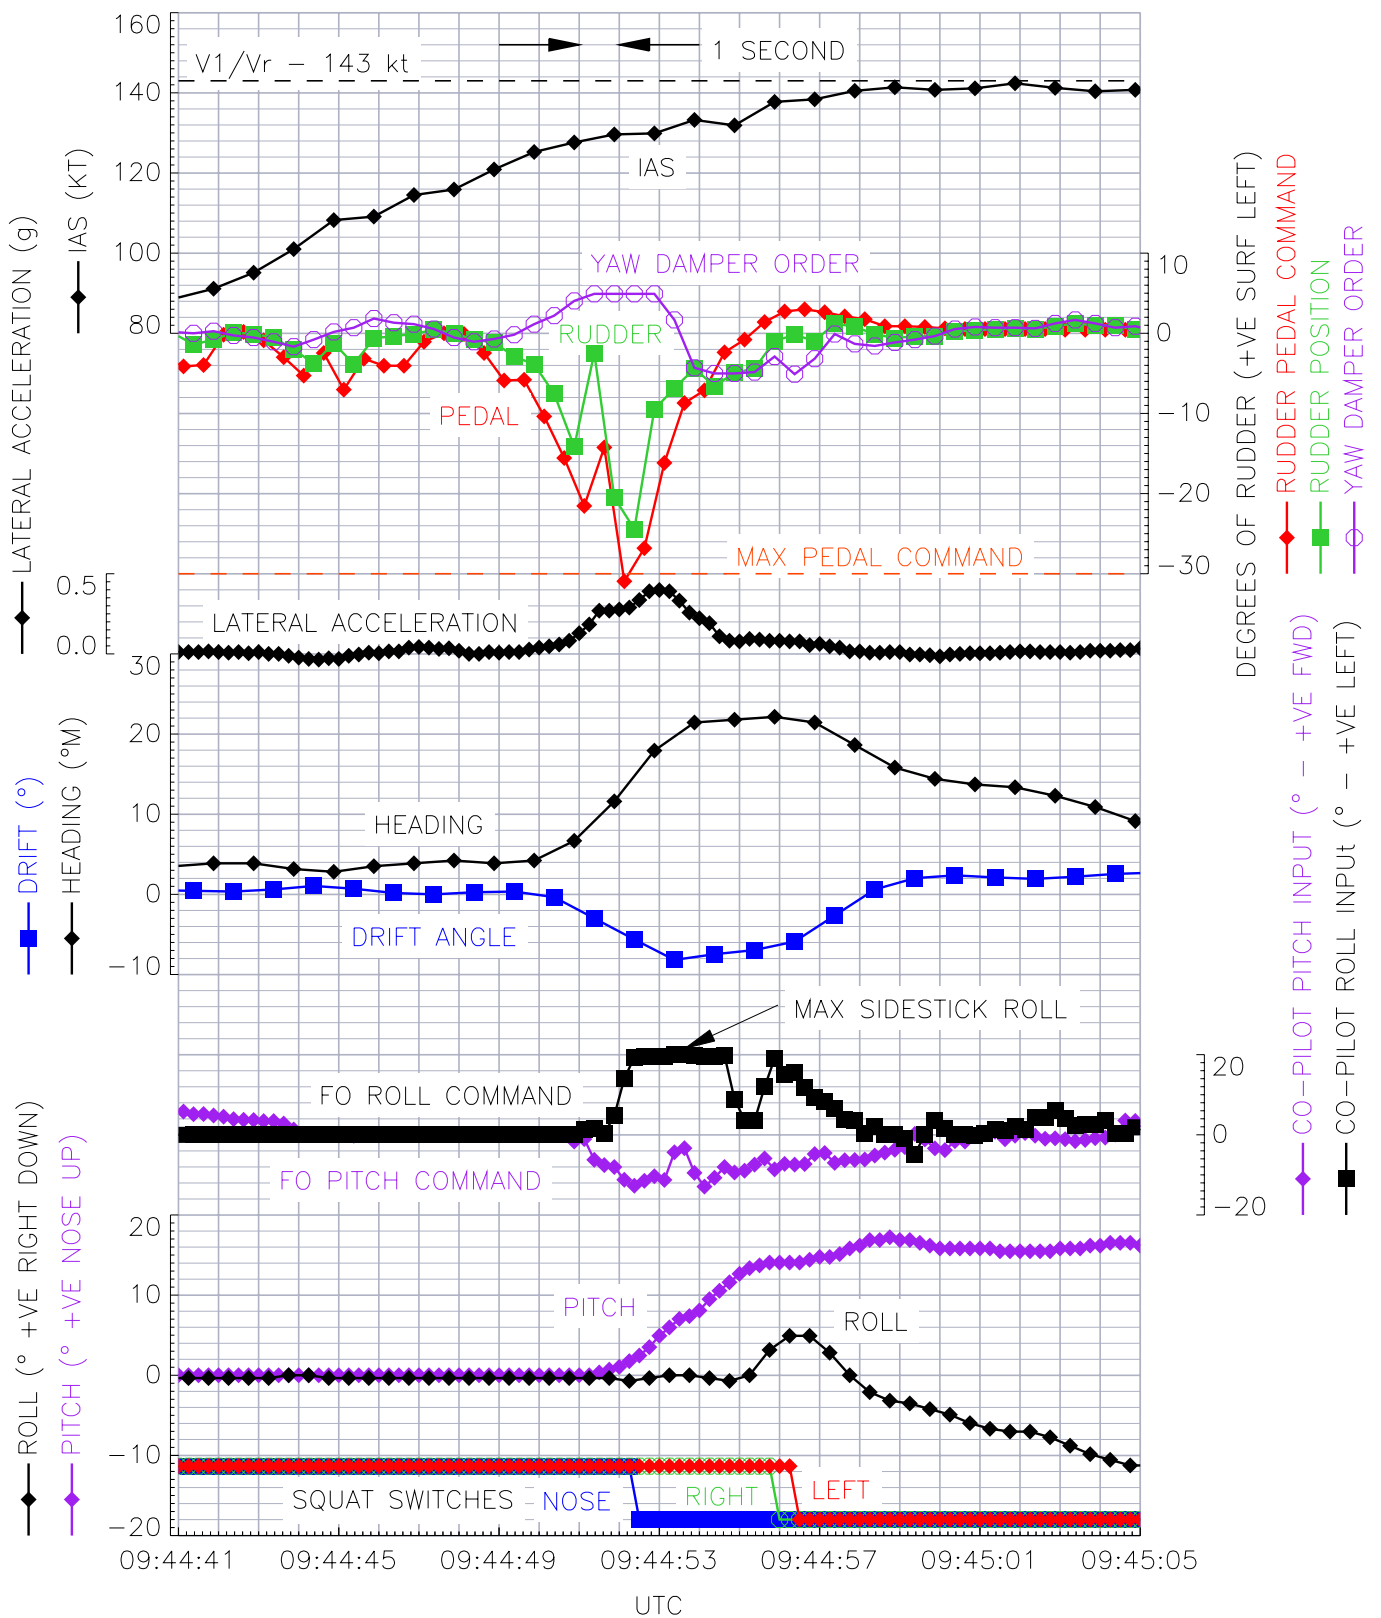
Figure 4

FDR Parameters showing control inputs and aircraft motion.
(Incident to G-DBCI on 18 April 2007)

At 0944:48 hrs, with an IAS of 116 kt, another right pedal input was initiated. Two seconds later, whereas previous inputs had started to return towards neutral, the right pedal input continued increasing and the heading increased through 005°M. One second later the data shows a brief peak in pedal input at approximately 72% of full deflection. At this point the IAS was 128 kt and increasing, aircraft heading was passing through 007°M and recorded drift angle was increasing through 3°.

The co-pilot's sidestick showed the start of a pitch-up command. Half a second later, the commander's sidestick registered a brief roll left input and the co-pilot's sidestick started to move towards a full left roll input. There was a one sample reduction in pedal input and rudder deflection. This was followed, half a second later, by a 31° yaw right command from the pedals (effectively a maximum 30° right rudder surface command) and an opposing 5° left rudder command from the yaw damper. This combination resulted in a recorded rudder surface deflection of 24° to the right.

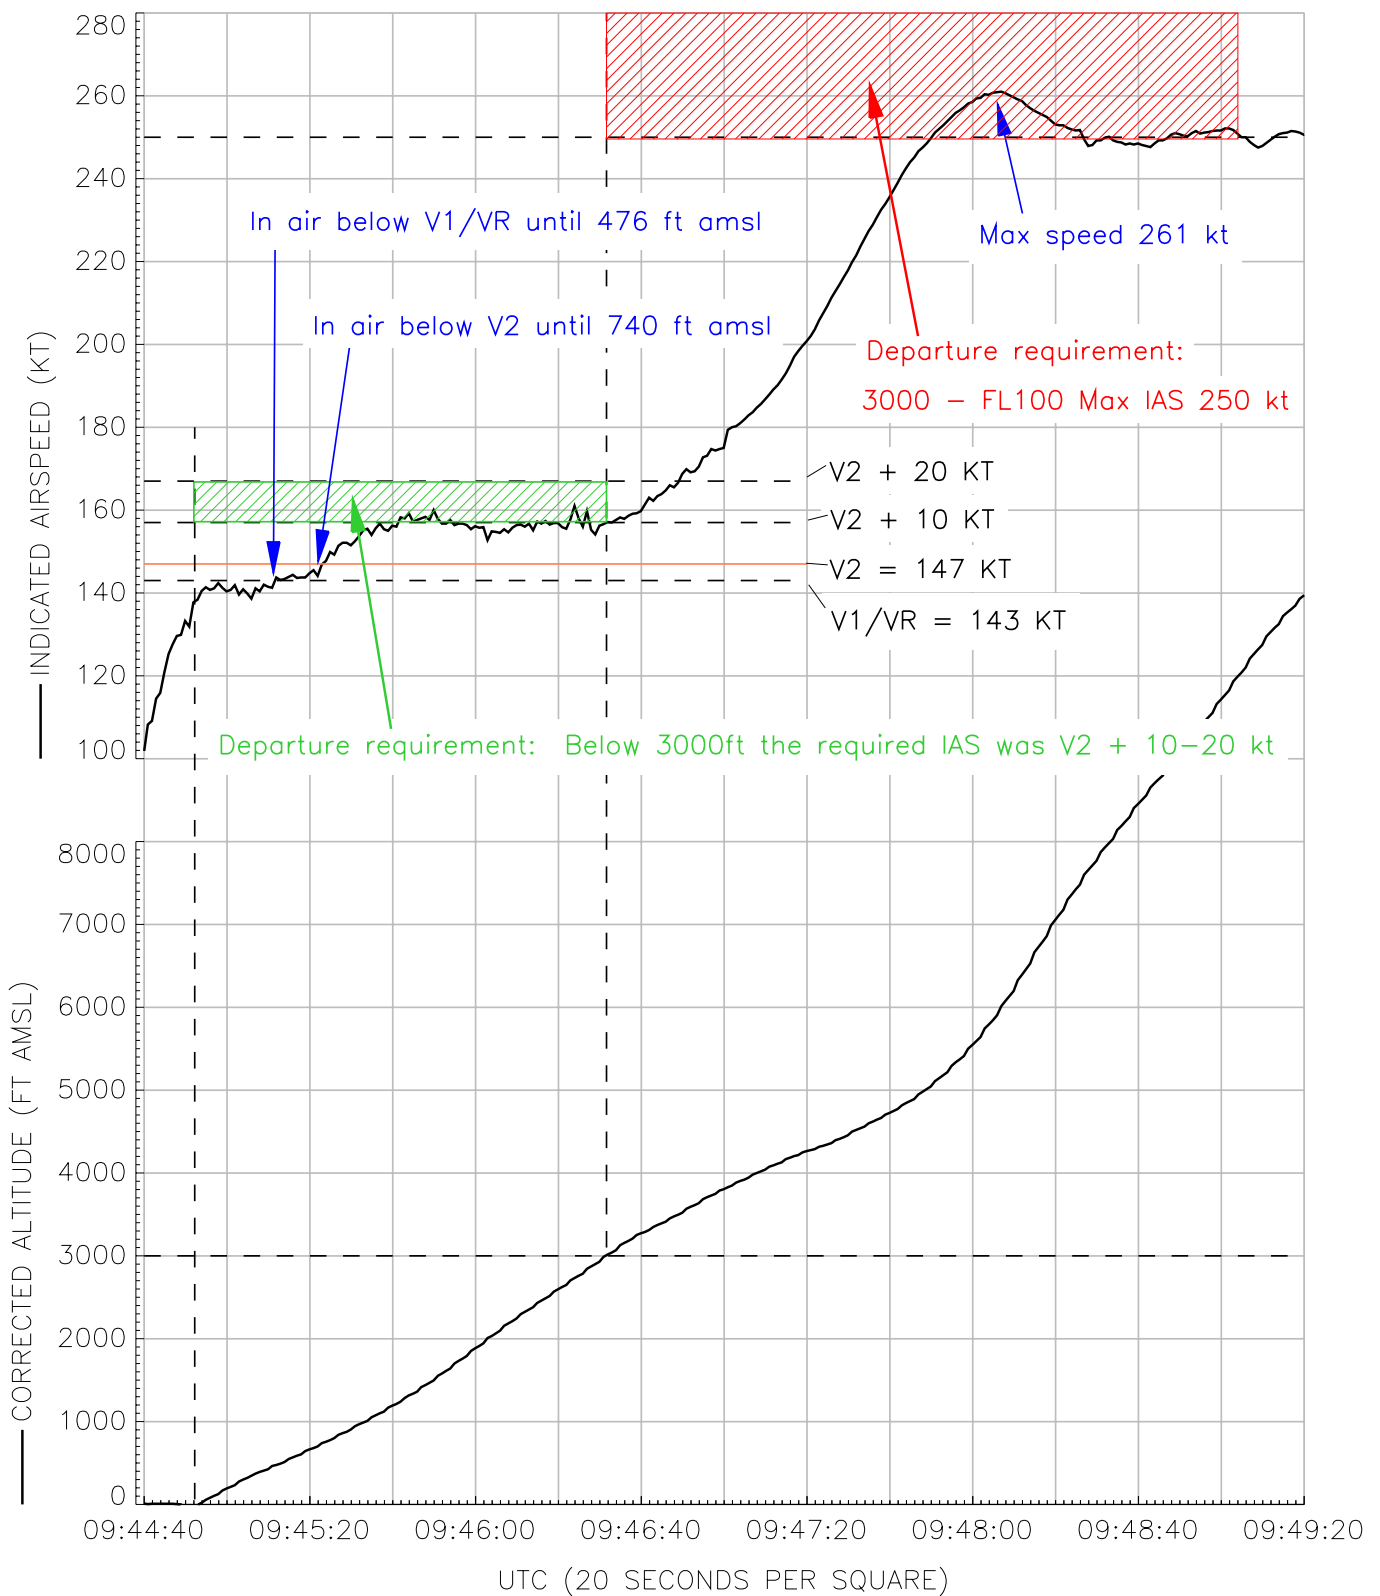
Figure 5 shows the aircraft speed and altitude compared to the noise abatement procedure requirements applicable to the departure from Schiphol Airport. The aircraft did not reach the V_1/V_R speed of 143 kt until passing 460 ft amsl (about 470 ft aal) and did not reach V_2 until passing 740 ft amsl (about 750 ft aal). The target initial climb speed was achieved at a height of 1,100 ft aal.

FDR parameters showing recorded airspeed relative to required airspeed after takeoff
(Incident to G-DBCI on 18 April 2007)
