ACCIDENT

Aircraft Type and Registration:	Vans RV-9A, G-CDCD	
No & Type of Engines:	1 Wilksch WAM-120 diesel engine	
Year of Manufacture:	2004 (Serial no: PFA 320-13925)	
Date & Time (UTC):	6 August 2013 at 1020 hrs	
Location:	1 mile South West of Wellesbourne Mountford Airfield, Warwickshire	
Type of Flight:	Private	
Persons on Board:	Crew - 1	Passengers - None
Injuries:	Crew - 1 (Minor)	Passengers - N/A
Nature of Damage:	Damage to both wings, nose landing gear and fuselage	
Commander's Licence:	Private Pilot's Licence	
Commander's Age:	59 years	
Commander's Flying Experience:	195 hours (of which 27 were on type) Last 90 days - 1 hour Last 28 days - 1 hour	
Information Source:	Aircraft Accident Report Form submitted by the pilot and additional investigation by the AAIB

Synopsis

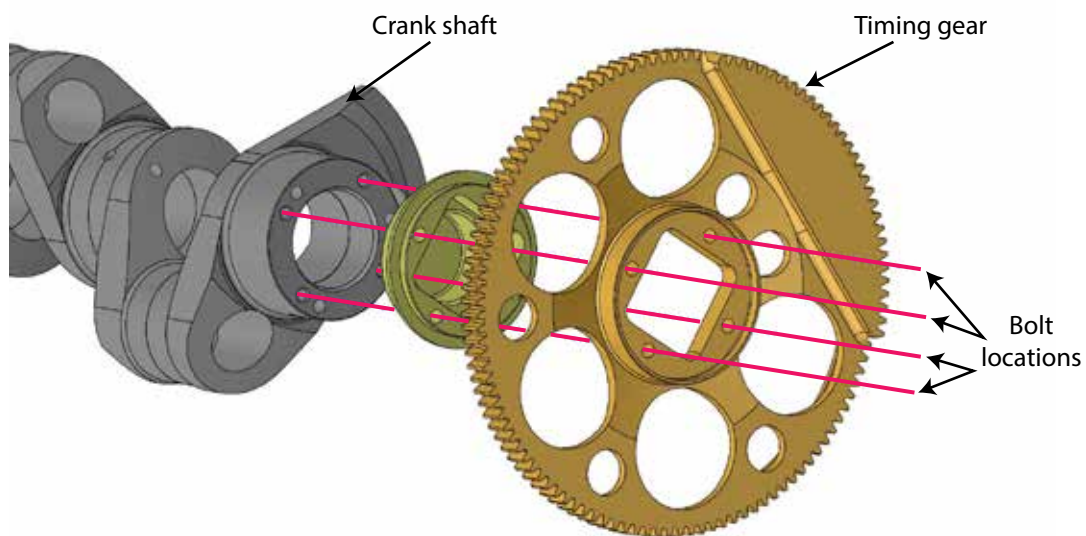
Figure 1

Exploded diagram showing attachment of timing gear to crankshaft.
(Diagram courtesy Wilksch Airmotive)

The AAIB examined the engine at the manufacturer's premises in the company of an engineer from the Light Aircraft Association (LAA). All three pistons had made repetitive contact with the exhaust valves, although the impacts did not appear to have occurred over a long period of running. It was found that three of the four bolts holding the timing gear to the crankshaft had failed; all three bolts had fractured at the head/shank interface and one had failed in the thread as well. They were recovered and sent for metallurgical

examination, which found that all the fractures bore the characteristics of high-cycle fatigue cracks whilst the two that only had head fractures had fatigue cracks developing in the threaded region where the third had failed. The manufacturer advised that the bolts were made from AISI 8740 chrome molybdenum steel.

Two of the bolts were also tested for hardness, and for their elemental composition using Energy Dispersive X-Ray (EDX) techniques. The bolts appeared to be deficient with respect to chromium and nickel content and were somewhat below minimum specification when tested for hardness (as a guide to calculate the tensile strength).

The manufacturer advised that the bolts were to a revised standard introduced by Wilksch Service Bulletin WA-SB-005 dated 8 July 2009. This had followed an in-service failure and introduced a change, in the specification of the bolts, from a commercial grade steel with relatively loose tolerance of the thread form to a higher standard of both material and thread form. The SB requested owners to send back the replaced bolts and it is understood that no failure or cracks in these have been found. It also contained detailed instructions for the bolt replacement to ensure that the correct torque is achieved.

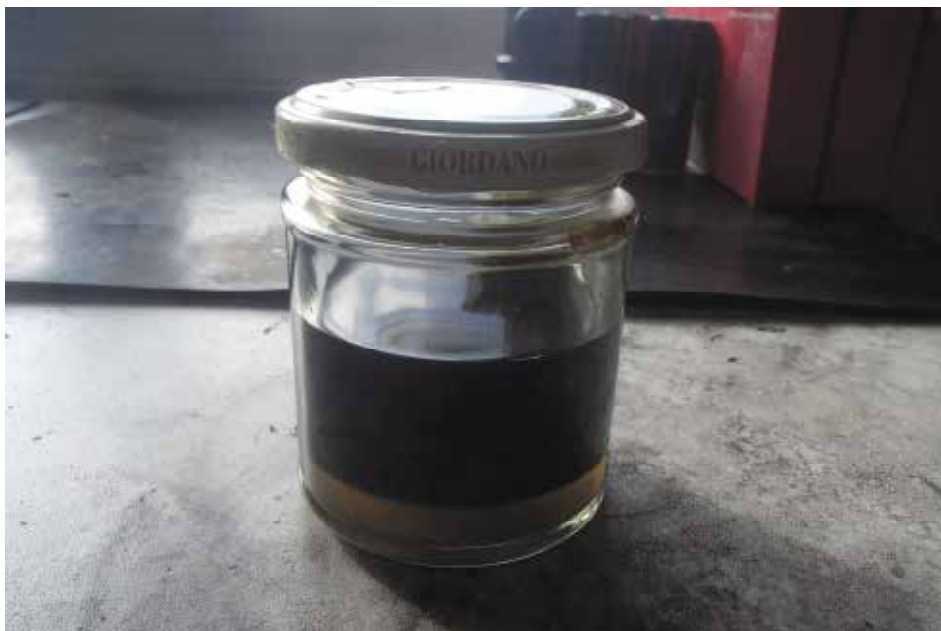
Figure 2

As part of the engine dismantling, the manufacturer had emptied the fuel filter bowl and was concerned at what was found (Figure 2). The fuel was a dense black colour and there was a high percentage of water present: in the manufacturer's estimation, there was enough to cause the engine to stop.

Photograph of fuel taken from filter bowl. Upper, dark layer is discoloured fuel and the lighter, lower layer is water

There are at least two potential reasons why this engine failed, contaminated fuel being, in the estimation of the engine manufacturer, the more likely. Metallurgical examination of the failed timing gear bolts showed evidence of high-cycle fatigue but, because of the nature of the internal damage to the engine, the manufacturer considers it unlikely that this failure occurred in flight. It is more likely that the damage occurred when the rotating propeller struck the fence.

Whether the cause of this engine failure was contaminated fuel or bolt failure, safety issues have been exposed and are being addressed. The apparent gross fuel contamination is beyond the control of the manufacturer but the LAA advise that they intend to highlight the need for regular fuel quality checks in their monthly publication, '*Light Aviation*'. The WAM-120 diesel engine is only in service in small numbers and all owners are known to the manufacturer. The LAA will be working with the manufacturer to ensure that critical internal engine work, such as was involved in this incident, is overseen by competent and authorised personnel.
