ACCIDENT

Aircraft Type and Registration:	1) Scheibe SF27 glider, HGM 2) Schleicher ASW 19 glider, GDP
No & Type of Engines:	1) None 2) None
Year of Manufacture:	1) 1965 2) 1979
Date & Time (UTC):	2 October 2006 at 1515 hrs
Location:	Sutton Bank, North Yorkshire
Type of Flight:	1) Private 2) Private
Persons on Board:	1) Crew - 1 Passengers - None 2) Crew - 1 Passengers - None
Injuries:	1) Crew - 1 (Minor) Passengers - N/A 2) Crew - 1 (Fatal) Passengers - N/A
Nature of Damage:	1) Aircraft destroyed 2) Aircraft destroyed
Commander's Licence:	1) British Gliding Association (BGA) Gliding Certificate 2) British Gliding Association (BGA) Gliding Certificate
Commander's Age:	1) 50 years 2) 48 years
Commander's Flying Experience:	1) 733 hours Last 90 days - 20 hours Last 28 days - 5 hours 2) 280 hours Last 90 days - 10 hours Last 28 days - 1 hour
Information Source:	AAIB Field Investigation with assistance from the British Gliding Association (BGA)

Synopsis

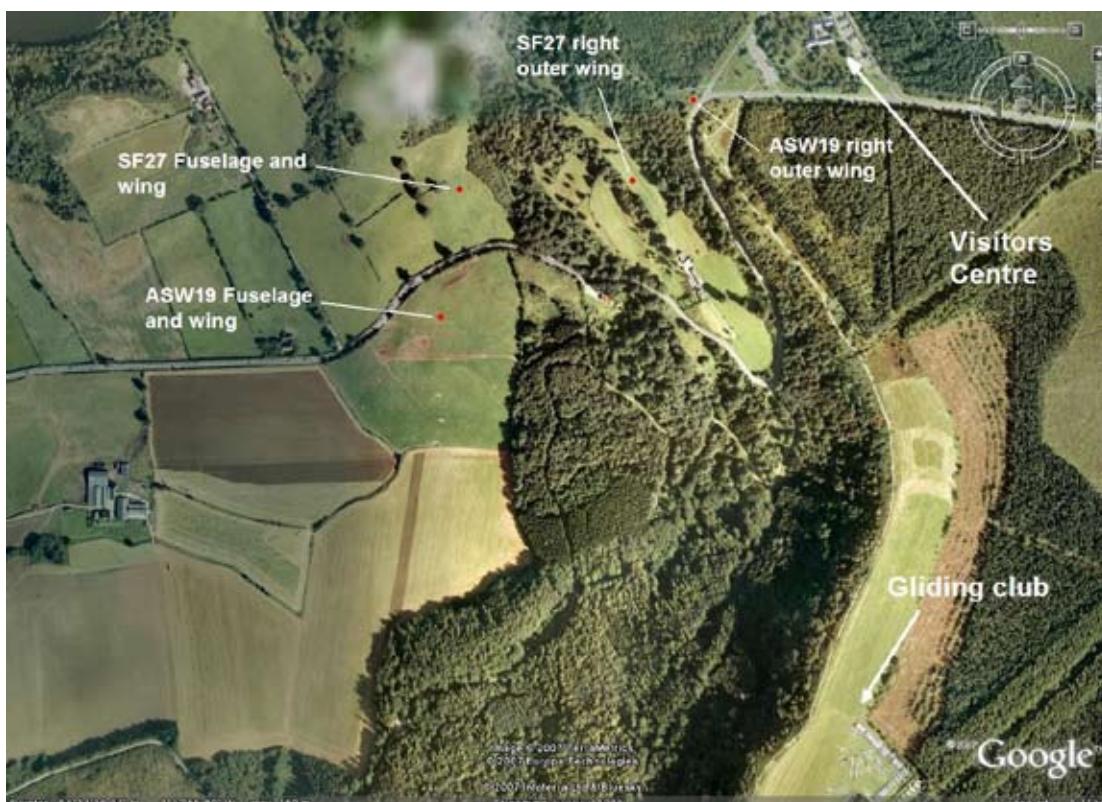
Figure 1
Accident site

The remains of the gliders occupied four separate sites. The fuselage and majority of the wing structure of the SF27 had landed in a field at the bottom of Sutton Bank, approximately 150 meters north of the A170 road. A section of the SF27's right wing, together with the remains of the aircraft's canopy, were found part way up the slope of the Bank, 200 metres east of the rest of the glider. The ASW 19 was at the bottom of the Bank in a field immediately to the south of the A170. Numerous fragments of both gliders' wings and canopies, the SF27's wing/fuselage fairing and a 2.9 metre long section of the ASW 19's right wing were found on the A170 and the visitors centre car park at the top of the Bank. The distribution of the wreckage is illustrated in Figure 1.

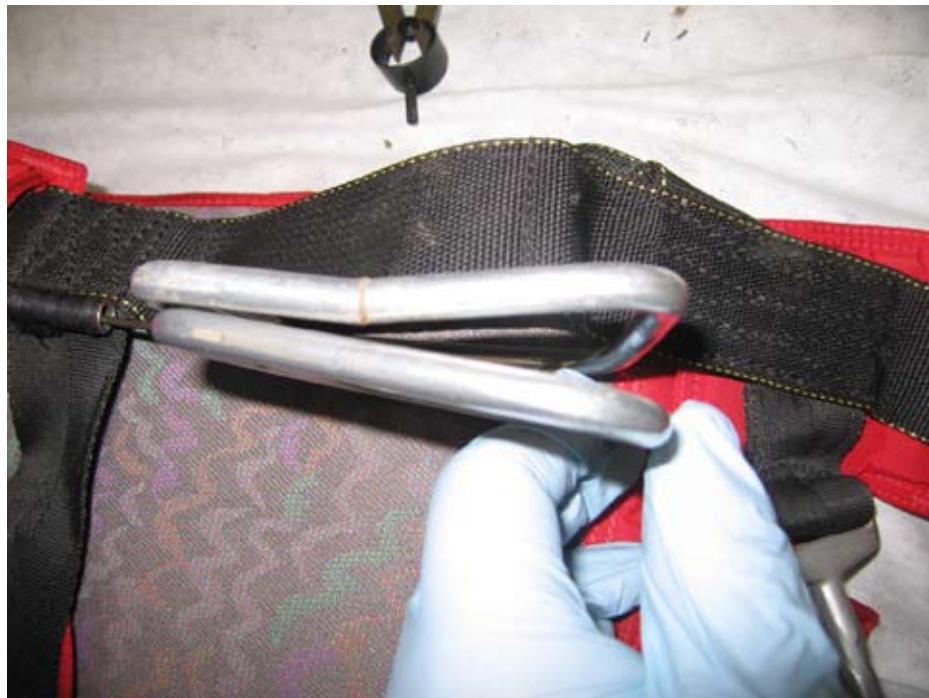
Figure 2
'D' ring distortion

which had become detached from the parachute deployment lanyard. The pilot's parachute had not deployed and the swaged 'ball' used to retain the 'D' ring had been pulled off the end of the deployment lanyard. A fingertip search of the area around the glider failed to locate the 'ball'. When the glider had been 'righted' the seat harness was found unfastened and apparently undamaged. The forward section of the cockpit canopy, which included the canopy jettison latch, was found in the cockpit - the latch was in the 'jettison' position but the canopy had remained attached to the glider by several electrical cables which had been secured by a cable tie.

The parachute’s deployment lanyard, consisting of a multi-strand cable, had ‘unwound’ and its end was bent, indicating the application of a significant side load. The ‘D’ ring was compared to that of a sample TSE28 and found to be deformed, see Figure 2. Tests carried out on a sample parachute showed that this damage was consistent with a high side load applied in the ground impact and, when pulled using the recommended method, the sample parachute and the parachute from the ASW 19 deployed with a steady force of about 6 kg.

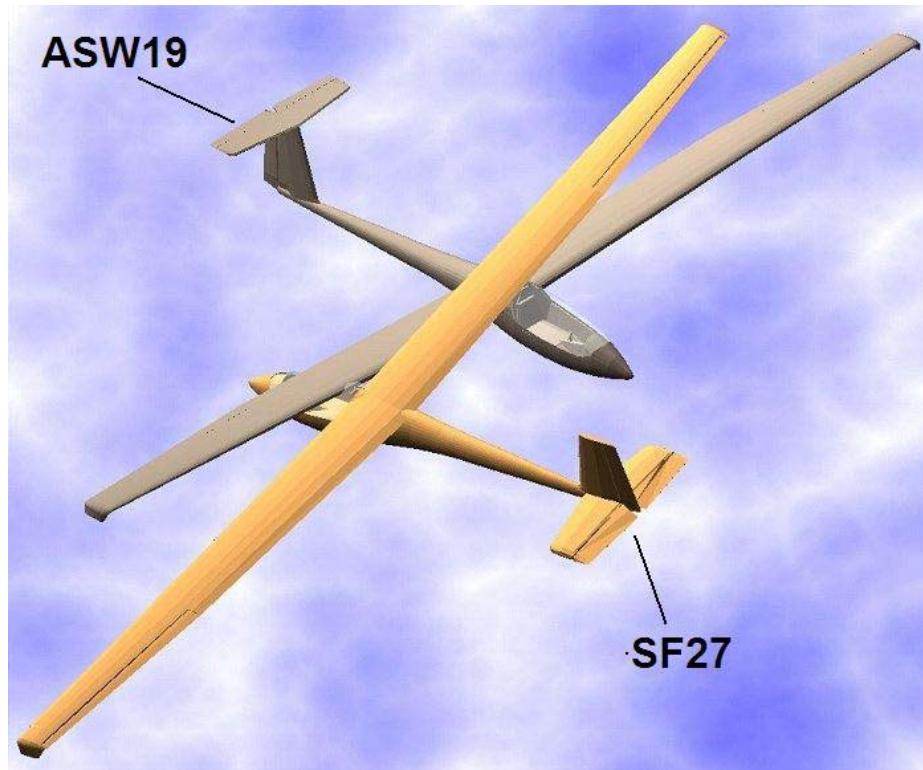
Figure 3
Collision reconstruction

The paint transfer seen on the SF27 overwing fairing, and the fragment of the lower surface of the right wing from the ASW 19, confirmed that initial impact was between the right wing of the ASW 19, approximately 3 metres outboard of the wing root, and the cockpit canopy and right wing root of the SF27, see Figure 3. The forces involved in such a collision would have been sufficient to disrupt the wing-to-fuselage mountings of the SF27 and cause the separation of the outboard section of the ASW 19 wing. The loss of such a large portion of the wing, including the aileron, would have made the ASW 19 uncontrollable and caused it to roll right as it descended. The fact that fragments of both glider's canopies were found at the top of Sutton Bank, and that a 3 metre section of the right outboard wing of the SF27 was found 200 metres away from the main wreckage, confirmed that there were additional impacts between the two gliders but there was insufficient evidence to

determine the sequence of these additional impacts. At some point after the initial impact the outboard right wing of the SF27 failed, approximately 4.5 metres from the wing root, which would have made this glider incapable of flight.
