ACCIDENT

Aircraft Type and Registration:	1) Scheibe SF27 glider, HGM 2) Schleicher ASW 19 glider, GDP
No & Type of Engines:	1) None 2) None
Year of Manufacture:	1) 1965 2) 1979
Date & Time (UTC):	2 October 2006 at 1515 hrs
Location:	Sutton Bank, North Yorkshire
Type of Flight:	1) Private 2) Private
Persons on Board:	1) Crew - 1 Passengers - None 2) Crew - 1 Passengers - None
Injuries:	1) Crew - 1 (Minor) Passengers - N/A 2) Crew - 1 (Fatal) Passengers - N/A
Nature of Damage:	1) Aircraft destroyed 2) Aircraft destroyed
Commander's Licence:	1) British Gliding Association (BGA) Gliding Certificate 2) British Gliding Association (BGA) Gliding Certificate
Commander's Age:	1) 50 years 2) 48 years
Commander's Flying Experience:	1) 733 hours Last 90 days - 20 hours Last 28 days - 5 hours 2) 280 hours Last 90 days - 10 hours Last 28 days - 1 hour
Information Source:	AAIB Field Investigation with assistance from the British Gliding Association (BGA)

Synopsis

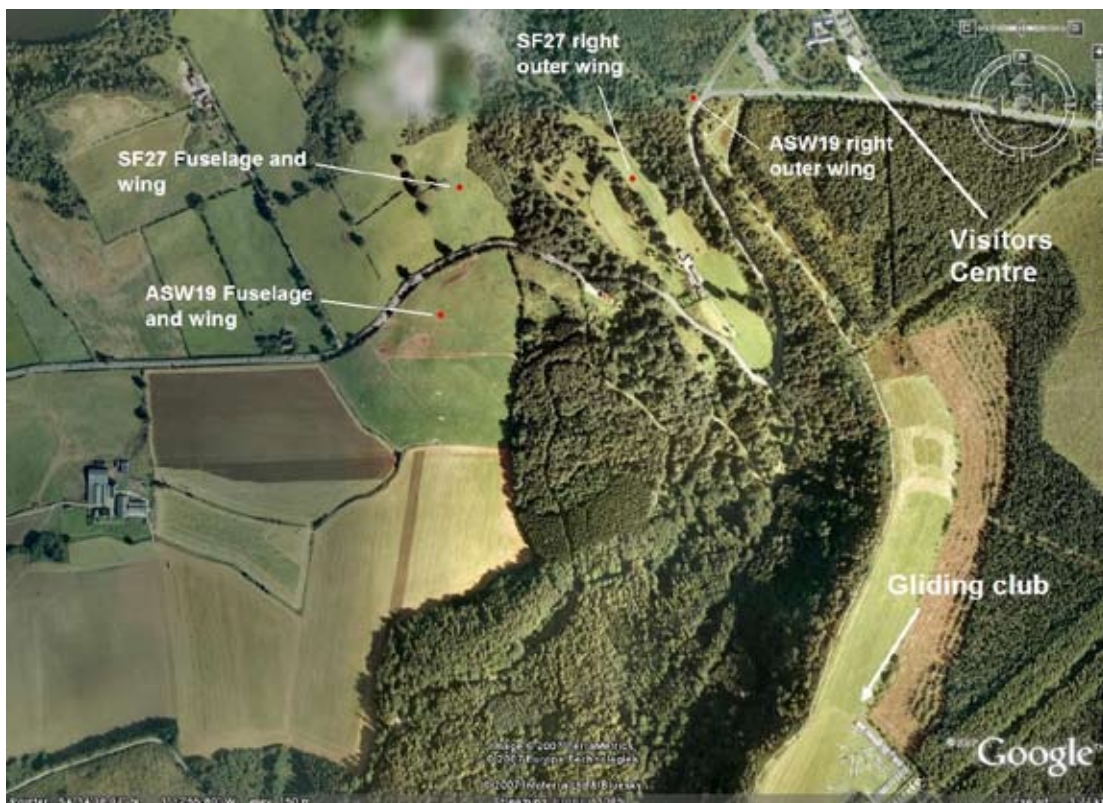
Figure 1
Accident site

The remains of the gliders occupied four separate sites. The fuselage and majority of the wing structure of the SF27 had landed in a field at the bottom of Sutton Bank, approximately 150 meters north of the A170 road. A section of the SF27's right wing, together with the remains of the aircraft's canopy, were found part way up the slope of the Bank, 200 metres east of the rest of the glider. The ASW 19 was at the bottom of the Bank in a field immediately to the south of the A170. Numerous fragments of both gliders' wings and canopies, the SF27's wing/fuselage fairing and a 2.9 metre long section of the ASW 19's right wing were found on the A170 and the visitors centre car park at the top of the Bank. The distribution of the wreckage is illustrated in Figure 1.

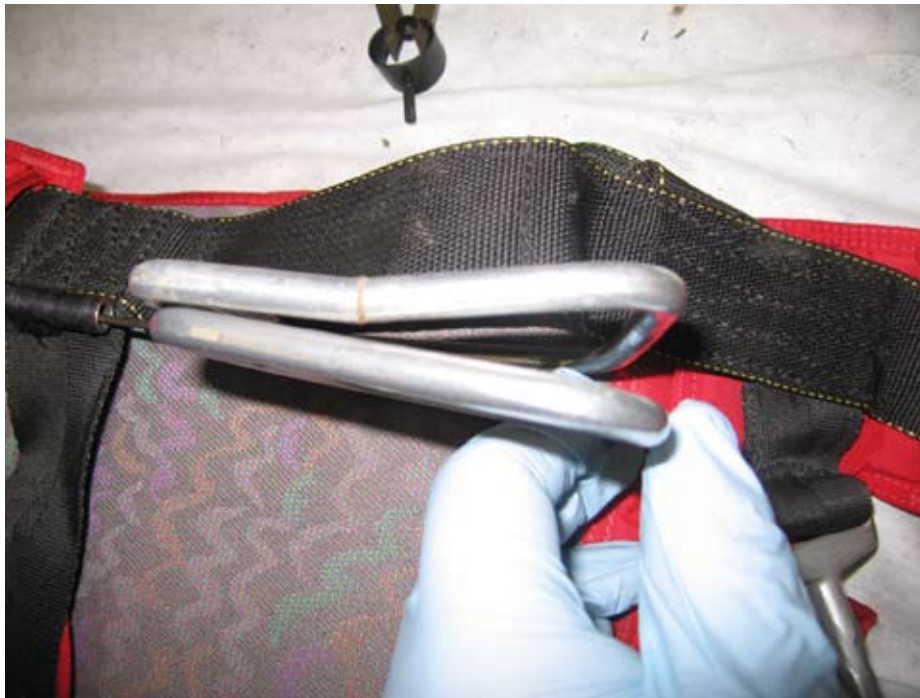
Figure 2

which had become detached from the parachute deployment lanyard. The pilot's parachute had not deployed and the swaged 'ball' used to retain the 'D' ring had been pulled off the end of the deployment lanyard. A fingertip search of the area around the glider failed to locate the 'ball'. When the glider had been 'righted' the seat harness was found unfastened and apparently undamaged. The forward section of the cockpit canopy, which included the canopy jettison latch, was found in the cockpit - the latch was in the 'jettison' position but the canopy had remained attached to the glider by several electrical cables which had been secured by a cable tie.

The parachute's deployment lanyard, consisting of a multi-strand cable, had 'unwound' and its end was bent, indicating the application of a significant side load. The 'D' ring was compared to that of a sample TSE28 and found to be deformed, see Figure 2. Tests carried out on a sample parachute showed that this damage was consistent with a high side load applied in the ground impact and, when pulled using the recommended method, the sample parachute and the parachute from the ASW 19 deployed with a steady force of about 6 kg .

'D' ring distortion

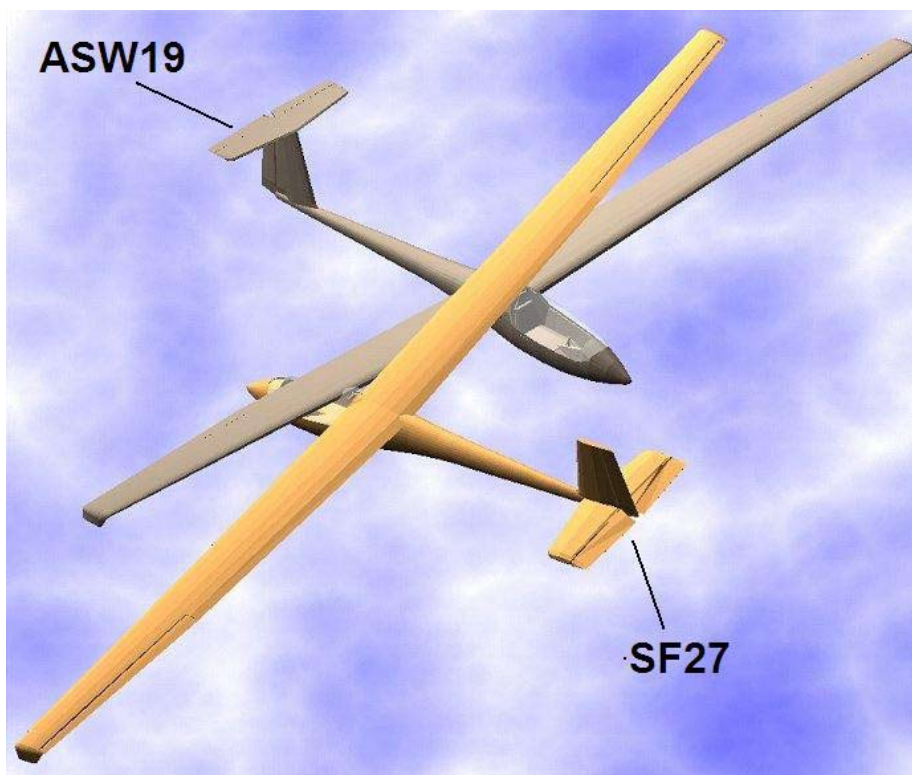
Figure 3

The paint transfer seen on the SF27 overwing fairing, and the fragment of the lower surface of the right wing from the ASW 19, confirmed that initial impact was between the right wing of the ASW 19, approximately 3 metres outboard of the wing root, and the cockpit canopy and right wing root of the SF27, see Figure 3. The forces involved in such a collision would have been sufficient to disrupt the wing-to-fuselage mountings of the SF27 and cause the separation of the outboard section of the ASW 19 wing. The loss of such a large portion of the wing, including the aileron, would have made the ASW 19 uncontrollable and caused it to roll right as it descended. The fact that fragments of both glider's canopies were found at the top of Sutton Bank, and that a 3 metre section of the right outboard wing of the SF27 was found 200 metres away from the main wreckage, confirmed that there were additional impacts between the two gliders but there was insufficient evidence to

determine the sequence of these additional impacts. At some point after the initial impact the outboard right wing of the SF27 failed, approximately 4.5 metres from the wing root, which would have made this glider incapable of flight.

Collision reconstruction
