DH82A Tiger Moth, G-ANPK

AAIB Bulletin No: 2/97 Ref: EW/C96/8/12 Category: 1.3

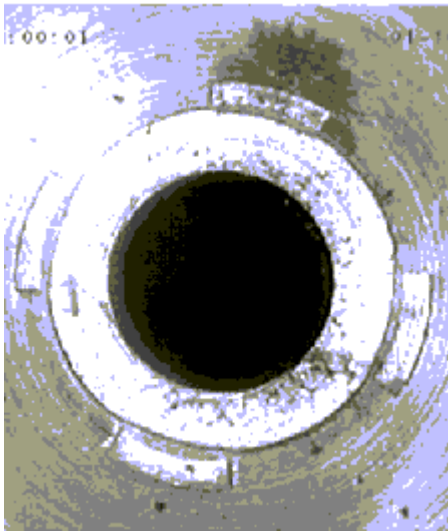
A flow test of the carburettor conducted with a fuel pressure of 4 psi showed that the float chamber needle valve was fully open; however, a subsequent strip examination did not determine whether this was due to the accident or to contamination of the needle valve seat. After the float valve had been reassembled it functioned correctly. Stains and deposits present on both the float needle valve seat and the float needle indicated that, *at some time*, contaminated water had been allowed to dry out in the float chamber.

Probable contamination from dried water deposits

Note: Different magnification used in both photographs
