## ACCIDENT

<b>Aircraft Type and Registration:</b>	Europa XS (prototype motorglider), G-CBHI	
<b>No &amp; Type of Engines:</b>	1 Rotax 912 ULS piston engine	
<b>Year of Manufacture:</b>	2001	
<b>Date &amp; Time (UTC):</b>	18 October 2011 at 1530 hrs	
<b>Location:</b>	Chilbolton (Stonefield Park) Airfield, Hampshire	
<b>Type of Flight:</b>	Flight test	
<b>Persons on Board:</b>	Crew - 1	Passengers - None
<b>Injuries:</b>	Crew - None	Passengers - N/A
<b>Nature of Damage:</b>	Propeller blade tip and wheelbay damaged	
<b>Commander's Licence:</b>	Commercial Pilot's Licence	
<b>Commander's Age:</b>	58 years	
<b>Commander's Flying Experience:</b>	11,311 hours (of which 80 were on type) Last 90 days - 24 hours Last 28 days - 13 hours	
<b>Information Source:</b>	Aircraft Accident Report Form submitted by the pilot and AAIB enquires

The pilot landed the aircraft with the landing gear unintentionally in the retracted position.

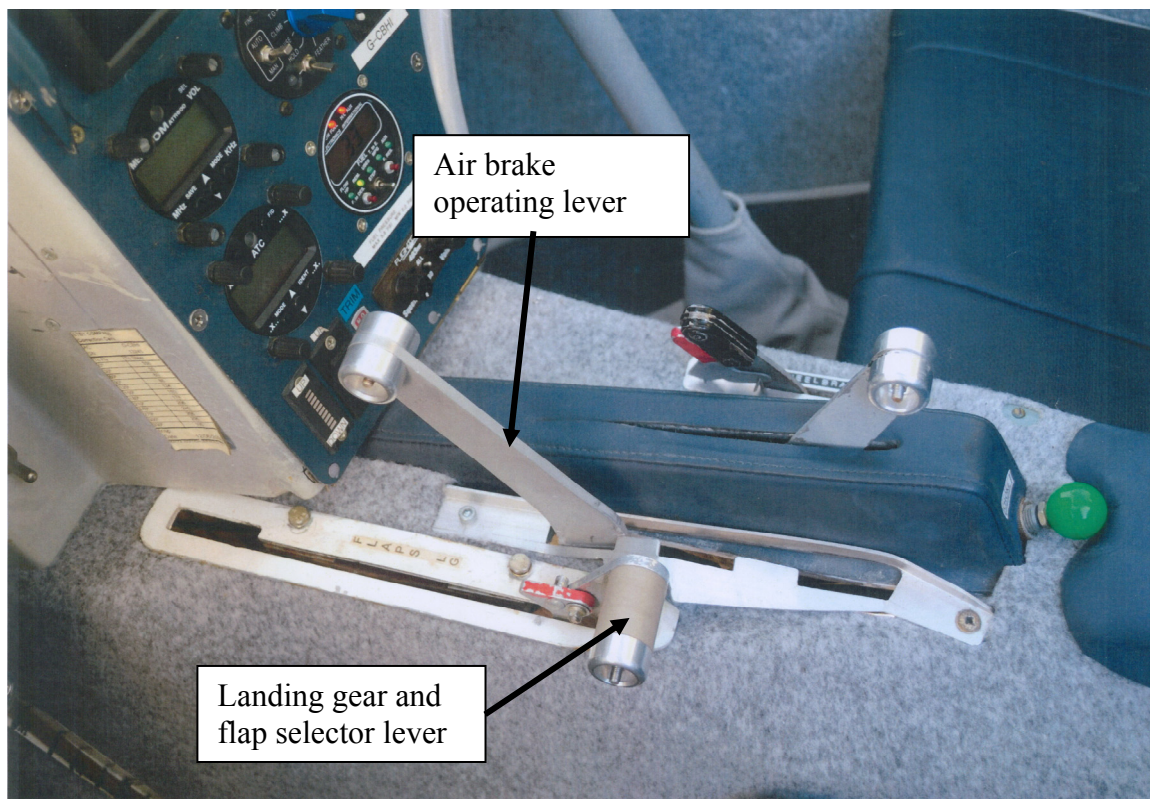
**Figure 1**

landing gear are operated by a single lever mounted on the centre console located between the seats (see Figure 1). Moving this lever rearward causes the flaps and landing gear to extend. At normal approach speeds, with the flaps retracted, the aircraft adopts a high-nose attitude which reduces the pilot's view of the runway. Selecting the landing gear and flaps to the extended position results in the aircraft adopting a significant nose-down attitude, which alerts the pilot to the fact that the gear has been extended. It was for this reason that it had been perceived that there was no requirement for a gear warning system.

The motor glider variant of the Europa XS is equipped with a 47.25 ft glider wing fitted with trailing edge airbrakes. On G-CBHI the airbrake lever had been mounted next to the landing gear lever. Moving the airbrake lever rearward causes the airbrakes to extend.

With the landing gear and airbrakes extended, there is negligible change in the aircraft attitude and therefore the pilot would be unable to tell from the attitude of the aircraft if the landing gear had been extended.

Neither variant of the Europa XS is fitted with a landing gear position indicator or a warning horn.

The pilot had considerable experience on the standard, short wing variant of the Europa XS where there is a significant change in the pitch attitude when the landing gear and flaps are extended. However, this change in attitude does not occur on the motor glider variant of the Europa XS. Ergonomic factors resulting from the positioning of the airbrake and landing gear lever, which also operate in the same sense, might also have been a factor in this accident.

Location of landing gear and flap operating lever

At the time of the accident, G-CBHI was the only prototype variant of the Europa XS motor glider operating in the UK. The LAA have advised that they would review the location of the landing gear

and airbrake levers, and the need for a gear position warning system, during the acceptance process prior to Type Approval being awarded.
