Europa, G-BWUP

AAIB Bulletin No: 11/2002	Ref: EW/G2002/05/17	Category: 1.3
Aircraft Type and Registration:	Europa, G-BWUP	
No & Type of Engines:	1 NSI Propulsion Systems EA-81/100 piston engine	
Year of Manufacture:	1998	
Date & Time (UTC):	31 May 2002 at 1045 hrs	
Location:	Shenington airfield, near Banbury	
Type of Flight:	Private	
Persons on Board:	Crew - 1	Passengers - None
Injuries:	Crew - None	Passengers - N/A
Nature of Damage:	Minor damage to rear fuselage and rudder	
Commander's Licence:	Airline Transport Pilot's Licence	
Commander's Age:	52 years	
Commander's Flying Experience:	16,258 hours (of which 115 were on type)	
	Last 90 days - 215 hours	
	Last 28 days - 80 hours	
Information Source:	Aircraft Accident Report Form submitted by the pilot	
	and additional enquiries by the AAIB

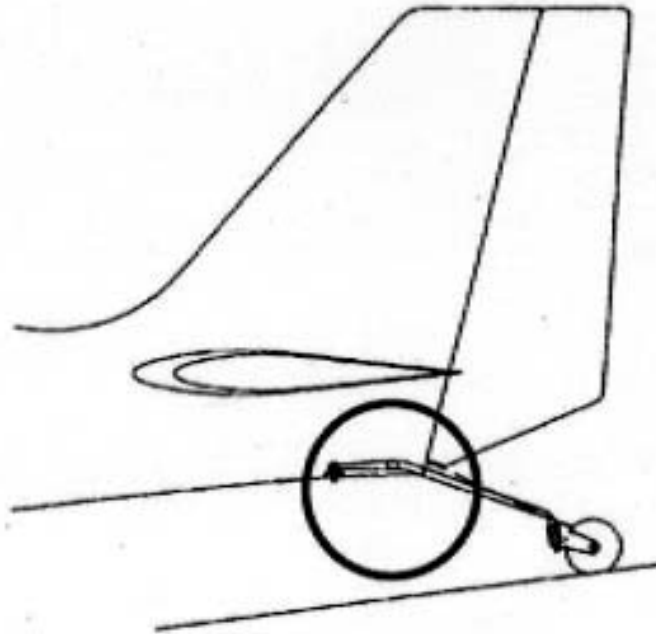
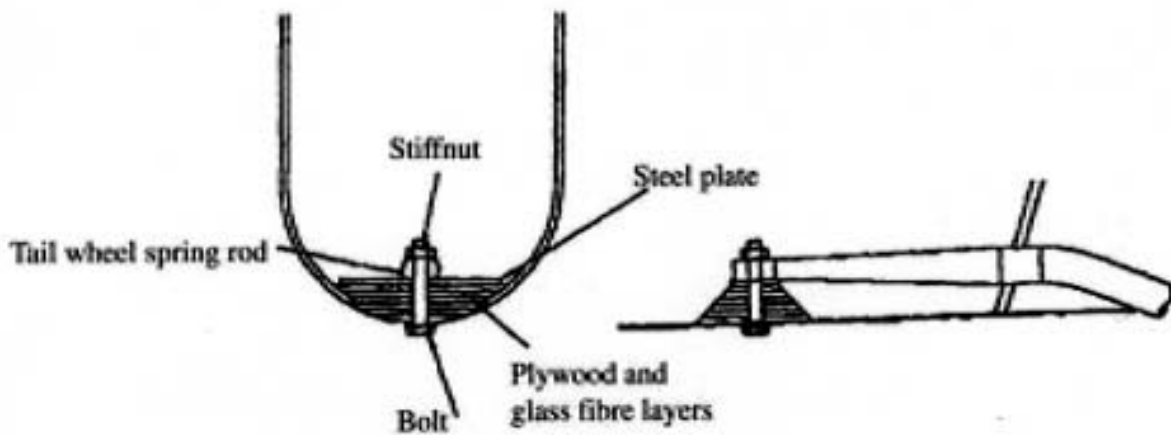
FIGURE 1. Details of Europa G-BWUP tail wheel installation

Whilst the aircraft was being turned to line up for take-off the tail wheel collapsed. The aircraft was brought to a halt and the engine shut down. A subsequent inspection revealed that the tail wheel spring rod attachment bolt had pulled through its hard point in the base of the rear fuselage, allowing the tail wheel assembly to rotate through 90°.

It was apparent that the collapse occurred in this case when the spring rod, under the influence of lateral force, rotated about the aircraft's longitudinal axis, bending the bolt and crushing the plywood/glass-fibre cloth, with the result that the wheel's plane of rotation was close to the horizontal.

The PFA noted that a number of owners had chosen to modify their aircraft by replacing the steel plate with two light alloy plates bonded either side of a block of Paxolin, which provides additional lateral support for the bolt. This is now a PFA approved modification and has been accomplished on six or seven 'mono-wheel' aircraft.
