**ACCIDENT**

<b>Aircraft Type and Registration:</b>	Jabiru UL-D, G-JAAB	
<b>No &amp; Type of Engines:</b>	1 Jabiru Aircraft Pty 2200B piston engine	
<b>Year of Manufacture:</b>	2006	
<b>Date &amp; Time (UTC):</b>	12 September 2007 at 1541 hrs	
<b>Location:</b>	Upper Dean, 10 nm north of Bedford, Bedfordshire	
<b>Type of Flight:</b>	Private	
<b>Persons on Board:</b>	Crew - 1	Passengers - 1
<b>Injuries:</b>	Crew - None	Passengers - None
<b>Nature of Damage:</b>	Landing gear and left wing damaged	
<b>Commander's Licence:</b>	National Private Pilot's Licence	
<b>Commander's Age:</b>	39 years	
<b>Commander's Flying Experience:</b>	175 hours (of which 131 were on type) Last 90 days - 34 hours Last 28 days - 18 hours	
<b>Information Source:</b>	AAIB Field Investigation

**Synopsis**

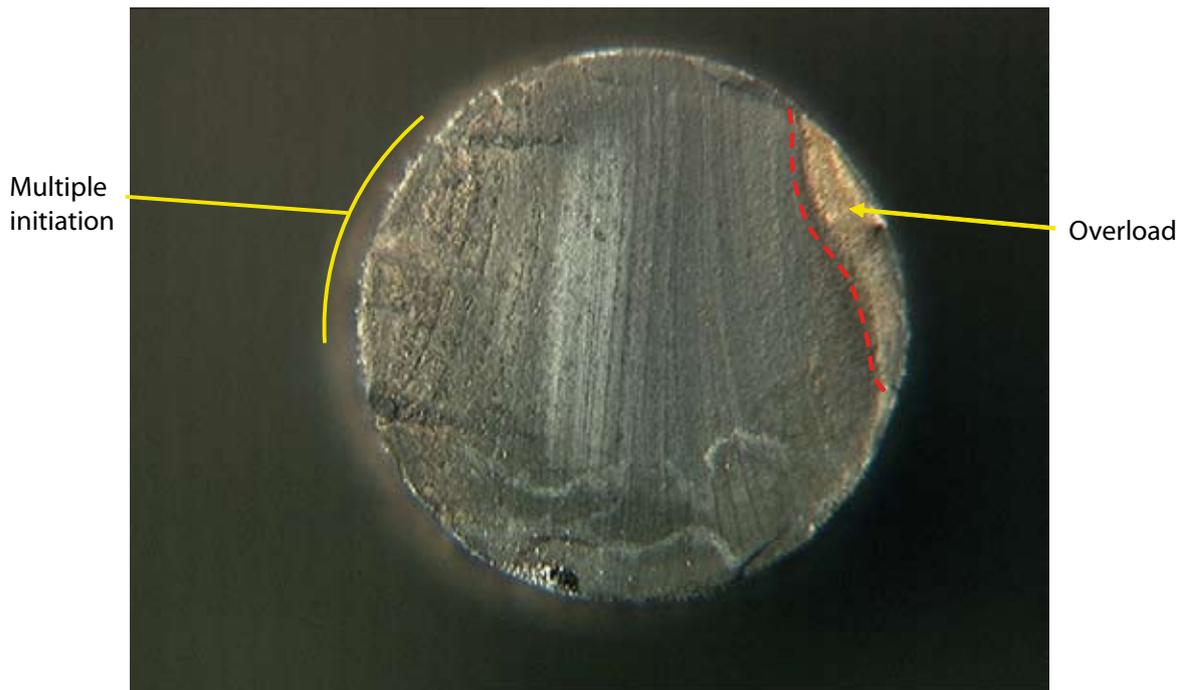
**Figure 4**

Fracture surface of No 1 exhaust valve from G-CBIP

within the exhaust port. Figure 4 shows beachmarks clearly visible on the fracture surface, characteristic of fatigue crack growth. The fatigue appeared to have initiated from multiple points on one side of the valve and propagated across the majority of the valve stem before final overload failure occurred.

deposit on the No 3 exhaust valve of the engine from G-JAAB, with large deposits of lead and bromine and some phosphorus. The lead and bromine were consistent with combustion products of 'anti-knock', and other, agents in Avgas fuel.

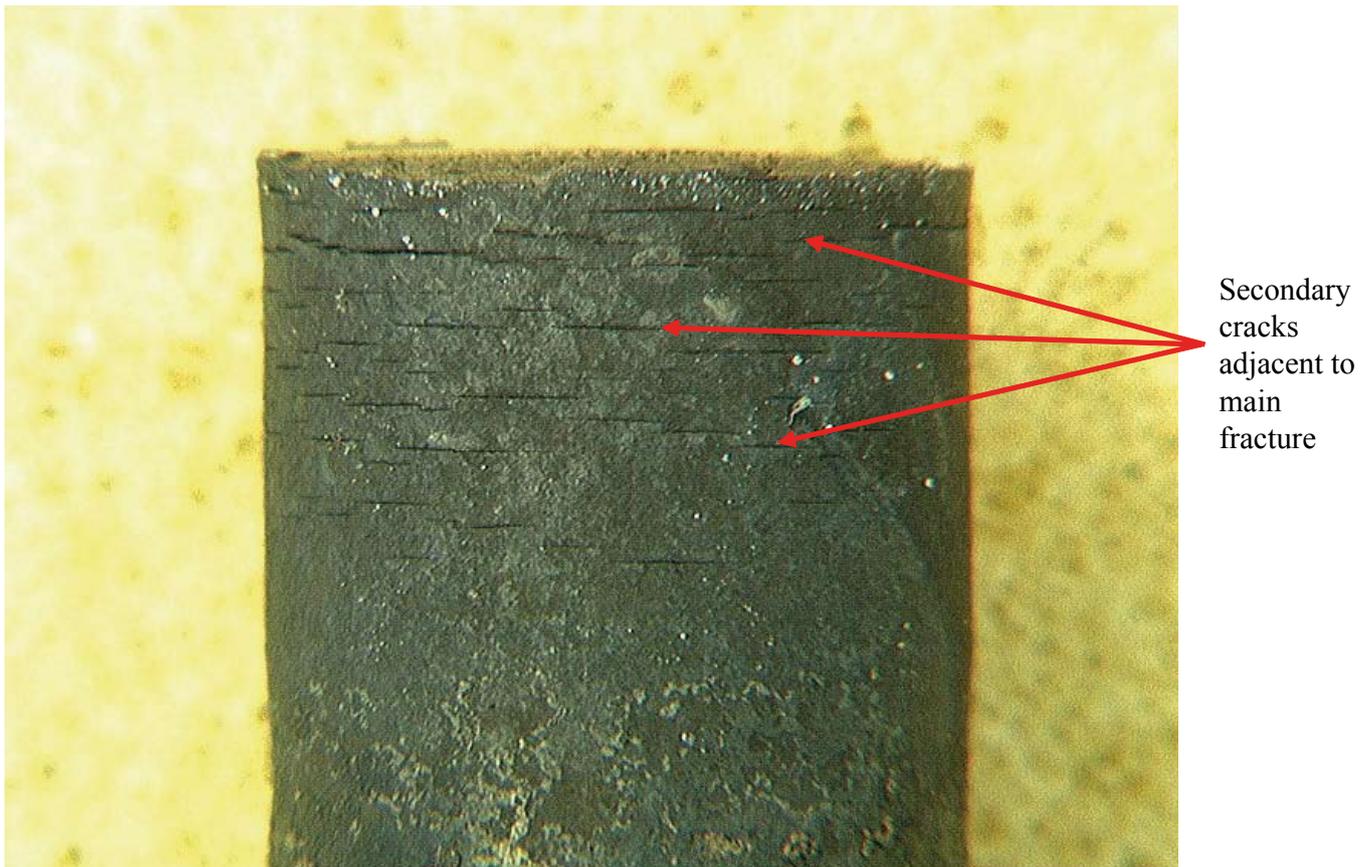
**Figure 5**

Examination of the stem surface adjacent to the fracture showed evidence of multiple secondary cracking (Figure 5) similar to that observed in G-JAAB.

Secondary cracking in the failed No 1 cylinder exhaust valve stem from G-CBIP
