**ACCIDENT**

<b>Aircraft Type and Registration:</b>	Jabiru UL-D, G-JAAB	
<b>No &amp; Type of Engines:</b>	1 Jabiru Aircraft Pty 2200B piston engine	
<b>Year of Manufacture:</b>	2006	
<b>Date &amp; Time (UTC):</b>	12 September 2007 at 1541 hrs	
<b>Location:</b>	Upper Dean, 10 nm north of Bedford, Bedfordshire	
<b>Type of Flight:</b>	Private	
<b>Persons on Board:</b>	Crew - 1	Passengers - 1
<b>Injuries:</b>	Crew - None	Passengers - None
<b>Nature of Damage:</b>	Landing gear and left wing damaged	
<b>Commander's Licence:</b>	National Private Pilot's Licence	
<b>Commander's Age:</b>	39 years	
<b>Commander's Flying Experience:</b>	175 hours (of which 131 were on type) Last 90 days - 34 hours Last 28 days - 18 hours	
<b>Information Source:</b>	AAIB Field Investigation

**Synopsis**

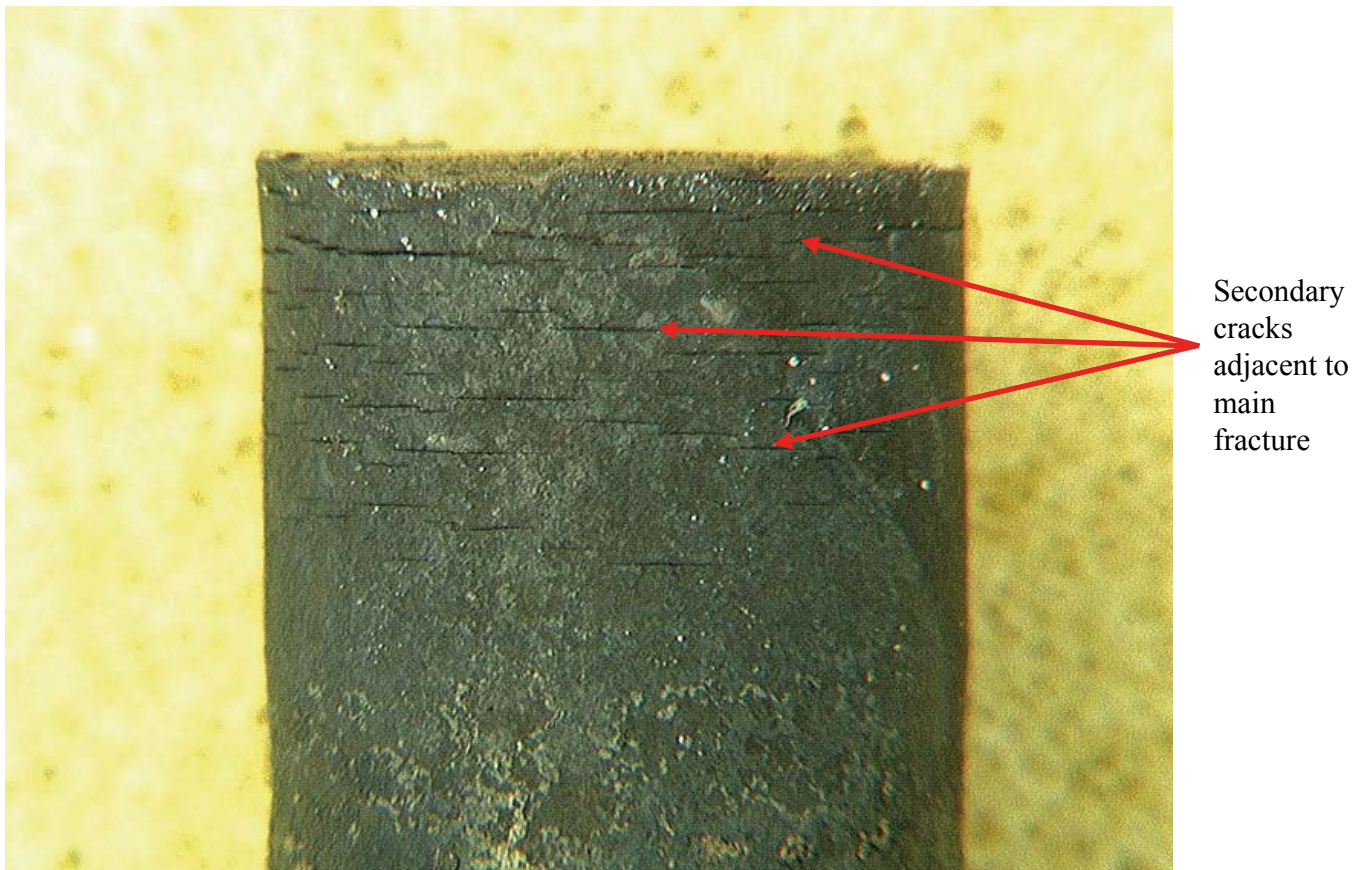
**Figure 5**

Examination of the stem surface adjacent to the fracture showed evidence of multiple secondary cracking (Figure 5) similar to that observed in G-JAAB.

Secondary cracking in the failed No 1 cylinder exhaust valve stem from G-CBIP
