Boeing 747-367, AP-BFV

AAIB Bulletin No: 11/2004	Ref: EW/C2002/12/01	Category: 1.1
Aircraft Type and Registration:	Boeing 747-367, AP-BFV	
No & Type of Engines:	4 RB211-524C2 turbofan engines	
Year of Manufacture:	1986	
Date & Time (UTC):	7 December 2002 at 2040 hrs	
Location:	London Heathrow Airport, Middlesex	
Type of Flight:	Public Transport	
Persons on Board:	Crew -15	Passengers - 457
Injuries:	Crew - None	Passengers - None
Nature of Damage:	Failure of the nose landing gear oleo outer cylinder	
Commander's Licence:	Airline Transport Pilot's Licence	
Commander's Age:	Not relevant	
Commander's Flying Experience:	Not relevant	
Information Source:	AAIB Field Investigation

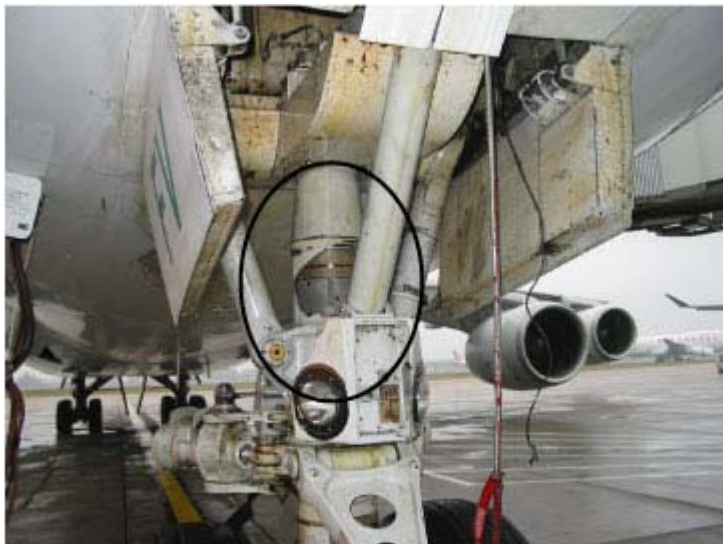
Figure 2

The nose landing gear outer cylinder had suffered a complete circumferential fracture resulting in a large section of the cylinder material being ejected onto the taxiway (see Figures 2, 3 and 4). The nose landing gear was removed from the aircraft and the upper section of the outer cylinder was dispatched to the aircraft manufacturer for a detailed metallurgical examination.

Nose landing gear showing the area of failure

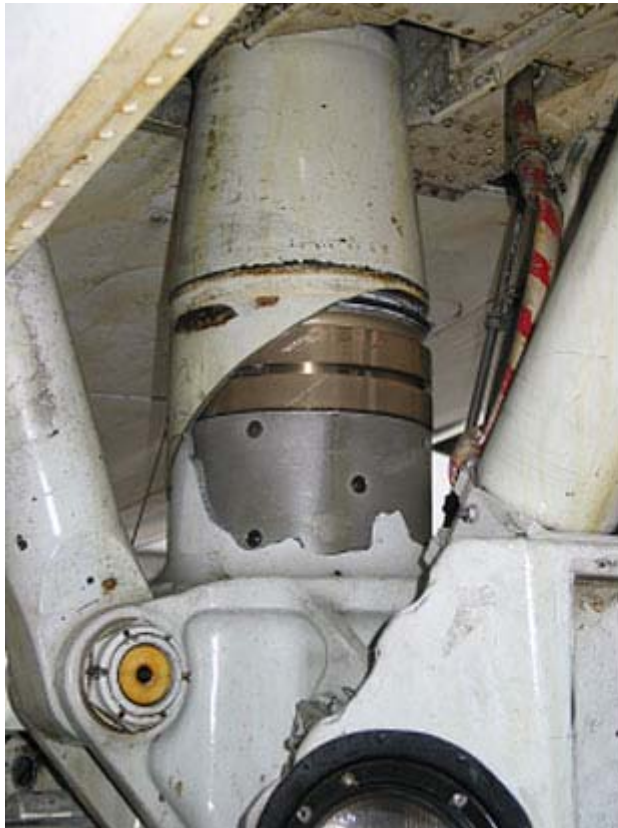
Figure 3

Nose landing gear outer cylinder showing the area from which the ejected section of cylinder material originated

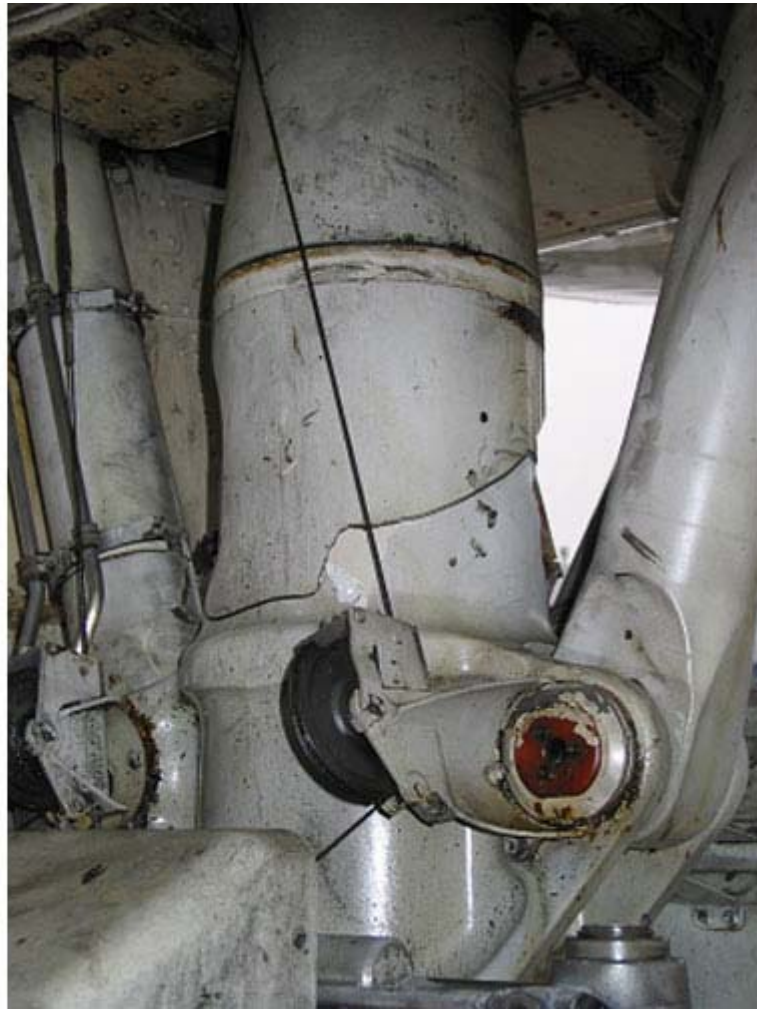
Figure 4

Nose landing gear outer cylinder showing the circumferential failure

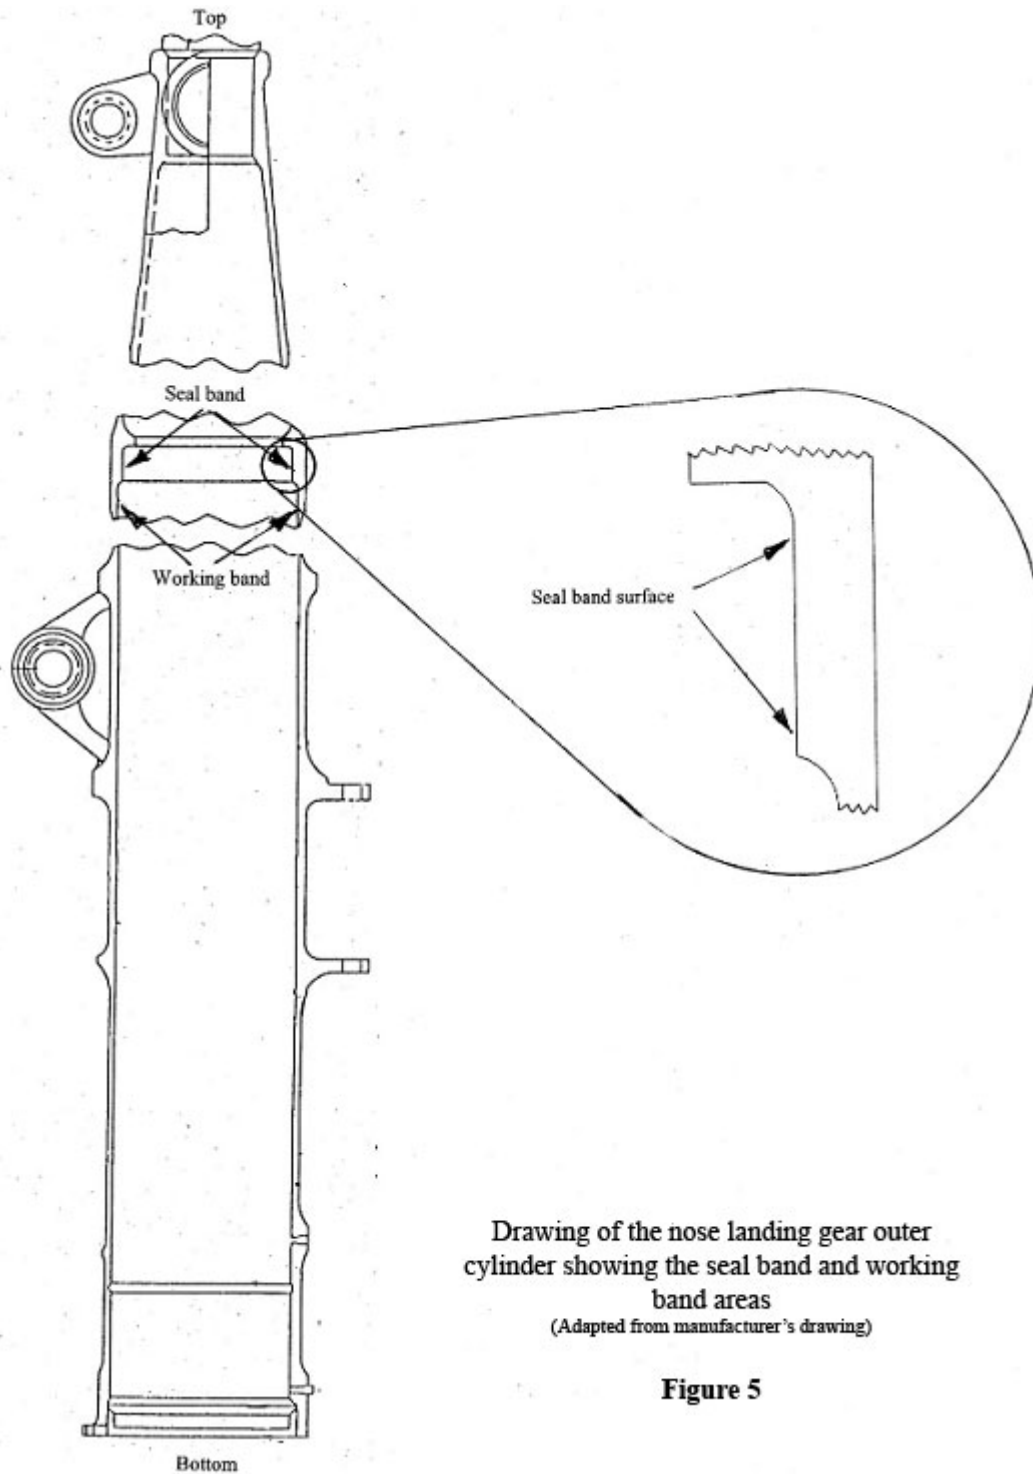
The metallurgical examination concluded that the fracture of the landing gear outer cylinder had occurred as the result of fatigue that had initiated at the base of a groove at the upper edge of the internal diameter (ID) seal band (see Figure 5 and Figure 6) and propagated through approximately half of the cylinder wall thickness prior to the final failure. The groove, square shaped in cross section and of an appearance that it had been made by a rotating cutting wheel, was machined into 70% of the internal circumference. The depth of the groove varied around the circumference. The deepest section was in the middle of the affected area where significant thinning of the outer cylinder wall thickness had introduced a critical stress concentration area. The groove was not part of the design, manufacturing or overhaul specifications.

Drawing of the nose landing gear outer cylinder showing the seal band and working band areas
(Adapted from manufacturer's drawing)

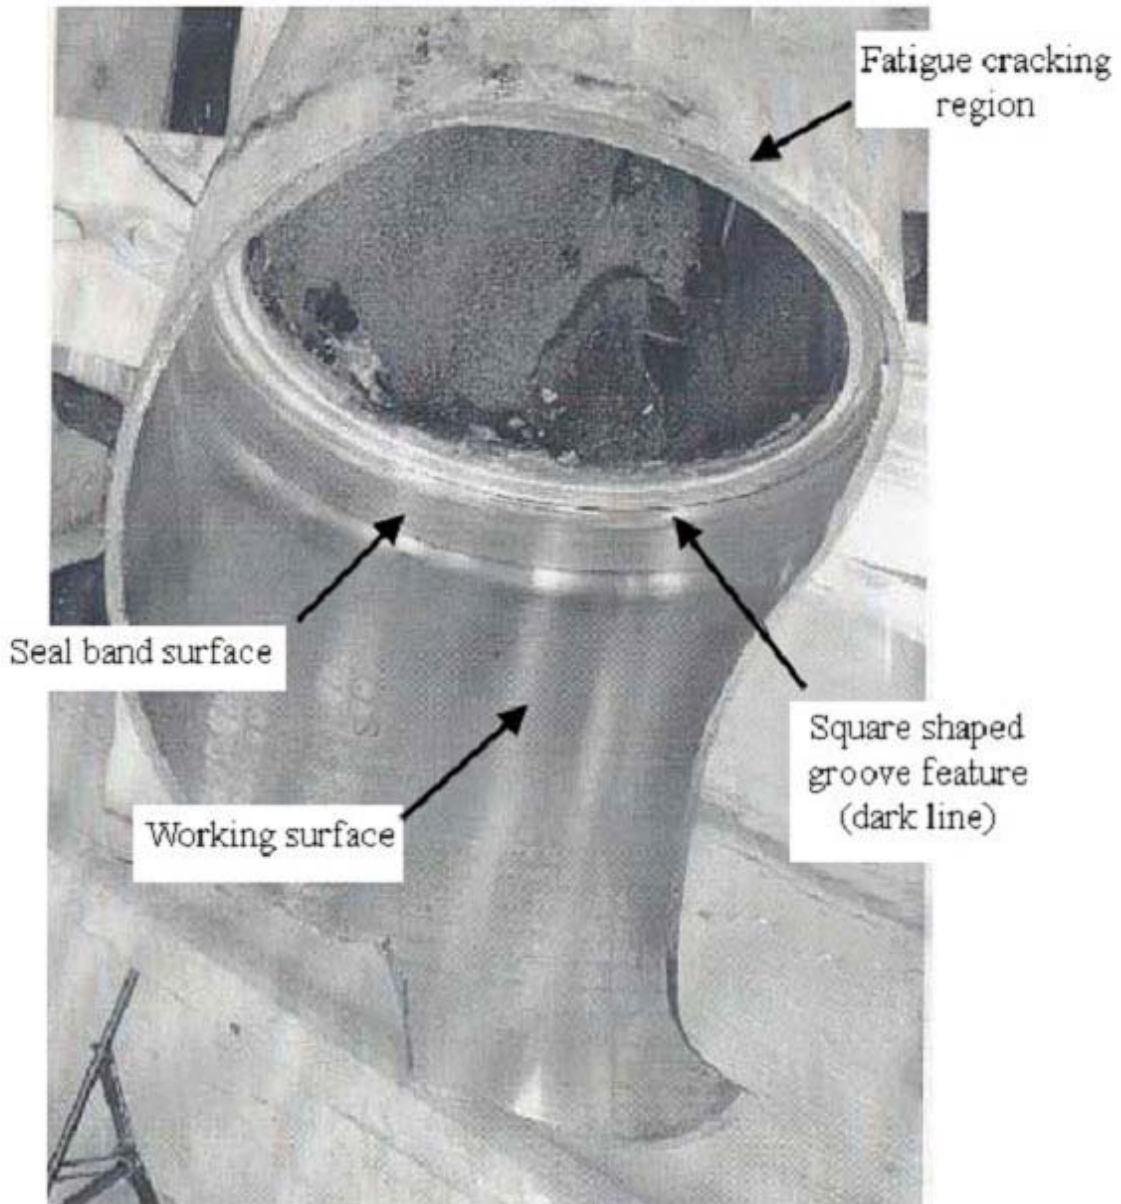
Figure 6

Upper section of the nose landing gear outer cylinder showing the area of the failure
(Photograph courtesy of Boeing Materials Technology)

The examination revealed a number of other deviations from the design, manufacturing and overhaul specifications in the area of the fatigue initiation. A blended depression was present at the transition between the seal band ID and the working surface ID that had resulted in localised outer cylinder wall thinning to a dimension below the minimum requirement. Some of the ID surfaces in the area of the fracture had been blended after nickel plating of the seal band surface. These areas showed no evidence of having been subsequently shot peened as required. Shot peening creates residual compressive stresses in the surface material which inhibits the development of fatigue cracks. A lack of shot peening left the material more prone to fatigue crack development.

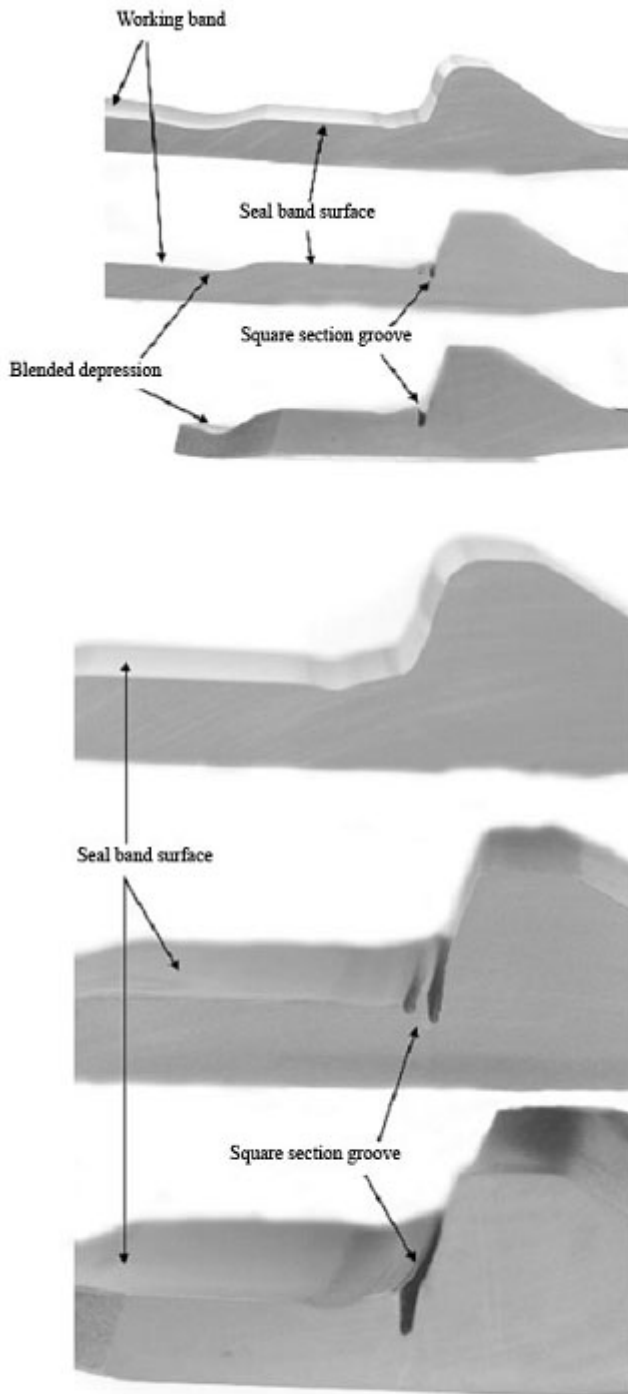
Figure 7

The manufacturer subsequently cut three vertical sections (see Figure 7) from the seal band area of the outer cylinder showing the internal profile and the square shaped groove in the area immediately above the seal band.

Two sets of photographs of the 3 vertical sections cut from the seal band area of the nose landing gear outer cylinder
(Photographs courtesy of Boeing Materials Technology)

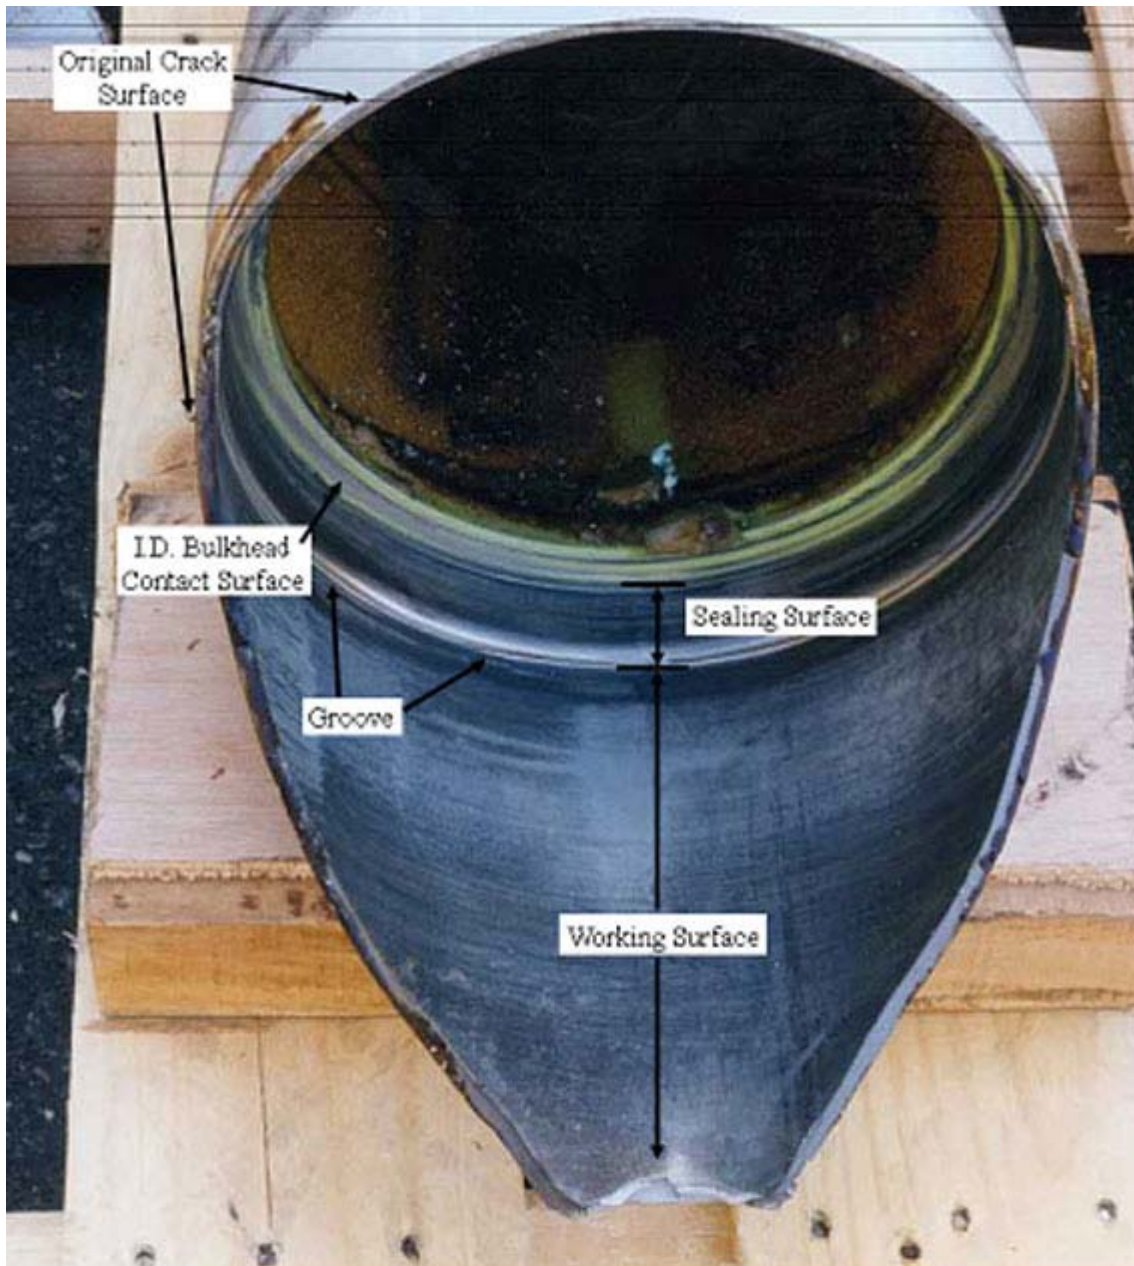
Figure 8

In June 1998 the nose landing gear outer cylinder fitted to a Boeing 747-300 failed while the aircraft was being towed. The outer cylinder had been overhauled/reworked in 1996 and at the time of the accident had completed 689 cycles since the overhaul. The type and location of the failure was very similar to that which is the subject of this investigation (see Figure 7) and the overhaul/rework had been carried out at the same Repair Station.

A metallurgical examination carried out by the aircraft manufacturer concluded that the fracture of the landing gear outer cylinder had occurred as the result of fatigue. The fatigue had been initiated at multiple sites at the base of an irregular circumferential groove just below the lower edge of the ID seal band (see Figures 5, 8 and 9). This had propagated through approximately 40% of the cylinder wall thickness prior to the final failure. The groove had resulted in a significant thinning of the outer cylinder wall thickness. During the examination it was also noted that there was an intermittent 'V- shaped' circumferential groove just above the seal band and that the bulkhead contact surface had been reworked to an angle of 109° instead of 90° as specified in the CMM.

Nose landing gear outer cylinder that was involved in the 1998 incident showing the area of failure
(Photograph courtesy of Boeing Materials Technology)

Following the failure of the nose landing gear outer cylinder in 1998 the Repair Station instigated a number of significant changes to their overhaul/rework practices and procedures and an inspection of all suspect outer cylinders that had been overhauled/reworked in their facility. This inspection required a unique Non Destructive Testing (NDT) technique to be developed to allow inspection of outer cylinders fitted on aircraft without removal or disassembly of the nose landing gear. A total of 35 outer cylinders were inspected using this NDT technique resulting in the rejection of 22 units because of incorrect internal tolerances detected during the inspection.

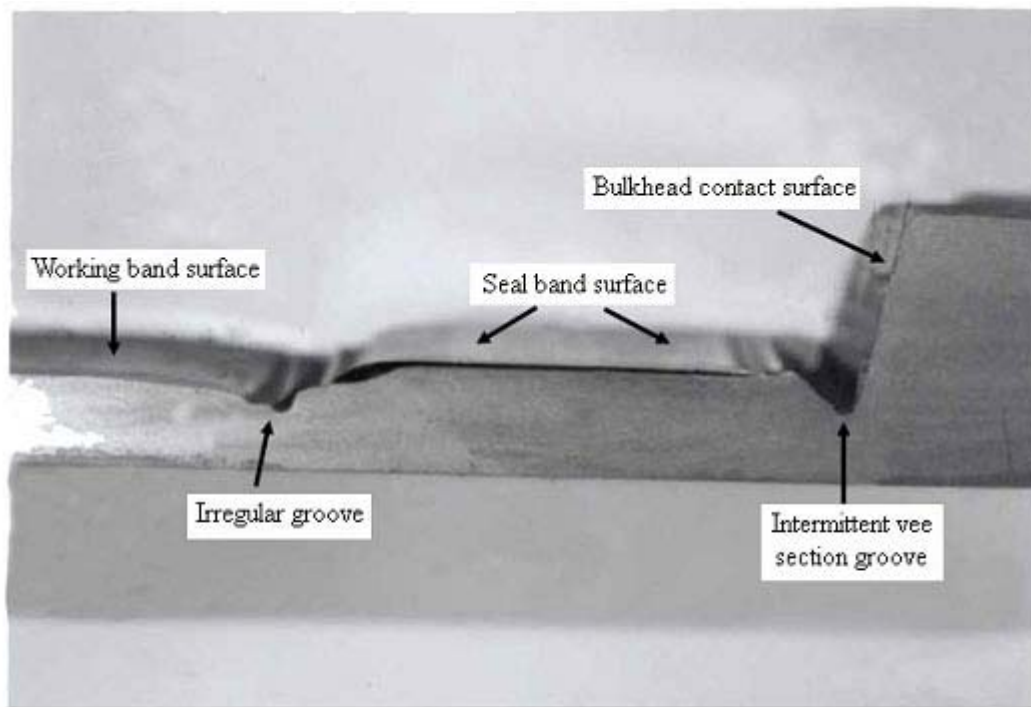
Figure 9

A vertical section cut from the seal band area of the nose landing gear outer cylinder involved in the 1998 incident
(Photograph courtesy of Boeing Materials Technology)
