# AAIB Bulletin S2/2013

## SPECIAL

**Aircraft Type and registration:** EC225 LP Super Puma, G-REDW  
**Date & Time (UTC):** 10 May 2012 at 1114 hrs  
**Location:** 20 nm east of Aberdeen

**Aircraft Type and registration:** EC225 LP Super Puma, G-CHCN  
**Date & Time (UTC):** 22 October 2012 at 1425 hrs  
**Location:** Approximately 32 nm southwest of Sumburgh, Shetland Islands  
**Information Source:** AAIB Field Investigations

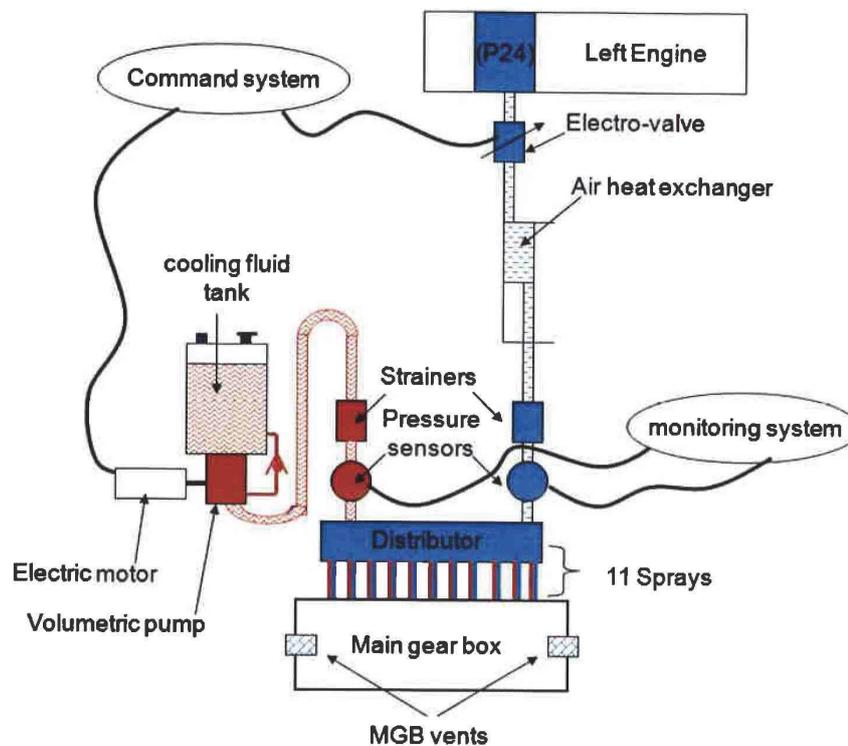
**Figure 1**

The MGB lubrication system includes two mechanically-driven oil pumps and a crew-activated emergency lubrication system (Figure 1). The latter comprises: a bleed-air supply from the left engine, a Hydrosafe 620 supply from an 11 litre reservoir, a series of small pipes around and inside the MGB (to deliver the Hydrosafe 620 in a spray), and monitoring and command systems on a dedicated Printed Circuit Board (PCB).

Schematic of the Emergency Lubrication System

A MGB EMLUB caption will illuminate if low pressure is detected by either of the two pressure switches, one in the Hydrosafe 620 line and the other in the bleed-air line. It will also illuminate if there is an erroneous signal detected by the PCB. The caption is inhibited for approximately 30 seconds after the emergency lubrication system is activated, to allow the system to reach a steady-state. The MGB EMLUB caption is not latched.

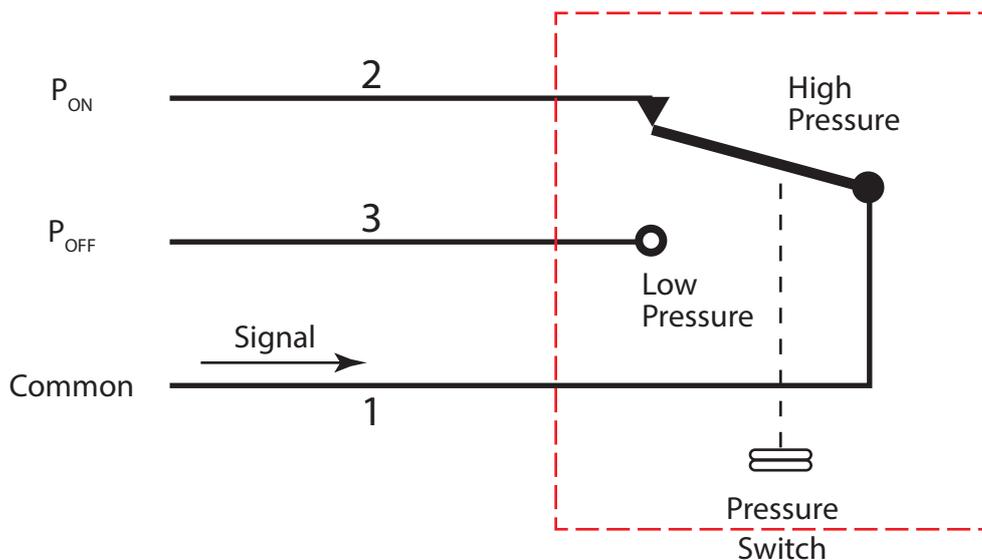
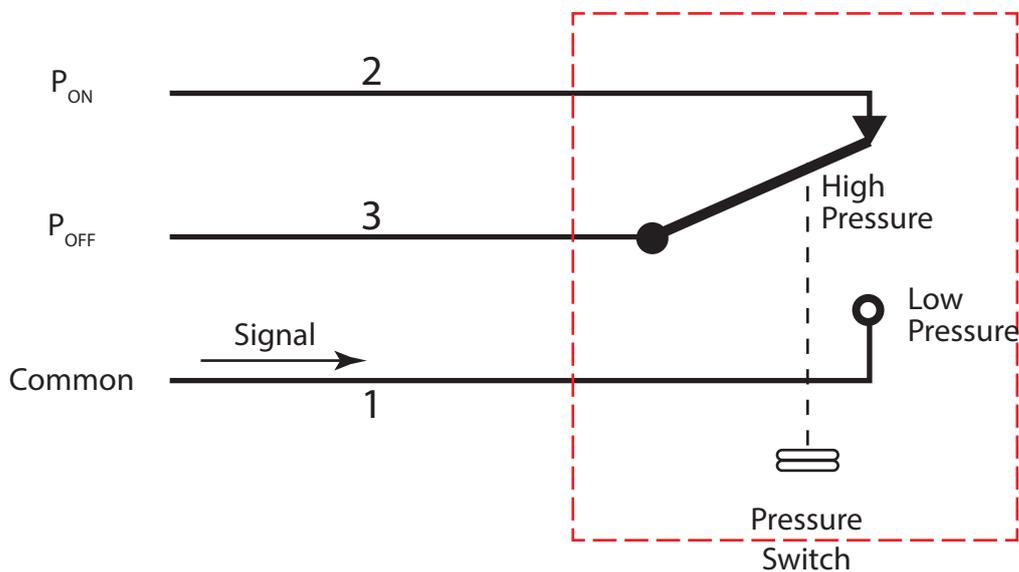
Figure 2

The pressure switches have three output pins, which are electrically connected to the PCB. The original standard pressure switches were constructed such that the wire from Pin 1 is common, the wire from Pin 2 carries the high pressure signal and the wire from Pin 3 the low pressure signal. However, following a modification in 2010 (MOD 0752520) the internal wiring of the switches was changed, owing to an error in the specification sent to the switch manufacturer. This resulted in the transposition of connections to Pin 1 and Pin 3 within the pressure switches. The wiring and internal schematic for the switches before and after MOD 0752520 is shown in Figure 2. The schematic is valid for both the Hydrosafe 620 and bleed-air switches.

Both G-REDW and G-CHCN had MOD 0752520 embodied. For helicopters with MOD 0752520, the MGB EMLUB caption will illuminate after a 30 second delay following activation of the emergency lubrication system, if there is:

Schematic of wiring and pressure switches pre and post MOD 0752520

An error in the specification issued to the pressure switch manufacturer resulted in all EC225 LPs, with MOD 0752520 embodied, having a pressure switch configuration that results in illumination of the MGB EMLUB caption once the system is activated and after the 30 second delay. This was the most likely cause of the MGB EMLUB caption during the accident flights for G-REDW and G-CHCN.

Eurocopter issued an Alert Service Bulletin (ASB) 05A032 on 22 February 2013, to modify the wiring on the helicopter, to be compatible with the pressure switches. The EASA issued Airworthiness Directive 2013-0037 on 22 February 2013 to mandate the ASB.

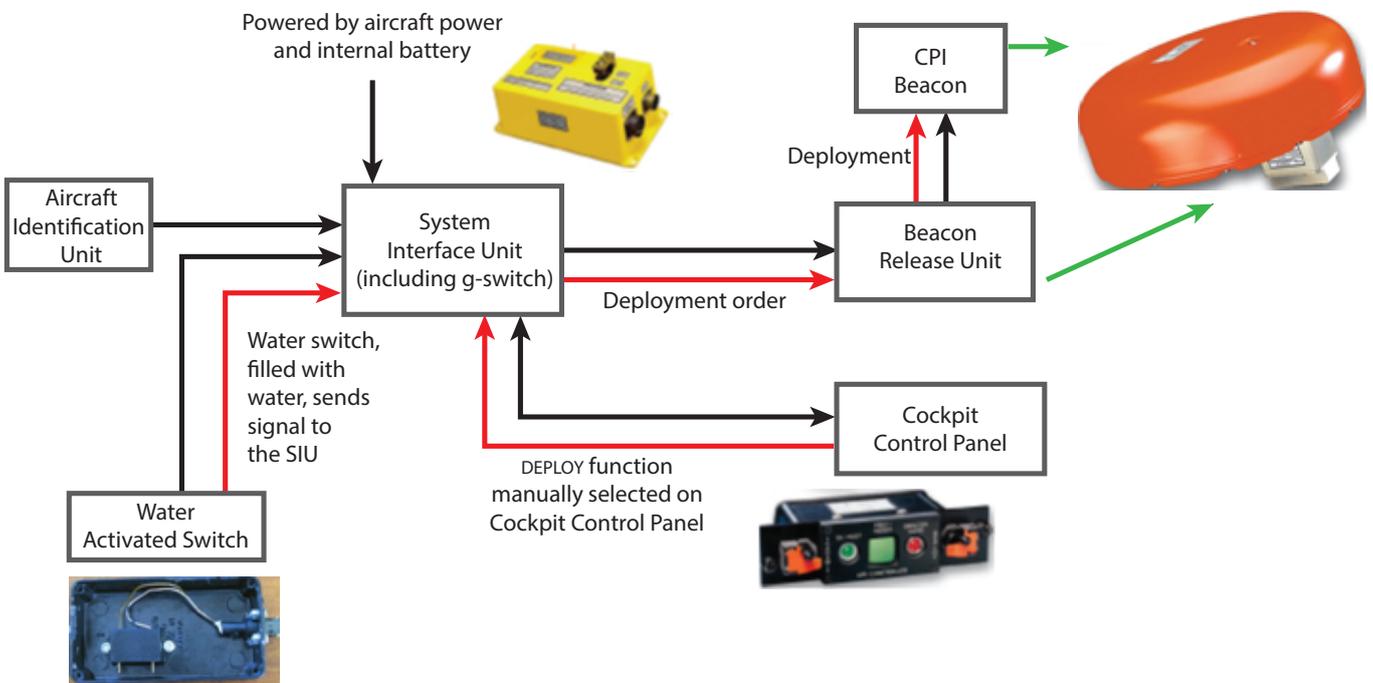
The CPI system consists of the CPI beacon, a beacon release unit, a system interface unit, a cockpit control panel, a water activated switch and an aircraft identification unit (Figure 3). These components are located in various positions around the helicopter, and are connected by wiring which is integrated with the rest of the helicopter’s wiring looms, and is therefore

**Figure 3**  
Schematic of Crash Position Indicator system

TRANSMIT function, all of the CPI system components were removed for testing. The cockpit control unit contained seawater and had suffered extensive internal deterioration due to corrosion, which rendered it incapable of operating. All of the other components were installed on the test bench and functioned correctly, leading to successful operation of the beacon release unit and deployment of the CPI. A visual examination of the water activated switch showed minor corrosion on one of the contacts, but no evidence of salt water deposits which may have indicated complete immersion in sea water. However, the external electrical connector was corroded, indicating that the water had reached at least that level. The activation code stored in the CPI system memory confirmed the manual TRANSMIT selection of the CPI during the accident. It was therefore concluded that there were no defects with these components that would have prevented the automatic deployment of the CPI beacon, had a manual TRANSMIT not been selected.
