AAIB Bulletin No: 4/95

Ref: EW/G94/12/12

Aircraft Type and Registration: Bell 206B JetRanger III, G-BBNG

Location: Cowmire Hall, Crosthwaite, Lancashire

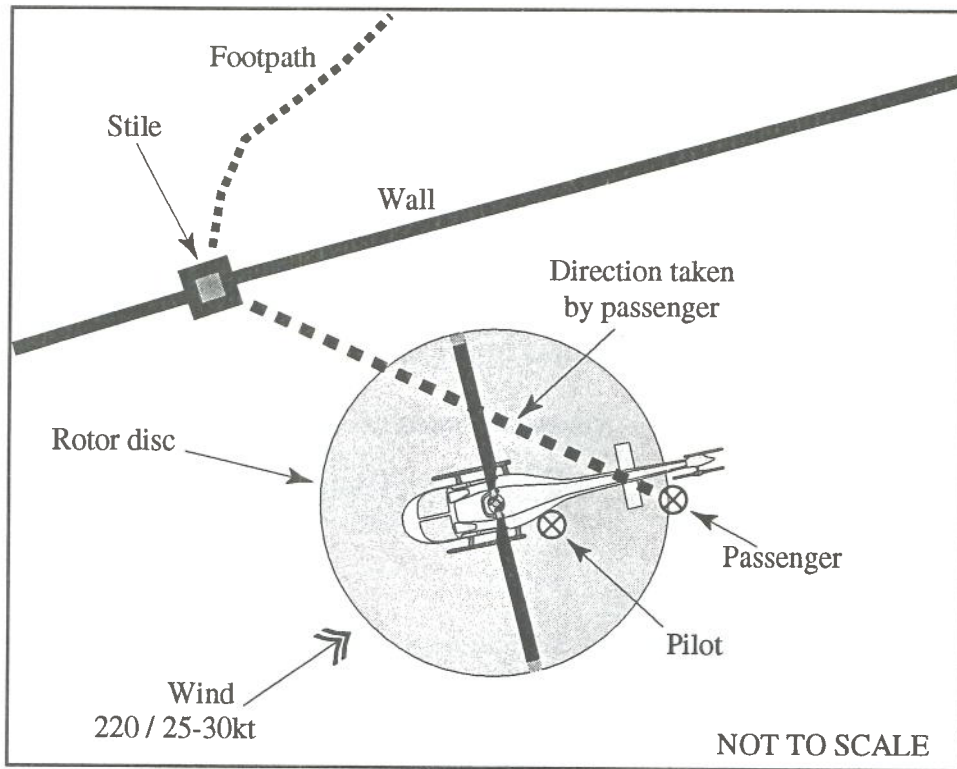
DIAGRAM OF LANDING SITE

The helicopter landed on a heading of about 250° and was positioned some 35 metres from a stile set in a 6 feet high slate wall that formed the boundary between the house lawn and the landing site (see diagram). The son, who was with his father in the house when the helicopter arrived, left his father and went to meet with the pilot. He approached the helicopter but remained clear of the rotor disc. On seeing a 'thumbs up' from the pilot the son approached the helicopter to discuss the details of the flight. He concluded by saying that he would return to the house to fetch his father and that there was some luggage left adjacent to the wall that would need to be loaded in the helicopter.
