AAIB Bulletin No: 6/95

Ref: EW/G95/03/08

Aircraft Type and Registration: i) Shorts SD3-30 Variant 100, G-BIOE
ii) Cessna 152, G-BNUL

Location: Exeter Airport, Devon

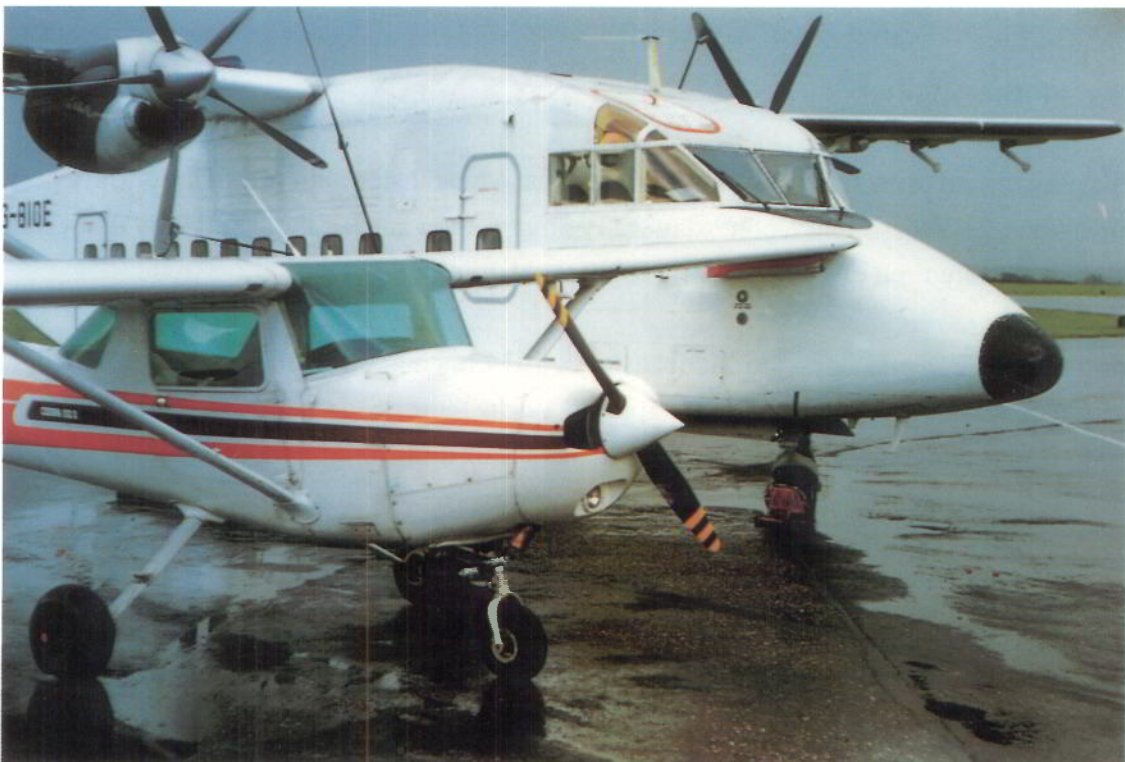
The Shorts 3-30 ('OE') had arrived at Exeter Airport at 0130 hrs on the morning of the accident and had been parked into wind in 'D' parking area on a heading of 180°. Chocks had been placed by the airport staff at the rear of the nosewheel and to the rear of left mainwheel. No chocks were placed in front of the aircraft wheels.

At 1109 hrs, as a weather squall crossed the airfield, a gust of wind caused 'OE' to weathercock to the right onto a heading of 230°. The nose section contacted to left wing of 'UL' raising the wingtip and left main landing gear from the ground. The Instructor and student vacated the aircraft and chocked 'OE' to prevent it from further movement. It was reported that, although the parking brake of the Shorts 3-30 was applied, the wheels were seen to rotate and not skid as the aircraft moved under the influence of the gust.

The Shorts 3-30 Company Operations Manager reported that the aircraft should have been parked with chocks placed in front and behind all wheels as this aircraft type is particularly prone to movement in wind gusts.

As a result of the accident the company issued a 'NOTICE TO PILOTS' explaining to crews the parking precautions to be taken before leaving an aircraft. The Airport Manager has also revised aircraft parking arrangements on parking area 'D' at Exeter Airport.
