AAIB Bulletin No: 9/93

Aircraft Type and Registration: SC7 Skyvan 3A, G-ASZJ

Nature of Damage: Left side crew door detached; damage to propeller and left tail fin leading edge.

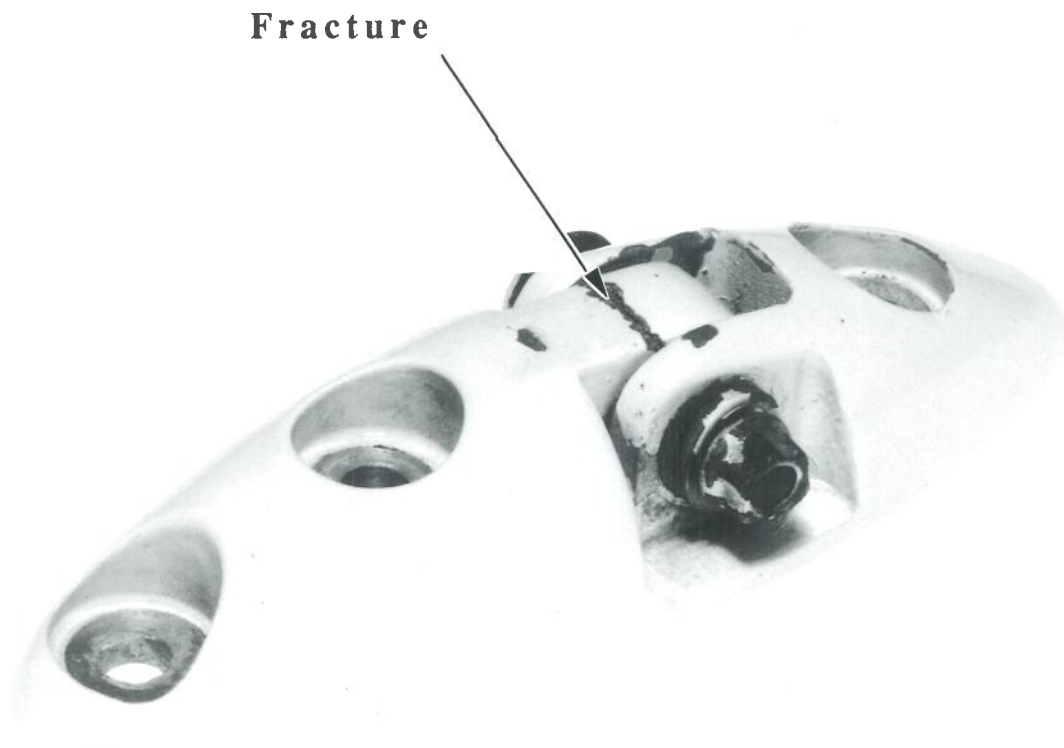
Each crew door is attached to the fuselage by three hinge assemblies each consisting of a tongue on the door and a fork on the fuselage. The door hinges about a shear pin passing through the fork and tongue. The upper and lower hinges castings had failed, and the components were subsequently examined by the Materials and Structures Department at DRA Farnborough. The centre hinge had remained intact and had torn off a piece of fuselage skin.

**Fig. 1 Hinge configuration
(Lower unit shown)**

The door hinges had been the subject of a Service Bulletin, No 52-62, which introduced Modification No 1273, dated December 1974. The reason for the Modification was to '.... provide an alternative door hinge with an improved service life'. The pre-modification components had been manufactured from L52 material (casting), the modified components were made from L77 material (forging). The modification had been partially embodied on G-ASZJ in that the centre hinge on the subject door had been replaced, and which, as noted above, had remained intact.

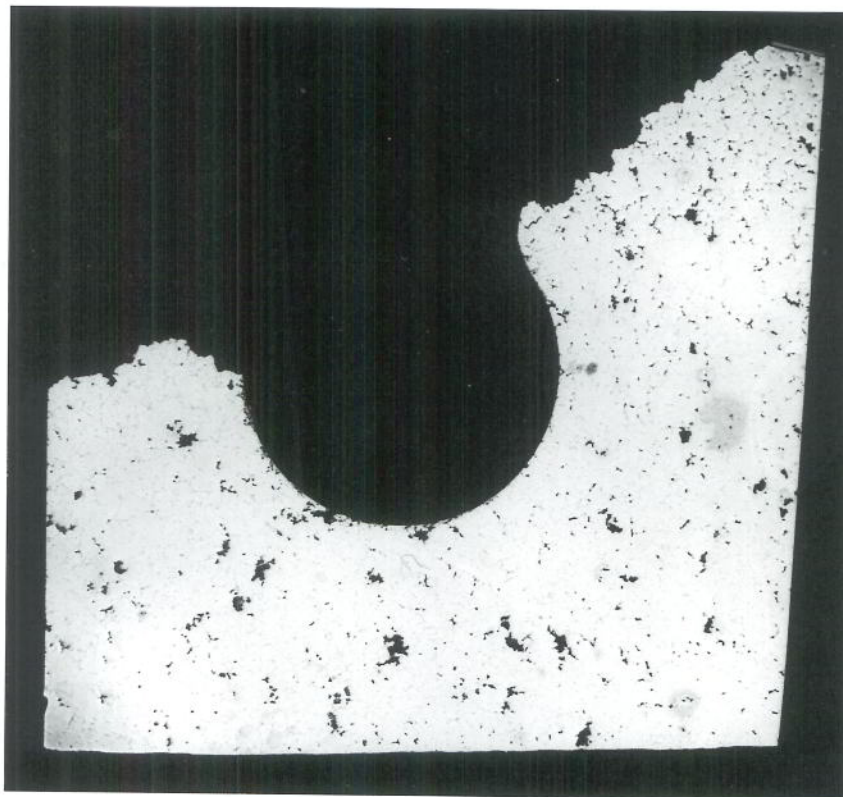
The lower hinge had failed in the tongue fitting, ie the part attached to the door, whilst the upper hinge had failed in the fork fitting, the part attached to the airframe. Both hinges contained considerable shrinkage porosity throughout the section and there was intergranular corrosion from the bores in which the shear pins were located. Additionally there was corrosion pitting on the steel bushings in the tongue fittings together with a general lack of lubrication. The fracture faces were generally brittle in nature, with no obvious evidence of pre-existing defects. However, microscopic examination revealed a small amount of fatigue close to the bores in the upper hinge forks. These features would have had a significant weakening effect and increased the susceptibility to fracture. Figures 1 and 2 show the hinge configuration and a section through one of the upper hinge castings in which the shrinkage porosity can be seen.

**Fig. 2 Section through upper hinge lug showing
shrinkage porosity (X6.3)**
