## Airbus A320-232, G-EUUI

<b>AAIB Bulletin No: 11/2004</b>	<b>Ref: EW/C2003/11/04</b>	<b>Category: 1.1</b>
<b>INCIDENT</b>		
<b>Aircraft Type and Registration:</b>	Airbus A320-232, G-EUUI	
<b>No &amp; Type of Engines:</b>	2 International Aero Engines (IAE) V2527-A5 turbofan engines	
<b>Year of Manufacture:</b>	2002	
<b>Date &amp; Time (UTC):</b>	29 November 2003 at 1955 hrs	
<b>Location:</b>	Overhead Birmingham	
<b>Type of Flight:</b>	Public Transport (Passenger)	
<b>Persons on Board:</b>	Crew - 7	Passengers - 92
<b>Injuries:</b>	Crew - None	Passengers - None
<b>Nature of Damage:</b>	None	
<b>Commander's Licence:</b>	Airline Transport Pilot's Licence	
<b>Commander's Age:</b>	39 years	
<b>Commander's Flying Experience:</b>	11,350 hours (of which 930 were on type)	
	Last 90 days - 166 hours	
	Last 28 days - 50 hours	
<b>Information Source:</b>	AAIB Field Investigation

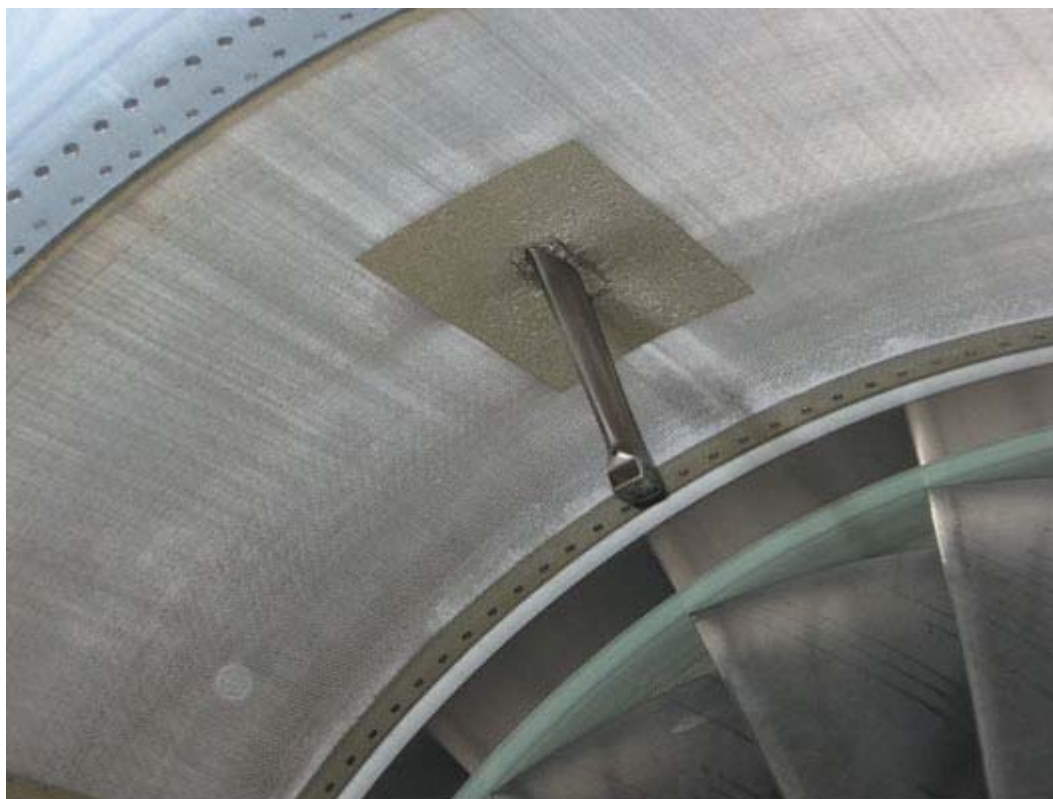
**Figure 1**

Engine inlet pressure ( $P_2$ ) and total air temperature ( $T_2$ ) is measured by a ' $P_2T_2$ ' probe located immediately ahead of the fan and on the upper inside surface of the engine inlet cowl, Figure 1.

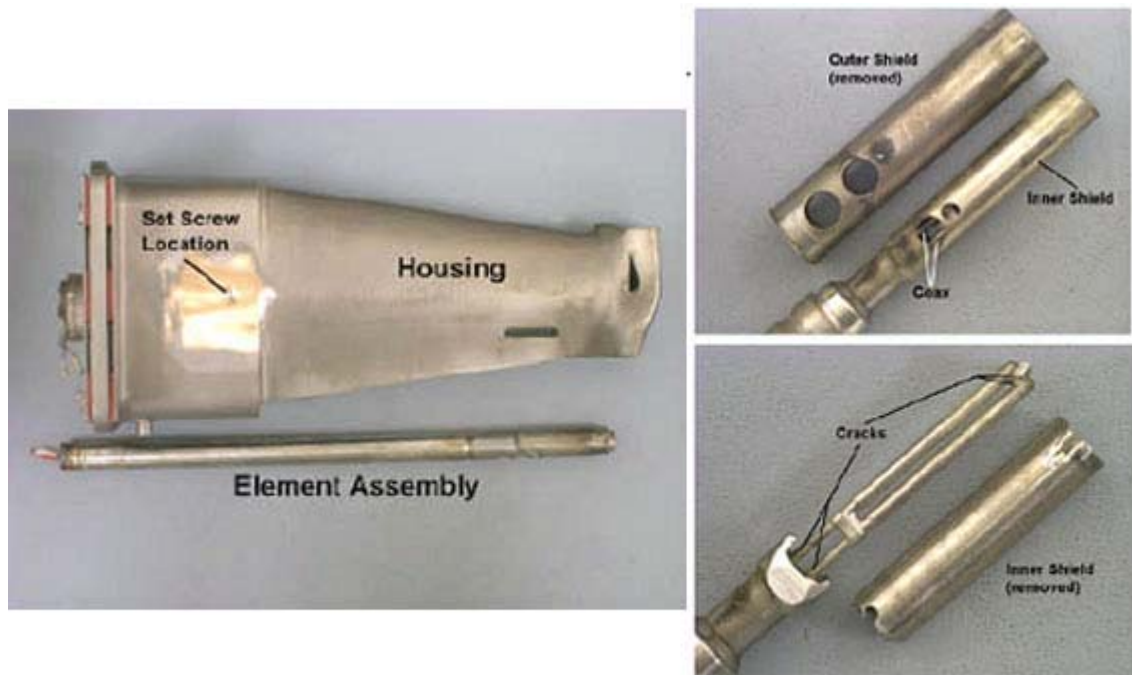
## **Figure 2**

The  $P_2T_2$  probe was removed and examined by its manufacturer. The probe consists of an aerodynamic housing inside which a tube, containing the two independent electrical resistance temperature sensing elements, are located. These two elements (Channels A and B) are contained within inner and outer shields and cracks were found within both elements, Figure 2.

These had allowed moisture to enter the dielectric material within the resistance elements and cause false temperature indications on both channels. The initial testing confirmed that, compared with the test points, a low temperature on Channel A was recorded, but Channel B results were closer to the test point. It was likely that the time between the incident and the probe examination allowed any moisture to dry out, at different rates, and hence be responsible for Channels A and B producing different test results.

It is recommended that Airbus Industrie and IAE review the EEC logic on the V2500 engine fitted to the A320 aircraft, regarding the selection of a temperature source, in the event that the system detects a greater than normally permitted difference between the available sources, so that an erroneous signal is not used for engine control.

It is recommended that Airbus Industrie review the logic of the Centralised Fault Data Interface Unit (CFDIU) and the Engine Electronic Control (EEC) on A320 aircraft fitted with the V2500 engine, with respect to the Class 3 classification (a fault having no impact on flight safety) of a T2 Sensor Soft Fault (SSF), so that soft faults, such as an erroneous signal, are brought to the attention of flight and maintenance crews at the earliest opportunity.
