ACCIDENT

Aircraft Type and Registration:	EC225 LP Super Puma, G-CHCN
No & Type of Engines:	2 Turbomeca Makila 2A1 turboshaft engines
Year of Manufacture:	2007 (Serial no: 2679)
Date & Time (UTC):	22 October 2012 at 1418 hrs
Location:	In the North Sea, approximately 32 nm southwest of Sumburgh, Shetland Islands
Type of Flight:	Commercial Air Transport (Passenger)
Persons on Board:	Crew - 2 Passengers - 17
Injuries:	Crew - None Passengers - None
Nature of Damage:	Fracture of the Main Gear Box bevel gear vertical shaft
Commander's Licence:	Airline Transport Pilot's Licence
Commander's Age:	46 years
Commander's Flying Experience:	Approximately 12,000 hrs (approx 1,000 hrs on type)
Information Source:	AAIB Field Investigation

This Special Bulletin contains information on the progress of the investigation into identifying the cause of the 360° circumferential crack in the bevel gear vertical shaft on G-CHCN (AAIB Special Bulletin S6/2012). It also compares the findings with those recorded previously on another EC225 LP accident involving a

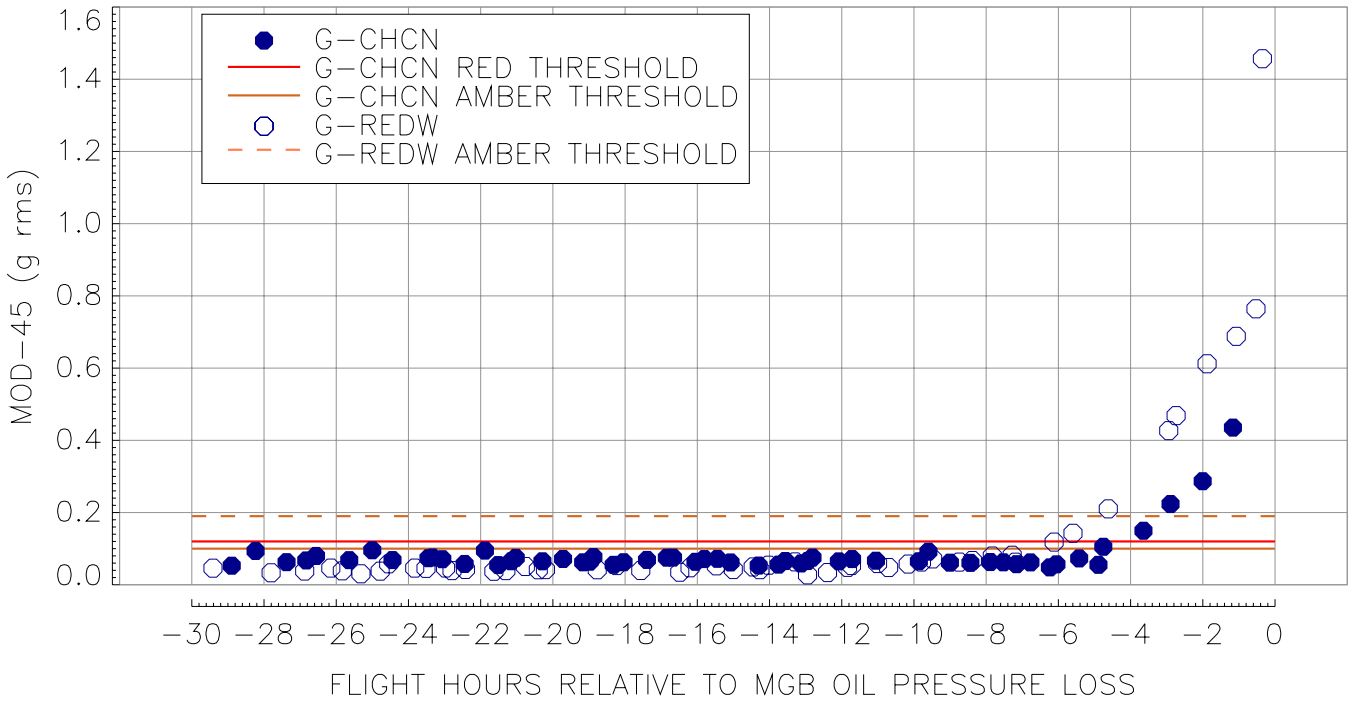
Comparison MOD-45 trend indications between G-CHCN and G-REDW

Figure 1 shows that the MOD-45 indicator for G-CHCN, exceeded its ‘learned’ amber threshold (0.10) 4.75 flying hours and its ‘learned’ red threshold (0.12) 3.63 flying hours prior to the loss of oil pressure. For G-REDW the MOD-45 indicator exceeded its ‘learned’ amber

threshold (0.19) 4.62 flying hours before the loss of the MGB oil pressure.

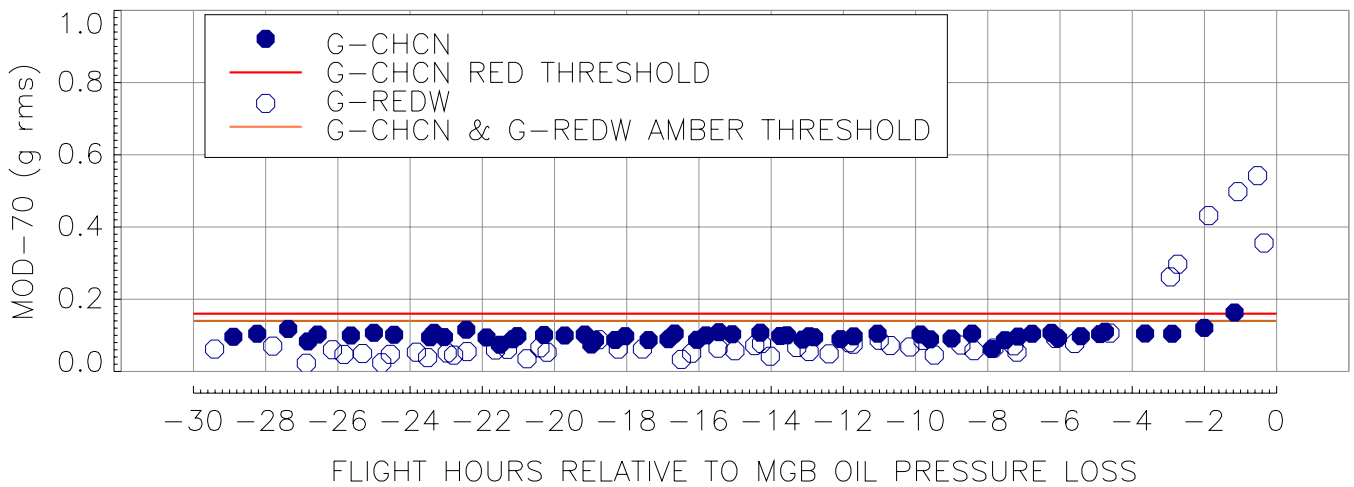
Comparison MOD-70 trend indications between G-CHCN and G-REDW

Figure 2 shows that for the MOD-70 indicator, the first instance that it exceeded the ‘learned’ amber

threshold (0.14) for G-REDW was 2.95 flying hours before the loss of MGB oil pressure. However, for G-CHCN only the last recorded value of this indicator, which was captured 1.17 flying hours before the loss of the MGB oil pressure, exceeded both its amber (0.14) and red (0.16) 'learned' thresholds.

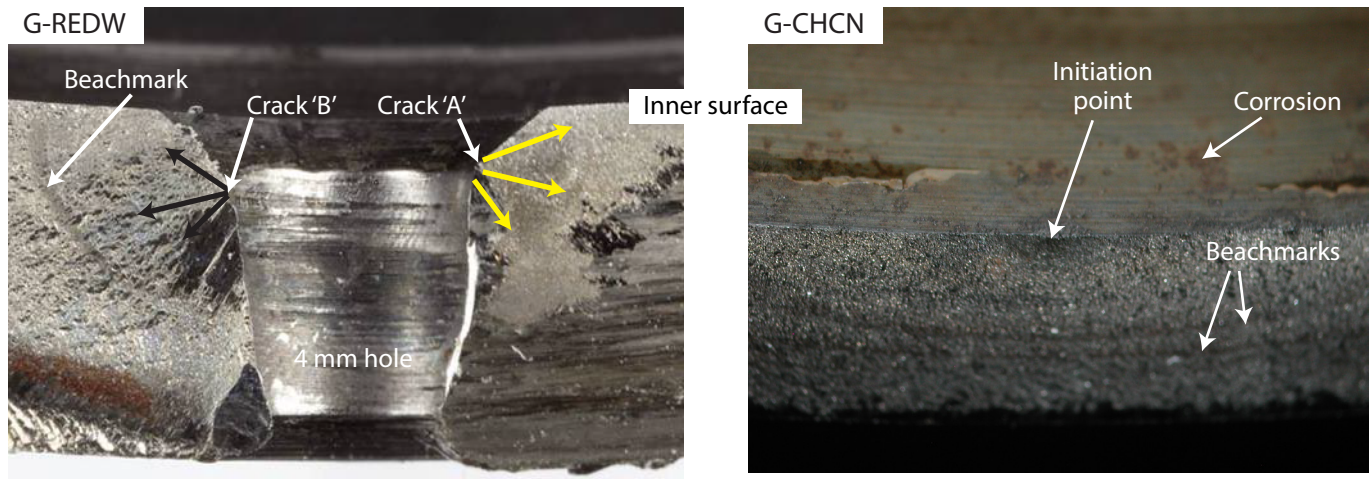
Figure 3

On G-REDW, the first crack to develop was identified as Crack 'A', which initiated at a corrosion pit approximately 0.06 mm deep located in the inner countersink of the $\text{\O} 4$ mm hole (Figure 3). The crack then propagated along the fusion line between the area of the weld which had been previously melted, and the heat affected zone in the parent material in the vertical shaft. A second crack, Crack 'B', initiated after Crack 'A' at a small

Location of crack initiation on G-REDW and G-CHCN

On G-CHCN the fatigue crack initiated at an area of corrosion on the inner surface of the shaft (Figure 3), approximately 47° around the circumference from the Ø 4 mm hole (Figure 4). It has not yet been determined where the crack initiated in relation to the heat affected zone. Away from the initiation point, the crack propagated in both directions in the parent material in the vertical shaft. Small areas of corrosion were also visible in the machining marks around the inner flange that had been machined during manufacture to remove the root of the weld. The initial examination has not
