No: 9/88

Ref: EW/C1063

**Aircraft Type and Registration:** Jodel D 120A, G-AZXE

G-AZXE LEFT  
WING FAILURE

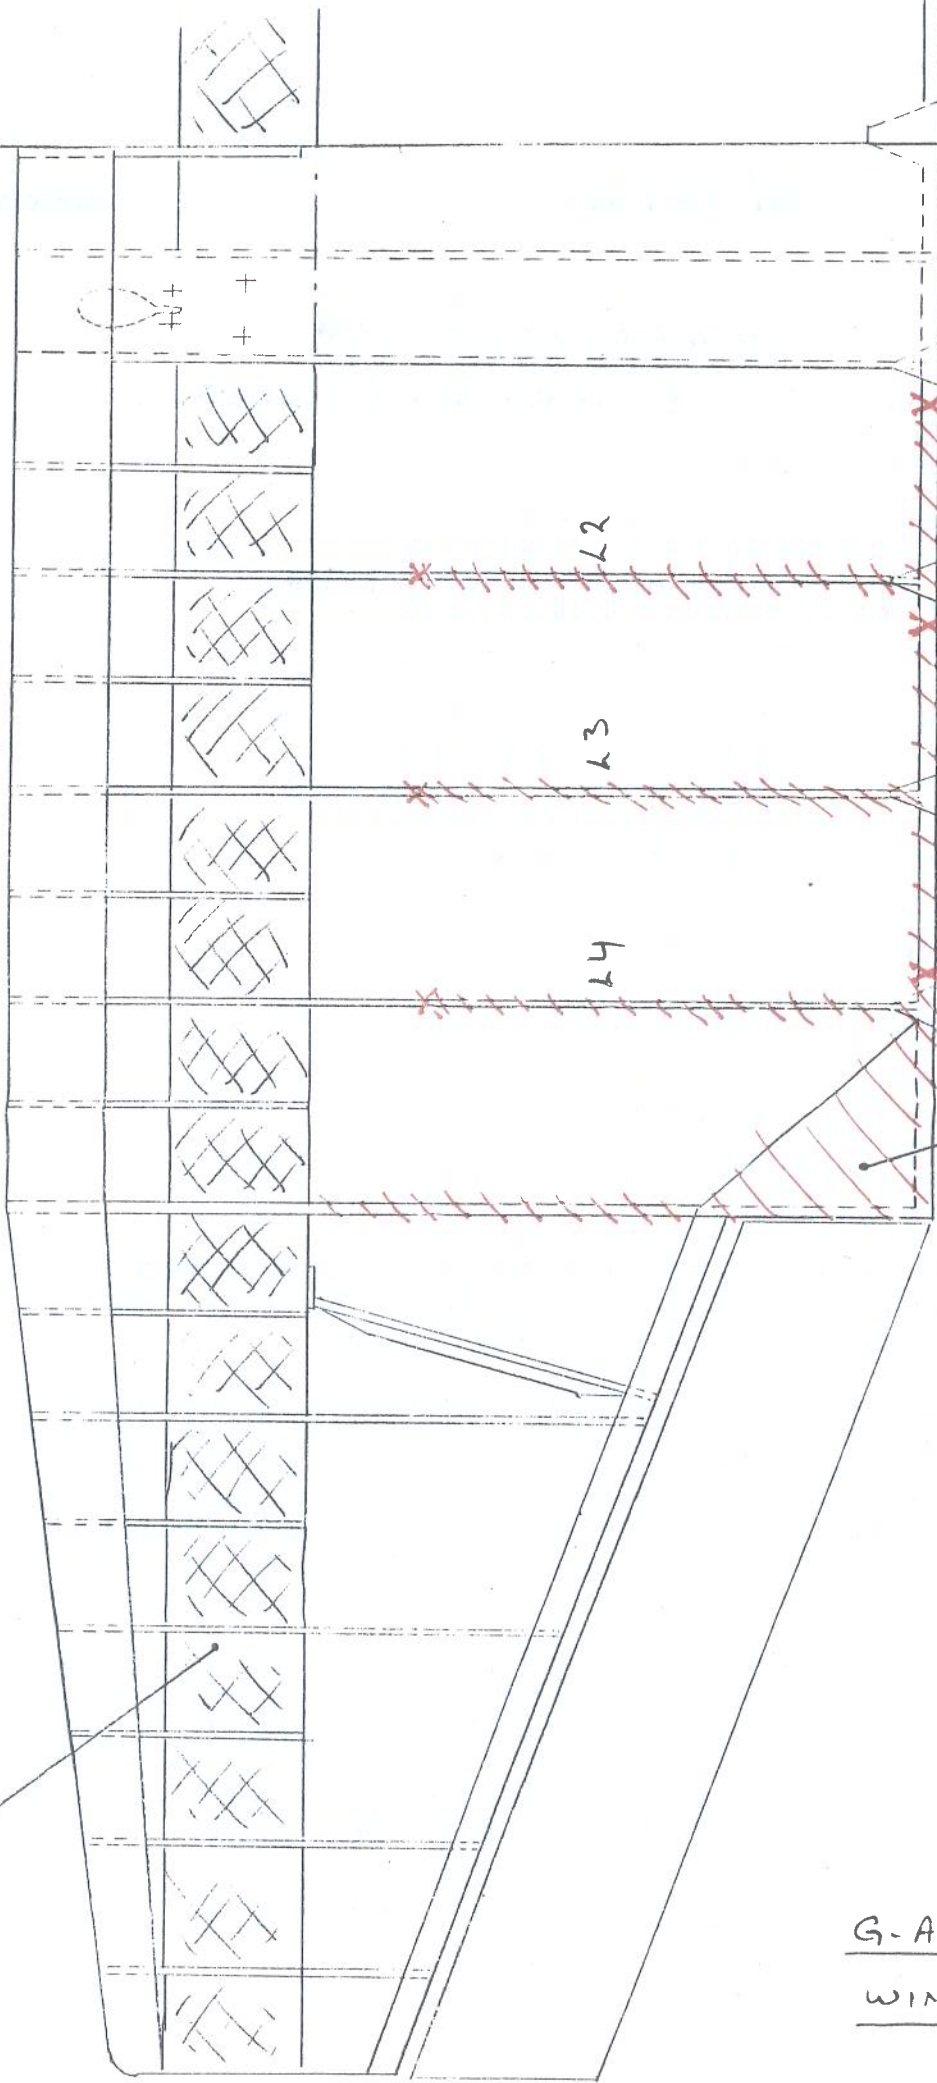
A reconstruction of the left and right wings showed the right wing to have been intact prior to impact, whilst the left wing showed evidence of failures having occurred in the centre wing rib structures, aft of the spar, and their associated trailing edge section (see figure 1). The spar itself had been intact at impact. The upper surface fabric covering this left wing had become detached in flight from the structure around all of the trailing edge. In addition, an area of lower surface fabric had also become detached at the trailing edge around the centre of this inner wing. Only some of the fabric and trailing edge section from this region of the wing was recovered from the wreckage trail.

- There was no evidence of fungal attack or water ingress.
- Considerable similarity was noted in the fractures present in the two centre ribs of the left wing, ie L3 and L4.

- Two fractures in rib L4 were associated with "sloping grain". This would have reduced the bending strength by 20%, although it was considered unlikely that this would have been sufficient to initiate the major failure. However, it was considered that it may well have been a contributory factor in the failure.

- There was some evidence of previous crack growth in rib L3, next to the trailing edge. There was also evidence of "rubbing together" of the fracture surfaces of one failure, in both ribs. There was considerable and consistent evidence that the rib members had been subjected to high compressive stresses and that these, because of their distribution, had not occurred at the time of the major break-up of the wing. It would appear, therefore, that the wing had been subjected to high compressive stressing before the final break-up. Two possible sources of such stressing were considered:-

While it was not possible to eliminate the possibility that separation and abrasion of the surfaces of one fracture in each rib occurred during the major break-up of the wing, it was likely from the extent of the abrasion that separation occurred at some time before the major break-up. In particular, the discolouration associated with one of the fractures would indicate that a considerable time elapsed (several months) between the generation of the crack along induced compression creases (in the wood fibres) and the final break-up of the wing. These findings would be consistent with overstressing of the wing at some earlier date.

The wing design dates from the late 1950's and this particular example was factory-built in 1965, in France. Four years ago, the wing was re-covered with a modern man-made polyester fabric. The main advantage of this material compared to linen type fabrics, is that it is virtually "rot-proof". One **characteristic difference** between such fabrics is that tautness is achieved through shrinkage with the modern material. This is induced by the application of heat, typically using a thermostatically controlled iron set at about 120°C. All French and British airworthiness documentation examined relating to this type of covering contain warnings to the effect that care is necessary to prevent the application of excessive heat, as this may cause excessive shrinkage of the covering and distort the underlying structure. The wing of G-AZXE had been modified, in common with other re-covered Jodel wings examined, by the addition of a three dimensional "gusset", stiffening the structure at the outboard aft corner of the centre wing. This modification is designed to resist local deflections of the wooden structure, when the wing is covered with polyester fabric. It is thus evident that this material can induce higher static loads into this design of wing than were contemplated when it was originally designed.

/// = WING STRUCTURE FAILED IN FLIGHT.  
X = CORNER STIFFENING
