AAIB Bulletin No: 11/93

Ref: EW/C93/6/1

INCIDENT

Aircraft Type and Registration: Boeing 757-236, G-BIKC

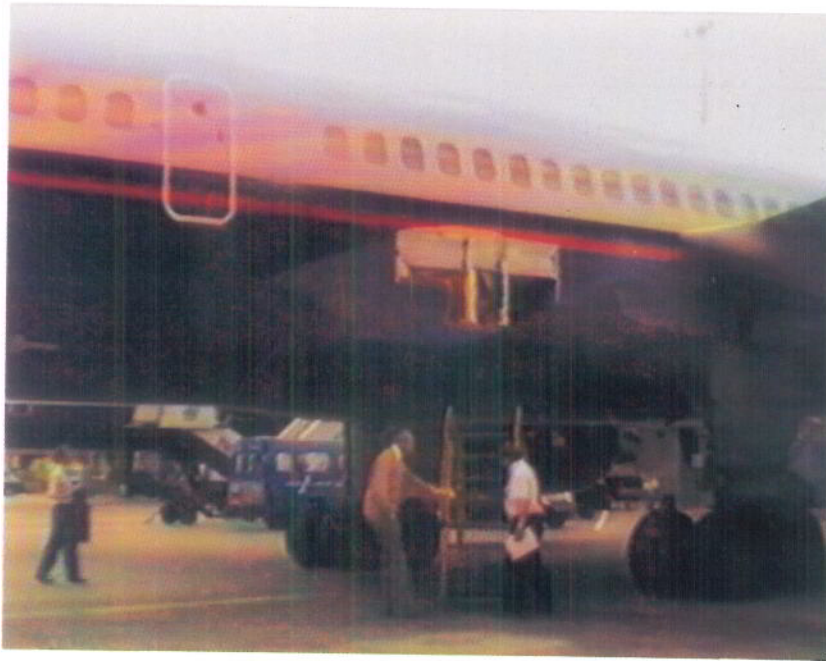
After landing it was found that part of the right overwing fairing had become detached from the aircraft. The detached sections of the GRP/honeycomb sandwich fairing consisted of a complete panel, 3 feet x 4½ feet, which had subsequently torn off a further L shaped section, about 5 feet x 5 feet. These had separated from the aircraft during the climb out of Glasgow and the parts had descended into the playground of a Primary School. Nobody in the playground had sustained any physical injuries. The panel was transported, immediately, to Heathrow and inspected in conjunction with the aircraft.

Fig 1 General view showing area of fairing which detached above flap.

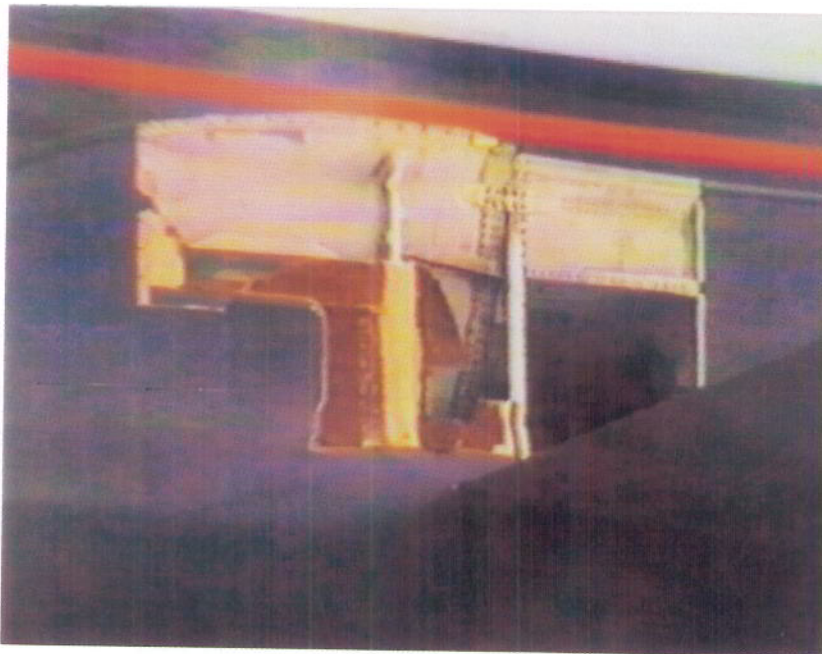
The panel, which formed part of the wing top surface to fuselage fairing, was normally retained along three of its four edges by a row of countersunk head screw fasteners, the top edge being free to move against the fuselage side. It was established, from the lack of damage to a number of the fastener holes in the panel, that a considerable number of fasteners, in particular all those attaching the panel leading edge, had not been installed at the time that the panel had separated from the aircraft.

A test of the friction locking properties of the captive nuts installed on the aircraft to retain these fasteners was performed. This showed that all the nuts associated with fasteners which had been missing at the time that the panel separated had lost their locking properties and it was possible to screw a new fastener in and out of any of them effortlessly using the fingers. The panel involved in this incident was not normally removed at any time during the maintenance cycle between inter-checks, which occur at about 2 year intervals, and the nuts are specified as being reuseable 15 times.

Examples of the degraded captive nuts were returned to the aircraft manufacturer whose investigations revealed that the captive nuts were no longer to specification in relation to their self locking properties, the threadform having become worn, but appeared to conform to the required material specifications. The manufacturer also stated that they had no reports from other Boeing 757 operators of problems with these fasteners.

Leading edge
all fasteners missing

Fig 2 Closer view showing forward rectangular section which detached as a result of missing fasteners and L shaped section of panel immediately aft which was torn off with it.

As a result of these findings, the operator has instituted a programme to check the rundown torque of the fasteners of all the overwing panels on the entire Boeing 757 fleet as part of a revised maintenance procedure. This check requires that the servicability of the nuts is checked at the next scheduled removal of each overwing panel and that sub-standard nuts must be replaced before panels are refitted. They have also conducted a survey of the levels, practices and frequencies of inspection of the fasteners on similar panels on all the other aircraft fleets which they operate. This revealed that inspection of the fasteners in this type of zone on the Boeing 757 fleet was markedly less frequent than on the other fleets. As a result of this survey, the operator's Boeing 757 Maintenance Schedule has been amended to increase the frequency of inspection of these fasteners from the previous period, of 2 years or 4,500 hours, to the current period of 1 year or 2,000 hours.
