ACCIDENT

Aircraft Type and Registration:	Pulsar (kit-built aircraft), G-CCBZ	
No & Type of Engines:	1 Rotax 582 two-cylinder two-stroke piston engine	
Category:	1.3	
Year of Manufacture:	2000	
Date & Time (UTC):	2 July 2005 at 1134 hrs	
Location:	Approximately 0.5 miles south-west of Deanland Airfield, East Sussex	
Type of Flight:	Private	
Persons on Board:	Crew - 1	Passengers - None
Injuries:	Crew - None	Passengers - N/A
Nature of Damage:	Extensive damage to fuselage and separation of nose leg	
Commander's Licence:	National Private Pilot's Licence (NPPL)	
Commander's Age:	47 years	
Commander's Flying Experience:	225 hours (of which 70 were on type) Last 90 days - 10 hours Last 28 days - 5 hours	
Information Source:	Aircraft Accident Report Form submitted by the pilot

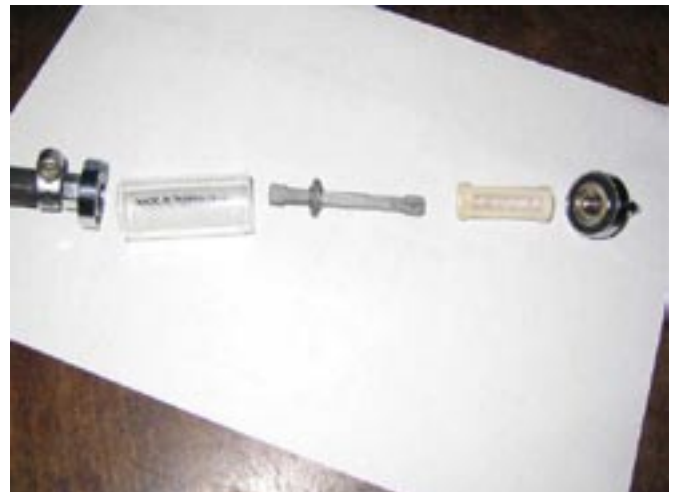
Figure 2

The pilot suspected fuel starvation and later removed the two carburettor float bowls, both of which contained sediment. He considered that there was a sufficient amount of sediment in the bowls to have restricted the supply of fuel (which was automotive MOGAS) into the engine. The larger items of sediment appeared to be small flakes of red paint, which matched the fuel cans from which he habitually filled the aircraft. It was not apparent how the sediment had reached the float bowls but further inspection showed that the replaceable element in the Purolator fuel filter assembly (Figures 1 and 2) had not been fully screwed home and could therefore 'rock' in place, allowing the flow of dirty fuel past the filter element.

G-CCBZ - fuel filter components

The pilot also considered that, in retrospect, he should have refuelled through a proper external strainer to filter the fuel into the tank, rather than using a simple 'jerry can' and siphon-tube arrangement. He also noted that the filter assembly did not indicate that the replaceable element should be screwed fully home and that, in this aircraft, the fuel supply to the engine primer is drawn from the fuel tank 'sight glass', which is not filtered.
