ACCIDENT

Aircraft Type and Registration:	Piper PA-28-181 Archer 2, G-EMAZ	
No & Type of Engines:	1 Lycoming O-360-A4M piston engine	
Year of Manufacture:	1981	
Date & Time (UTC):	4 September 2005 at 1221 hrs	
Location:	Irish Sea, 5 nm north-west of Strumble Head, Pembrokeshire	
Type of Flight:	Private	
Persons on Board:	Crew - 1	Passengers - 1
Injuries:	Crew - 1 (Fatal)	Passengers - 1 (Fatal)
Nature of Damage:	Aircraft destroyed	
Commander's Licence:	Private Pilot's Licence	
Commander's Age:	63 years	
Commander's Flying Experience:	Approx 150 hours (of which approx 45 were on type) Last 90 days - Not known Last 28 days - Not known	
Information Source:	AAIB Field Investigation

Synopsis

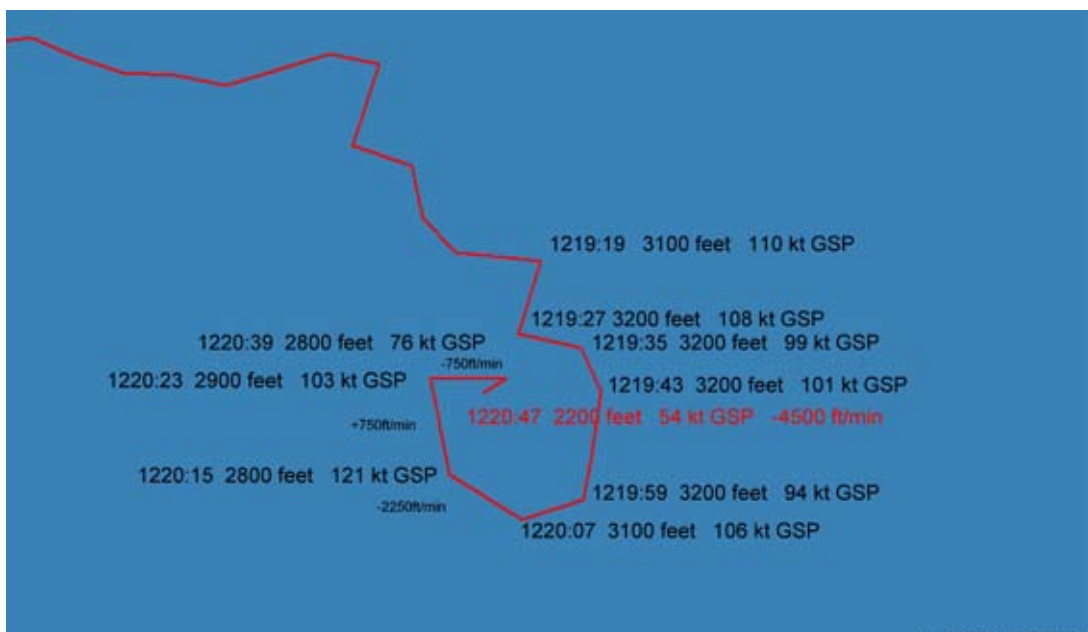
Figure 1

The recorded radar information indicates that G-EMAZ coasted out at 1143 hrs just north of Wexford. The radar trace continued until 1148 hrs when radar contact was temporarily lost. The next radar contact was at 1159 hrs when G-EMAZ was in the middle of the St George's Channel, just prior to the FIR boundary. There was then another break in radar contact from 1201 hrs to 1204 hrs. The remainder of the radar trace was continuous until radar contact with G-EMAZ was lost at 1220:47 hrs, 5 nm north-west of Strumble Head, with an indicated height of 2,200 ft. (See Figure 1: Radar Plot).

Radar Plot

The aircraft's initial track over the Irish Sea was on a relatively straight course of 112°(T), towards the Strumble navigation beacon. At 1217 hrs the aircraft turned left onto 052°(T) and held this track for 24 sec before turning right on to 091°(T), this track was maintained for approximately one minute. The aircraft's track then became erratic, with at least four large heading changes occurring over a period of about one minute.

At 1219:35 hrs, the aircraft entered a right turn through approximately 140° over a period of 40 sec: this equates to a turn rate of 3.5°/sec. The aircraft then commenced its rapid descent whilst turning very quickly through a further 150° to the right. The radar trace was then lost.

The radar information suggests that the flight profile was normal until 1217 hrs. G-EMAZ had been maintaining a relatively steady track of 112°(T) but then turned left onto 052°(T) before reversing the turn to the right onto 091°(T). Approximately one minute later the aircraft's track became erratic, with at least four large heading changes occurring over a period of about one minute. At 1219:35 hrs, the aircraft entered a right turn through approximately 140° over a period of 40 sec. It is possible that at this point the pilot was attempting to maintain or regain VMC, by turning away from poor weather using the technique he had learnt during his PPL training. The aircraft then entered a rapid descent and turned very quickly through a further 150° to the right. The radar trace was then lost. The aircraft appears to have entered a steep spiral dive from which it did not recover.
