## INCIDENT

<b>Aircraft Type and Registration:</b>	Boeing 737-800, EI-DLJ
<b>No &amp; Type of Engines:</b>	2 CFM 56-7B26 turbofan engines
<b>Year of Manufacture:</b>	2005
<b>Date &amp; Time (UTC):</b>	17 July 2009 at 1225 hrs
<b>Location:</b>	London Stansted Airport, Essex
<b>Type of Flight:</b>	Commercial Air Transport (Passenger)
<b>Persons on Board:</b>	Crew - 6                      Passengers - 164
<b>Injuries:</b>	Crew - None                      Passengers - 1 (Minor)
<b>Nature of Damage:</b>	None
<b>Commander's Licence:</b>	Airline Transport Pilot's Licence
<b>Commander's Age:</b>	40 years
<b>Commander's Flying Experience:</b>	8,500 hours (of which 4,755 were on type) Last 90 days - 259 hours Last 28 days - 91 hours
<b>Information Source:</b>	AAIB Field Investigation

## Synopsis

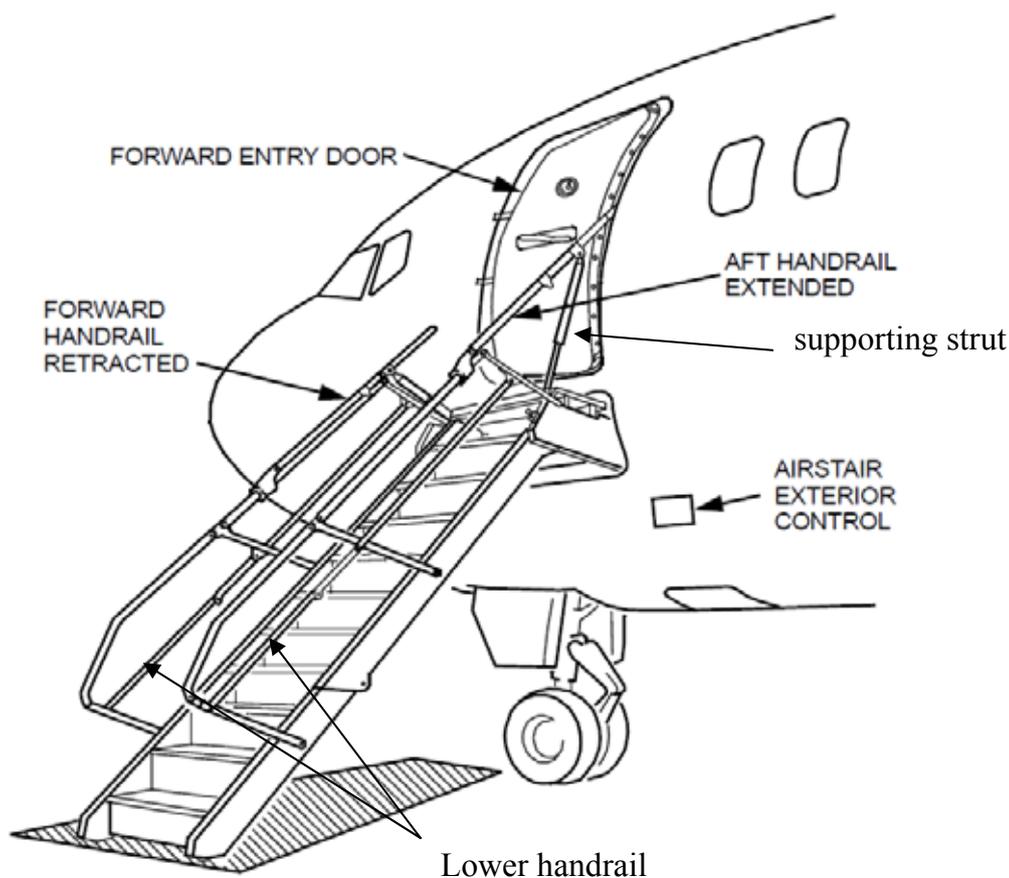
**Figure 1**

restrictions imposed by the retraction mechanism design, they do not extend to the fuselage side. In order to bridge the gap between the top of the handrails and the fuselage, a manually extendable handrail is fitted to each of the integral rails. After deployment of the airstairs, these are extended and secured to points in the entry door frame, Figure 1. Each extendable rail is supported by a strut extending from the side rail of the airstairs.

Boeing 737 forward airstairs  
(Published with the permission of Boeing)

The Boeing 737 series of aircraft is one of a number of types that use integral airstairs to facilitate boarding and disembarkation without relying on the presence of ground based steps or an airbridge. When deployed, the left and right extendable handrails are intended to provide protection against people falling sideways off the upper section of the airstairs. Whilst these handrails appear to provide adequate protection for adults, a gap exists between the handrail and the airstairs platform which is large enough to allow a small child to pass through it and fall onto the hardstanding below. At the

The gap between the extendable handrail and the upper platform of the Boeing 737 airstairs, represents a hazard to small children boarding or disembarking the aircraft. Four previous events resulted in the publication of FAA SAIB NM-07-47 in September 2007, the amendment of the Boeing 737 Flight Attendant Manual and the release of two SBs. Whilst these SBs provide increased protection against slipping on the airstairs upper platform, and visual cues to a potential personal injury risk, they do not provide physical protection against a child falling through the gap. The modification proposed by the operator provides a significant visual cue to the lack of a rigid barrier in this area, but provides only a limited physical protection against falling. Therefore, the following Safety Recommendation is made:

It is recommended that Boeing review the design of the Boeing 737 forward airstairs with the intention of adding a removable barrier to minimise the possibility of a child falling through the gap between the extendable handrail and its upper platform.
