ACCIDENT

Aircraft Type and Registration:	Pierre Robin DR400/180, G-BSLA	
No & Type of Engines:	1 Lycoming O-360-A3A piston engine	
Category:	1.3	
Year of Manufacture:	1990	
Date & Time (UTC):	4 November 2005 at 1700 hrs	
Location:	Rochester Airport, Kent	
Type of Flight:	Private	
Persons on Board:	Crew - 1	Passengers - None
Injuries:	Crew - None	Passengers - N/A
Nature of Damage:	Propeller tip damage and engine possibly shock loaded	
Commander's Licence:	Private Pilot's Licence (with night rating)	
Commander's Age:	53 years	
Commander's Flying Experience:	797 hours (of which 350 were on type) Last 90 days - 15 hours Last 28 days - 1 hour	
Information Source:	Aircraft Accident Report Form submitted by the pilot and further enquiries by the AAIB

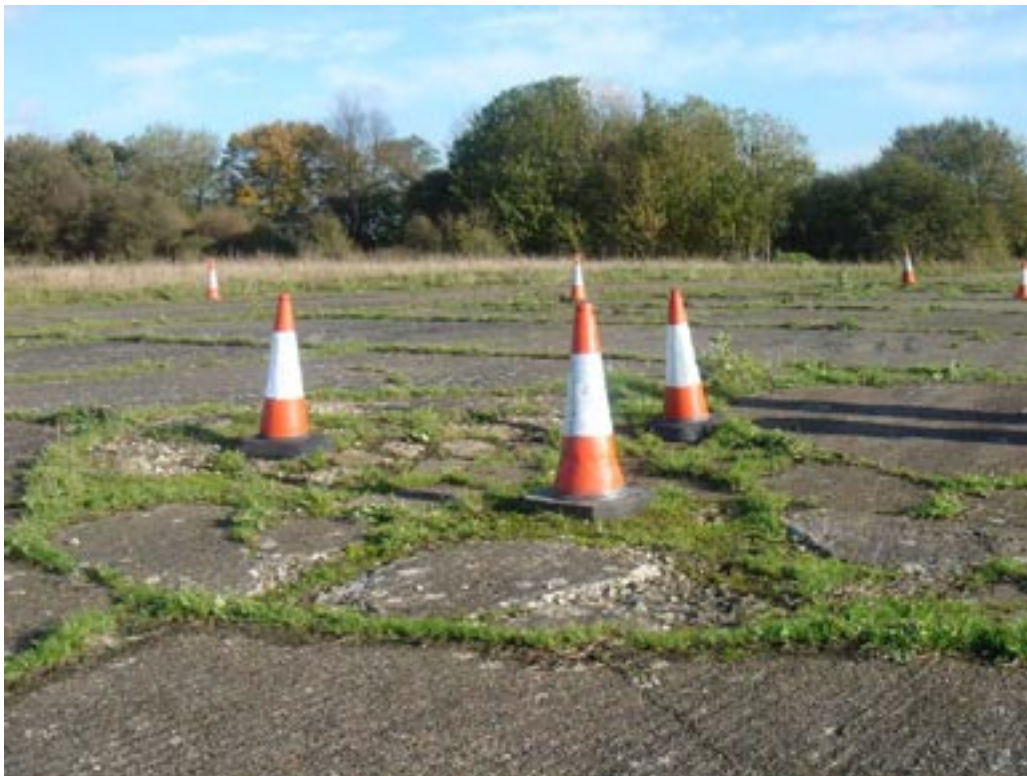
Figure 1

After the incident the airport staff inspected the concrete area and found a depression with propeller strike marks. They placed three traffic cones over the area to warn pilots to stay clear. The pilot inspected the concrete area five days later and measured the depressed area.

He reported that it was approximately 3 m in diameter and was approximately 9 cm deep over most of its area. The area was cracked and had grass growing along the cracks. The propeller strike marks were at the edge of the depressed area.

The propeller strike was caused by the nose gear dropping into the depressed area of concrete. The concrete surface appeared to be poorly maintained and the depression was unmarked at the time of the incident, which occurred after sunset. The soft oleo was probably a contributory factor to the incident and probably allowed the oleo to bottom out, further reducing the already small propeller tip-to-ground clearance. The airport manager was contacted by the AAIB and he said that he planned to have the depressed area of concrete filled.

Depressed area of concrete marked by three cones (post incident)
