ACCIDENT

Aircraft Type and Registration:	X-Air 582, G-BZUP	
No & Type of Engines:	1 Rotax 582/48-2V piston engine	
Year of Manufacture:	2000	
Date & Time (UTC):	4 December 2008 at 1410 hrs	
Location:	Londonderry Park, on approach to Newtownards Airfield, Co. Down, Northern Ireland	
Type of Flight:	Training	
Persons on Board:	Crew - 2	Passengers - None
Injuries:	Crew - None	Passengers - N/A
Nature of Damage:	Damage to right main wheel, nosewheel and propeller	
Commander's Licence:	Private Pilot's Licence (Microlight) with Instructor rating	
Commander's Age:	60 years	
Commander's Flying Experience:	3,008 hours (of which 104 were on type) Last 90 days - 117 hours Last 28 days - 43 hours	
Information Source:	Aircraft Accident Report Form submitted by the pilot and further enquiries by the AAIB

Synopsis

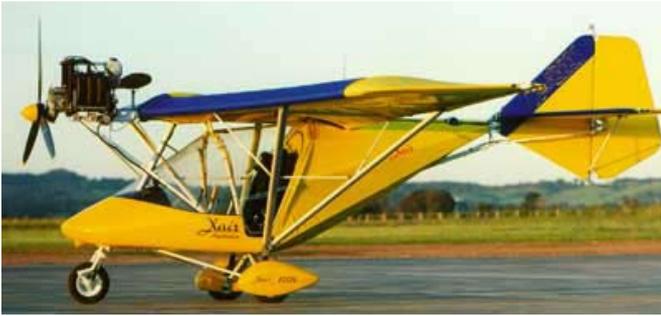
Figure 1

X'Air 582 micro-light aircraft
