ACCIDENT

Aircraft Type and Registration:	MCR-01 VLA , G-TOOT	
No & Type of Engines:	1 Rotax 912-UL piston engine	
Year of Manufacture:	2003	
Date & Time (UTC):	17 April 2010 at about 1622 hrs	
Location:	Weyhill, near Thruxton, Hampshire	
Type of Flight:	Private	
Persons on Board:	Crew - 1	Passengers - 1
Injuries:	Crew - 1 (Fatal)	Passengers - 1 (Fatal)
Nature of Damage:	Aircraft destroyed	
Commander's Licence:	Private Pilot's Licence	
Commander's Age:	55 years	
Commander's Flying Experience:	398 hours (of which 180 were on type) Last 90 days - 14 hours Last 28 days - 5 hours	
Information Source:	AAIB Field Investigation

Synopsis

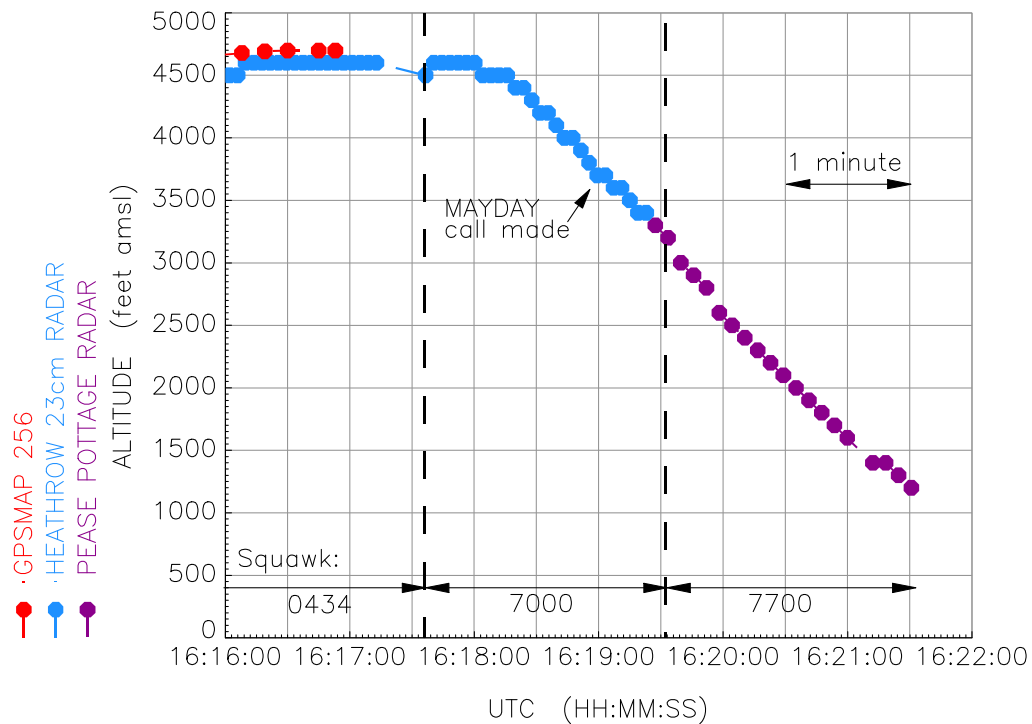
Figure 2 shows that the aircraft started descending 30 seconds after the squawk code of 7000 was selected. The descent rate was approximately 1,000 ft/min. The groundspeed during the descent (not illustrated) remained between 100 and 110 kt, slowing to 80 kt over the last 20 seconds.

G-TOOT altitude and Mode A squawk codes
