No: 7/88

Ref: EW/C1048

Aircraft Type and Registration: Boeing 747-136 G-AWNB

Nature of Damage: Left landing gear support beam end fitting failed, damage to wing top skin panels and secondary structure

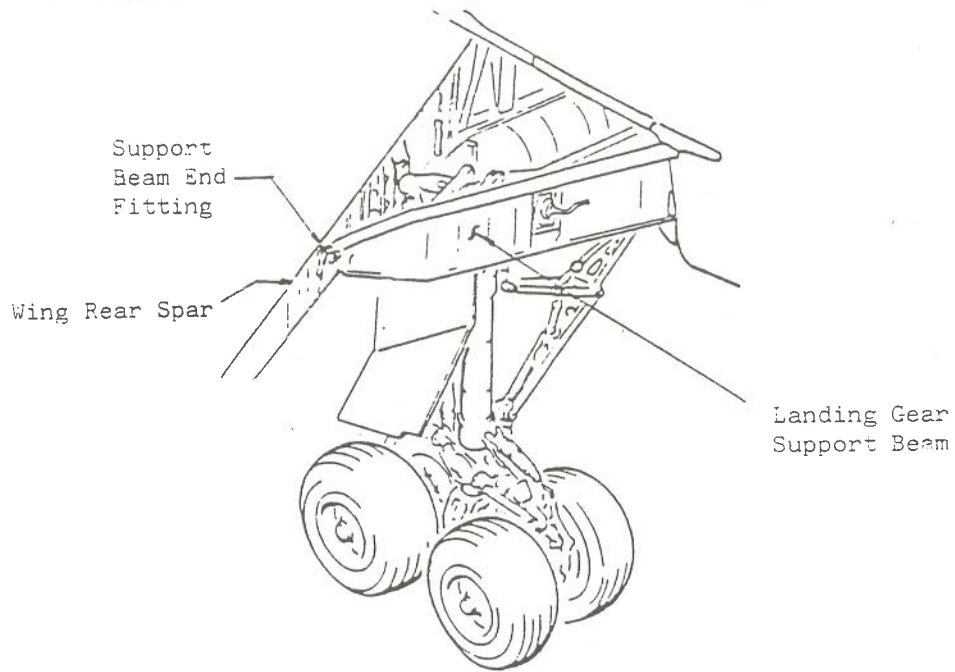
Fig. 1

Examination showed that there had been a failure at the outboard end of the left wing landing gear support beam where it attaches to the aft face of the rear wingspar. The wing gear is mounted between the rear spar and the support beam (see Fig.1). The support beam is designed to be fail-safe in the event of any disconnection at the outboard end. If unsupported at the outboard end the beam, acting as a cantilever, is capable of supporting 90% of the design ultimate undercarriage loads but, at any given load, will deflect to a far greater degree than it would intact. Such deflection will result in abnormal movement of the undercarriage leg and also of the inboard flap, the inboard rail of which is attached to the support beam. There would have been some increased movement of the flap under flight loads but no adverse effect on the aircraft's performance or control was remarked upon by the crew. Upward

bending of the beam had caused it to hit and rupture the light structure and honeycomb sandwich panelling which form the top wing skin aft of the wing box. With this type of failure there is also the possibility of damage to adjacent control cables and hydraulic lines.

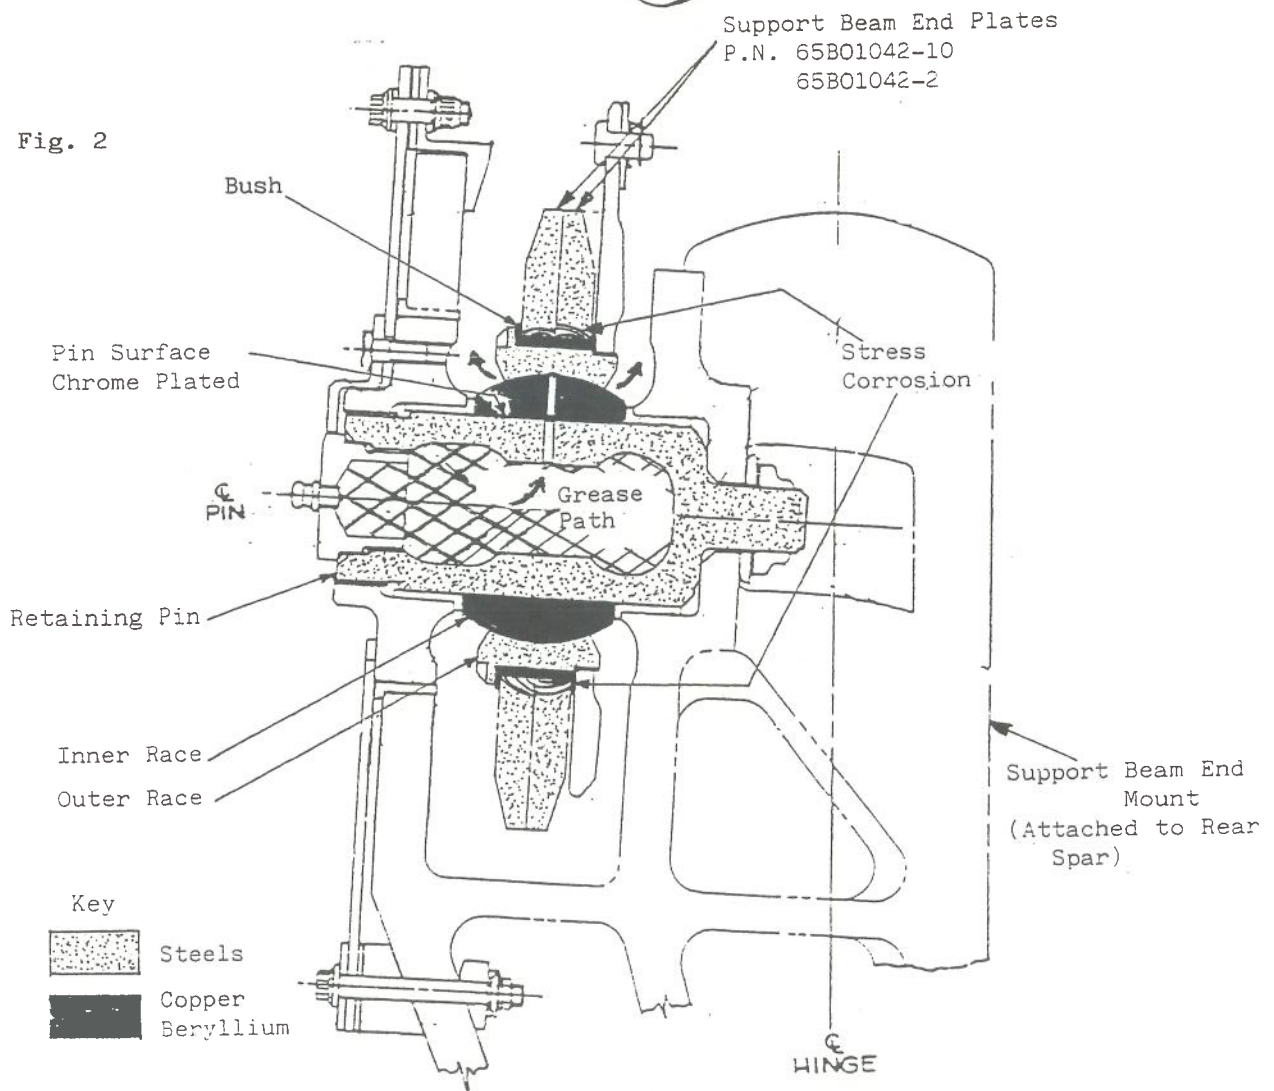
Fig. 2

The outboard end fitting (Fig. 2) is an articulated joint comprising a spherical bearing on the beam which attaches to a separate vertical hinge on the rear wing spar. The spherical bearing is mounted in doubled plates which are clamped to either side of the support beam end. The central retaining pin for the spherical bearing is a hollow fuse pin and lubrication is by grease injected through a nipple into the pin core. Grease then flows outward through passages in the pin and in the copper-beryllium inner race to lubricate the surfaces between the pin (chrome plating on steel) and the inner race and between the inner race and the outer race (stainless steel). The outer race is located in copper beryllium bushes in the support beam end plates. These bush surfaces are not lubricated but are assembled into the beam end plates with wet primer to provide a seal against moisture ingress.

A preliminary metallurgical inspection was carried out by the Materials Department, RAE Farnborough and a full examination by the aircraft manufacturer. The end plates had both suffered nearly identical fractures initiating from the internal bore surfaces; two fractures in each case running inboard along lines focusing on the centre of the bore and angled at about 45° above and below the beam spanwise direction. Small areas of pre-existing cracking could be seen emanating from the bore internal surface (which mates with the copper-beryllium bush). This surface was severely pitted by corrosion which was unevenly distributed over the bore surface but was present at the origins of the cracks. The pre-existing cracking was found to be predominately due to stress-corrosion and the four separate areas of cracking (top and bottom fractures, fore and aft end plates) had penetrated by between 0.1 and 0.3 ins (combined penetration of corrosion and cracking). Later analysis of the end plate material (9Ni-4Co-0.3C) showed it to be within specification.

Following the incident, on the 11th November, the Civil Aviation Authority issued an Emergency Airworthiness Directive (A.D. 012-11-87) requiring an inspection of all Boeing 747-100 and -200 aircraft with over 7 years service using an ultrasonic inspection technique developed by the operator (British Airways J57U113) to detect defects or cracks. This was followed by a further requirement for dismantling and visual inspection of the affected area during the next appropriate scheduled maintenance.

Boeing developed an ultrasonic technique for crack detection of the beam end fitting (NDT Manual, D6-7170, Part 4 Chapter 57-40-03 revision 15 Feb 88) and developed a rework procedure and limits which appeared in Service Letter 747-SL-57-50-A (11 December and subsequent). A Service Bulletin (747-57-2244) issued on 31 March urged operators to carry out the described ultrasonic crack detection procedure upon the accumulation of 30,000 flight hours or 8 years service (whichever earlier) or within 18 months after receipt of the bulletin, whichever later. The bulletin also described the reworking procedure to be carried out if cracking were detected and which also could be implemented to terminate a requirement for 18 monthly repeat inspections. From airframe 696 onward
